VH-MDX

Part 1:

An Initial Overview

Version: 3rd Edition (13th August 2015)

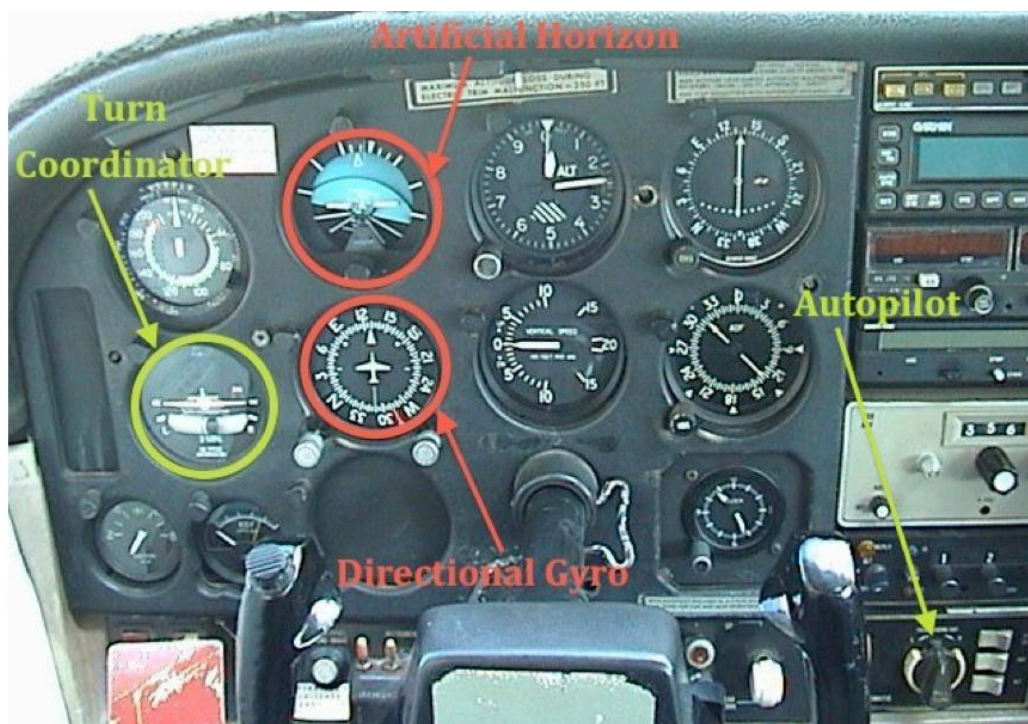
Figure 37: Cessna 210 instrument panel. Red = unserviceable, green = serviceable *gyroscopic* instruments. The AH and DG/DI were vacuum operated and were reported as unserviceable by the pilot of VH-MDX. The TC is electrically driven thus would have been serviceable. Autopilot roll error detection can be sourced from the DI for a 'heading select' type mode via the right knob on the DI or, from the TC for a 'turn-rate hold' type mode. Consequently, the pilot of VH-MDX had the ability to set a turn-rate and thus maintain a steady turn-rate or heading. Heading select was also still possible if the pilot continually, manually adjusted the DI for current compass heading. The autopilot shown is not the exact same model fitted to VH-MDX but, the 'pull-roll' knob is effectively the same (Photo: Glenn Strkalj 2002).

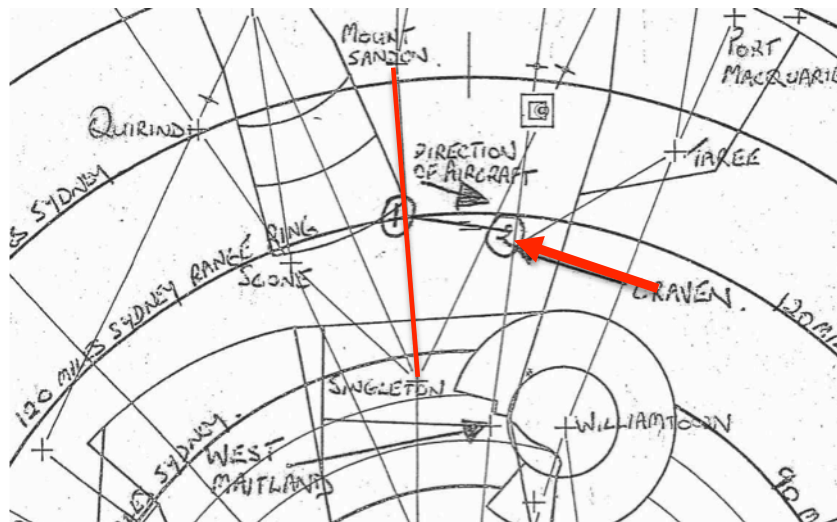
Figure 43: Sydney radar positions of VH-MDX. '1' is the initial Sydney radar position, '2' is the final observed radar position. The red line depicts the Singleton NDB-Mount Sandon NDB track. Craven intersection/waypoint is at the tip of the red arrow (Base image: Australian Government (Department of Transport Australia) 1981, additions: Glenn Strkalj 2014).

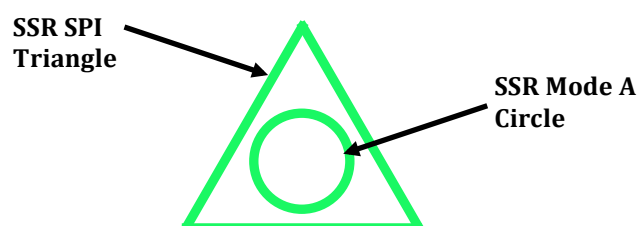
Figure 47: Observed VH-MDX returns at 0936:00UTC. The ATCO cannot recall with *complete* certainty the *type* of SSR mode A symbol that was displayed but was absolutely certain it was observed along with the SPI triangle. The ATCO recalls a circle. The SPI triangle was observed as being unclipped by the outer edge of the PPI and *not* hanging over the 44NM MTI boundary. Primary paints from VH-MDX were not discernable in the terrain clutter (Image: Glenn Strkalj 2014).

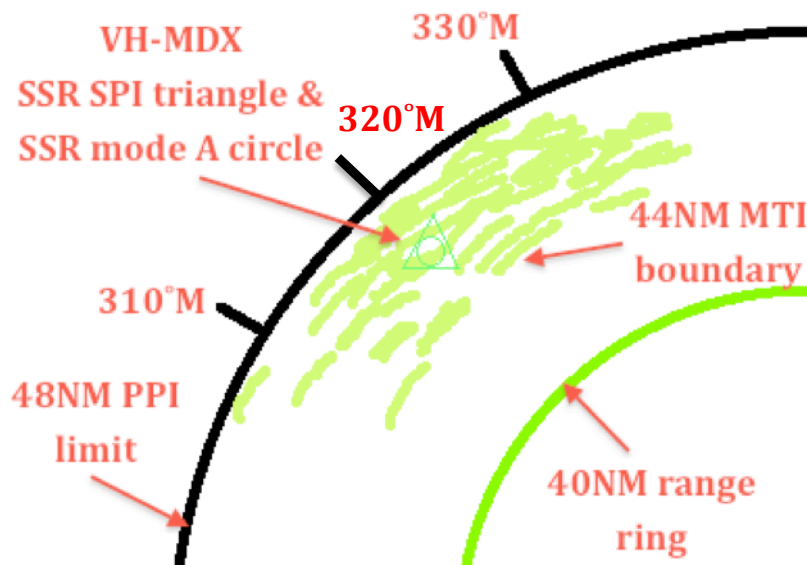
Figure 51: Reported position of the 320°M/45NM fix. SSR returns are purposely dulled down in the picture to show the effect of terrain clutter on the ability to discern returns. Regardless, the Williamtown ATCO did state that the SPI triangle and mode A squawk (circle) were 'clearly visible' despite the clutter due to the *shape* of the symbols cutting across the permanent echoes. 5° bearing checks are also included on the real PPI compass rose (Image: Glenn Strkalj 2014).

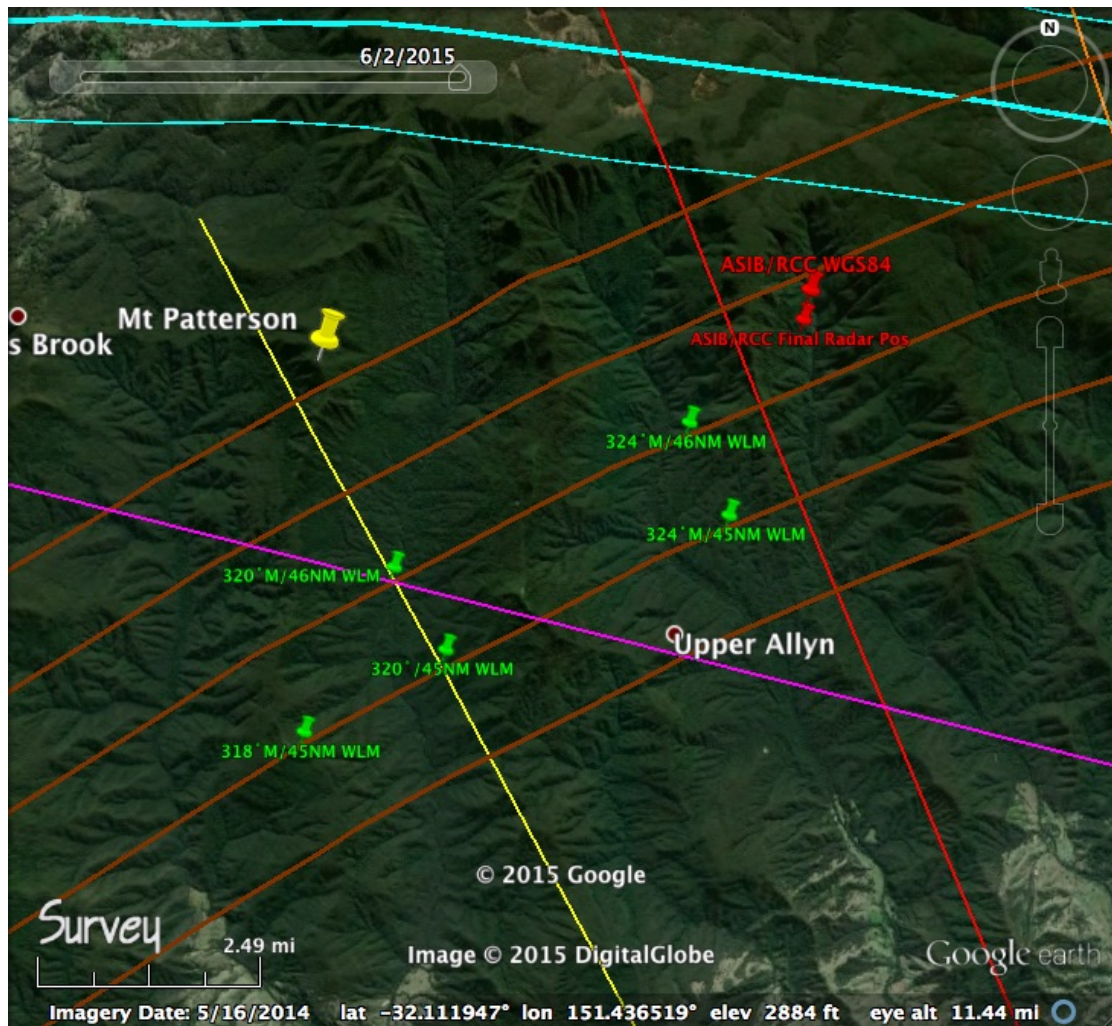
Figure 54: Gating line position and 320°M/45NM fix. Assuming reliance on SSR paints, it is unlikely VH-MDX was at the pure 320°M/45NM position considering this image. An angular position further north of 320°M and a range more than 45NM can be seen to be more probable. This supports various findings indicating the same. If the primary paints were gated in the same way, there would be no VH-MDX paints in the 320°/45NM position (Image: Google Earth 2015, Digital Globe 2015, Additions: Glenn Strkalj 2015).

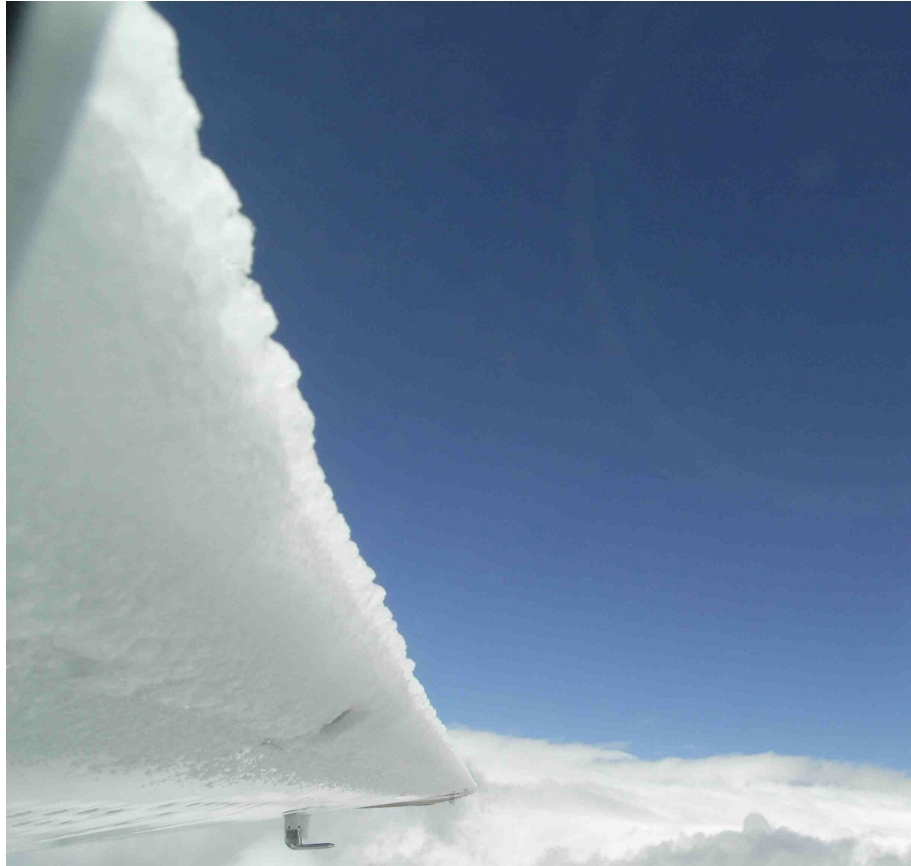
Figure 57: Icing accumulation: Cessna 210 wing leading edge. Significant ice has accumulated on the leading edge and immediately aft and underneath. The pilot's view from the Cessna 210 cockpit does not allow inspection of the critical upper surface of the wing. The effects of the rough and jagged ice on laminar airflow of the wing is readily predictable when viewing this photo. It can be seen why stall speed and drag increases. Additionally, the extra weight of the ice can be significant further burdening performance. The pitot tube under the wing is free of ice indicating that pitot heating was probably selected during this ice encounter.

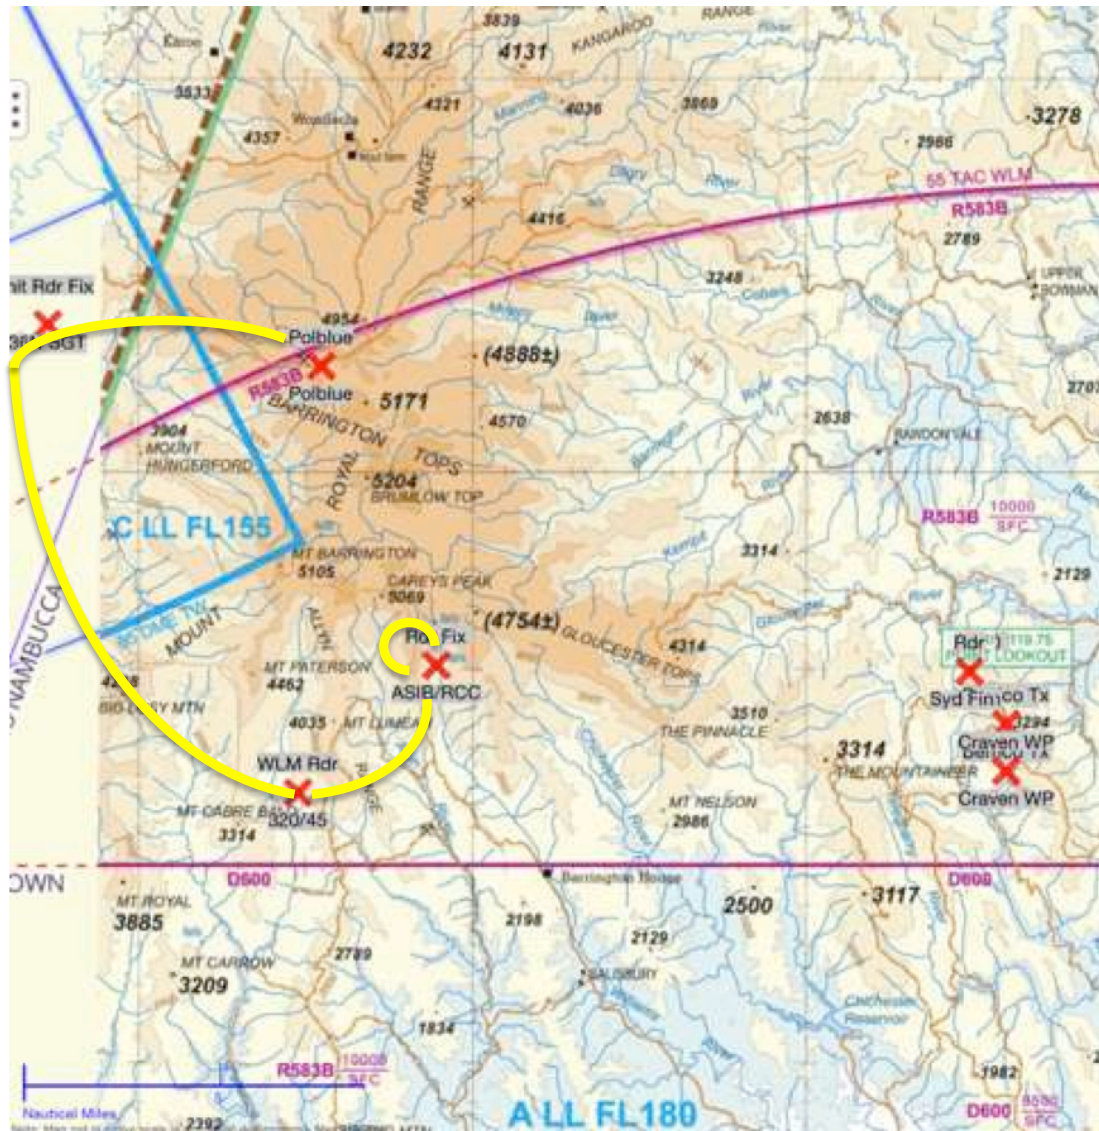
Figure 65: Possible flight path to the ASIB/RCC last radar position. The assumption made here is that a loss of directional control occurred from around 0936:00UTC resulting in a high average turn rate towards the ASIB/RCC final radar position. Communications transcripts can support this theory but they also cast doubt. A Sydney ATCO also suggests VH-MDX tracked from the initial Sydney radar position in a southerly direction followed by a slow rate turn towards the east. This observation does go against the above theory (Base image: OzRunways 2015, additions: Glenn Strkalj 2015).

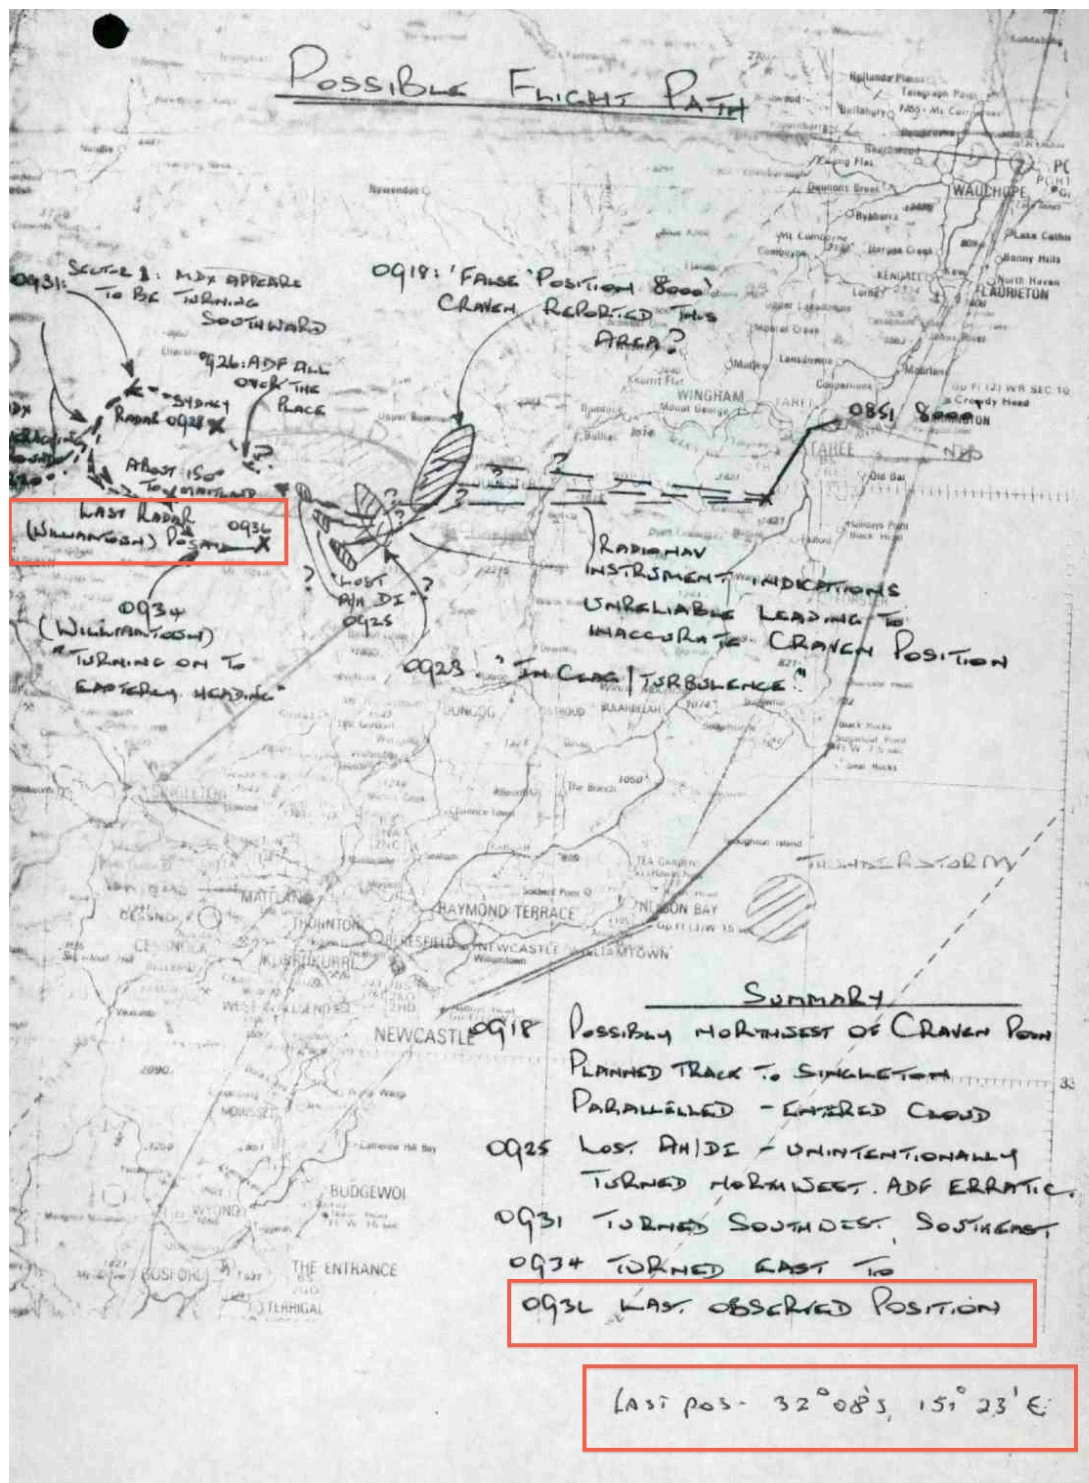
Figure 69: 1983 BASI final radar observed position. The Upper Williams River Valley ASIB/RCC final radar position is no longer classed as the final radar observed position by Williamtown in 1983; it was suggested the 320°M/45NM fix was the final Williamtown radar fix. This does make sense considering transcripts and ATCO interviews. Interestingly, no Sydney ATC final radar position is mentioned (Image: Australian Government (Bureau of Air Safety Investigation) 1981, Additions: Glenn Strkalj 2015).

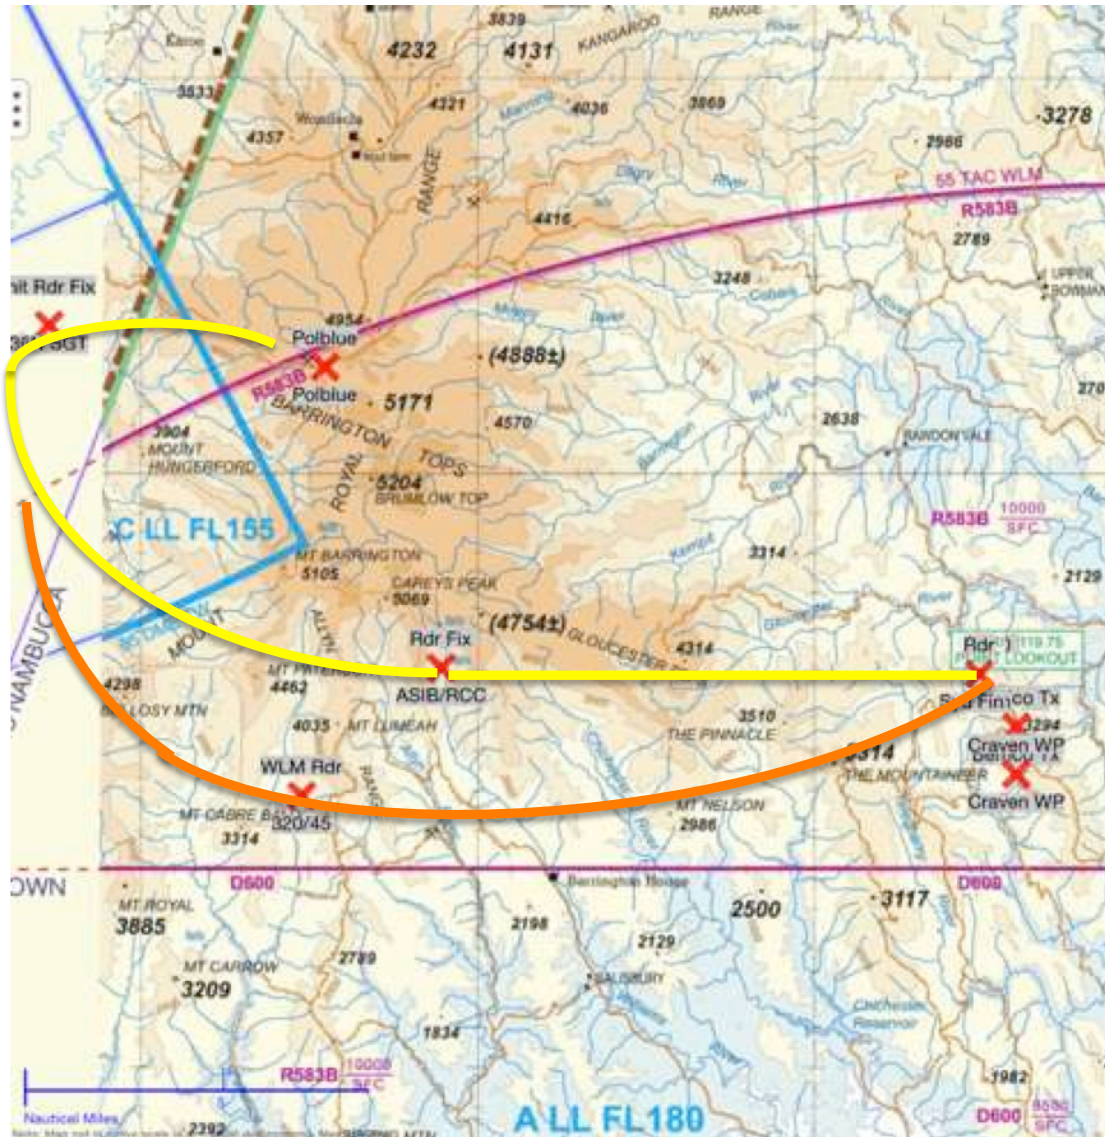
Figure 72: Approximate tracks to the Sydney final radar position. The ASIB/RCC final radar position could simply be a composite or refined version of the 0936:00UTC or 0938:30 Williamtown radar positions. There was much confusion in the RCC during the initial period following the accident and this position could simply have been miss labeled. Passing through the ASIB/RCC final position (as the fix at 0936:00UTC) would better fit the Williamtown ATCO's description of VH-MDX being '...just over the top of the Barrington Tops'^[1] and resolve the issue of two 'final' radar positions (yellow track). Such a track would also have taken VH-MDX through the worst weather (closer to the tops). Either track fits the description by a Sydney ATCO of a slow turn towards the east observed on radar. Equally, this position could represent the 0938:30UTC 330°M bearing position (Base chart: OzRunways 2014, Additions: Glenn Strkalj 2015).
