VH-MDX

Part 1:

An Initial Overview

Version: 2nd Edition (2nd July 2015)

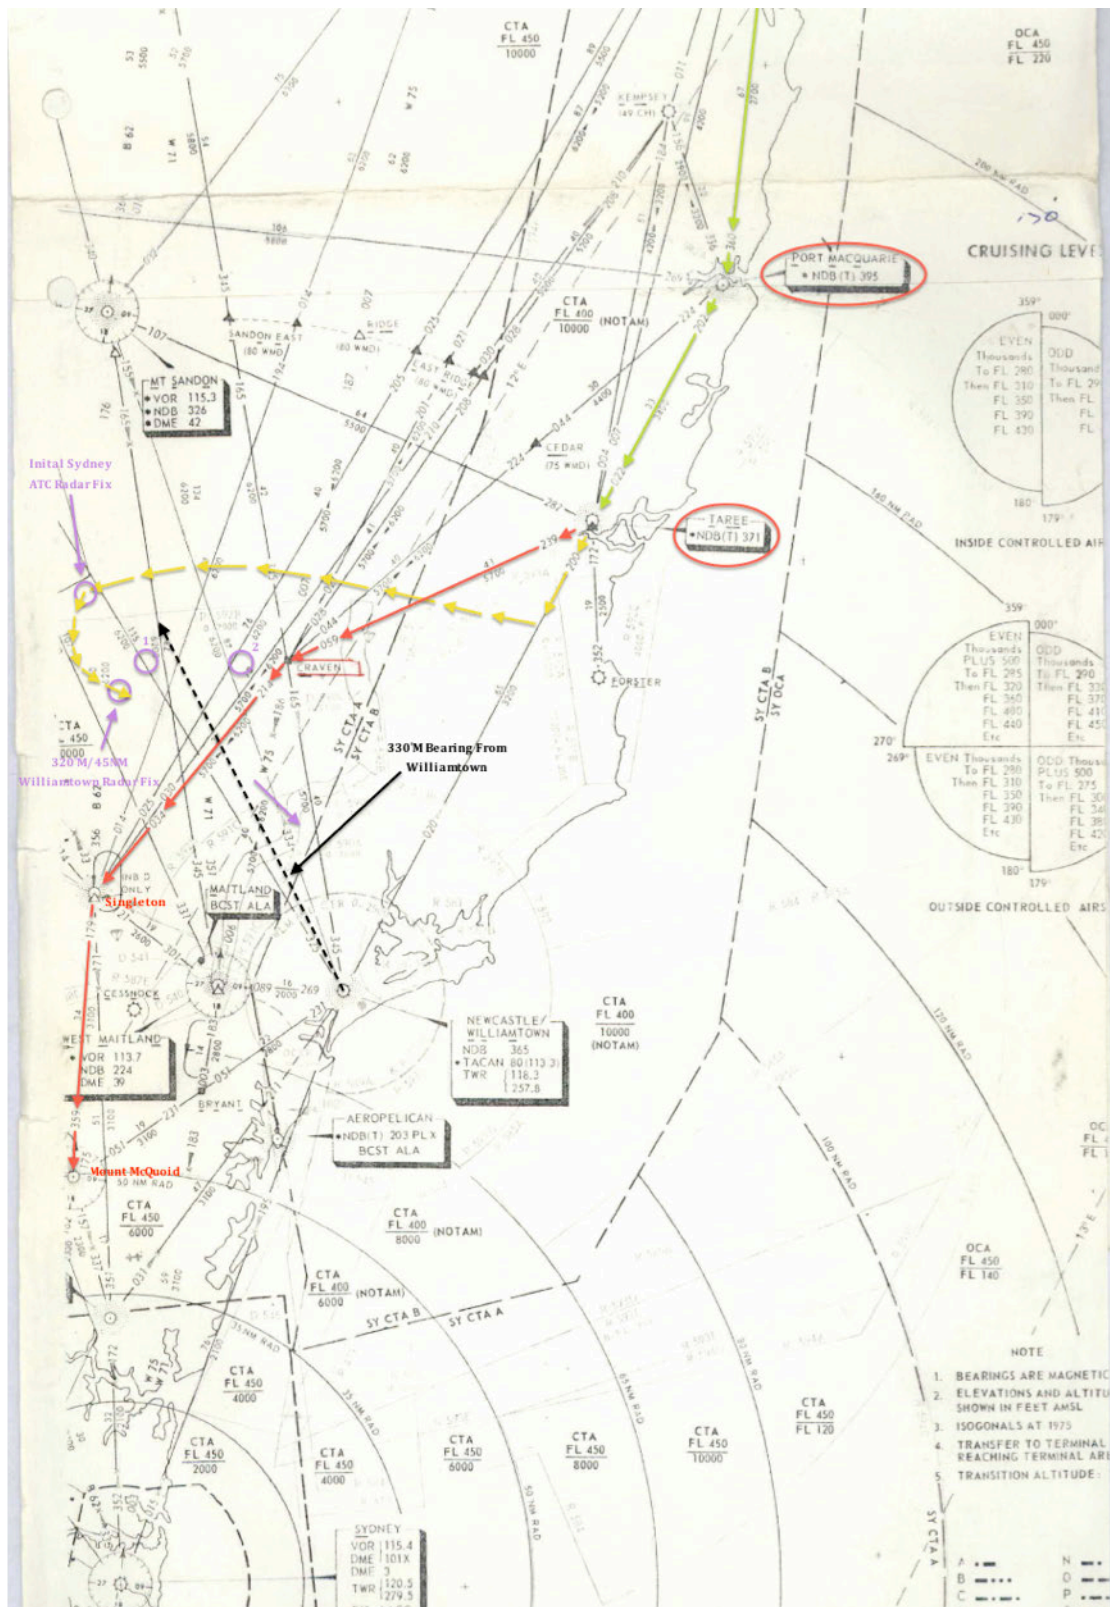
Figure 22: Flight progress Coffs Harbour onwards. Green arrows represent actual flight path, yellow one possible flight path and red the original flight plan route from Taree. Radar positions are represented with purple circles with circle '1' being the ASIB/RCC final radar position, circle '2' being the Sydney ATC deposited final radar position. The 330°M bearing from Williamstown is also shown. The position of Scone NDB is indicated off the chart with a black star (Base image: Australian Government, (Department of Transport Australia) c.1981).

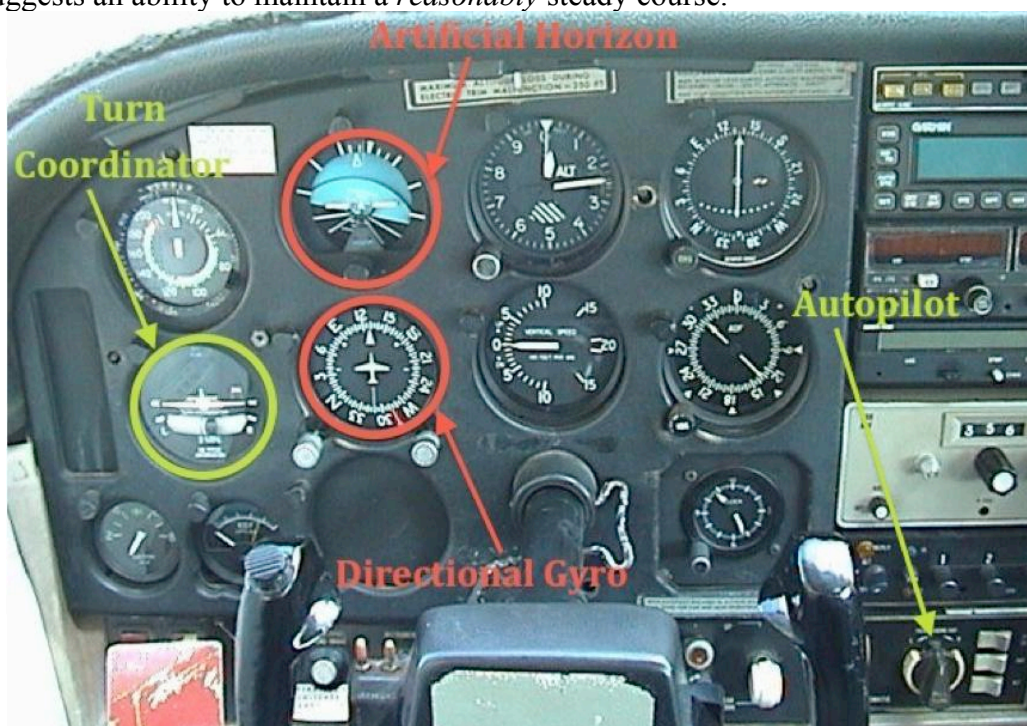
Figure 37: Cessna 210 instrument panel. Red = unserviceable, green = serviceable *gyroscopic* instruments. The AH and DG/DI were vacuum operated and were reported as unserviceable by the pilot of VH-MDX. The TC is electrically driven thus would have been serviceable. Autopilot roll error detection can be sourced from the DI for a 'heading select' type mode via the right knob on the DI or, from the TC for a 'turn-rate hold' type mode. Consequently, the pilot of VH-MDX had the ability to set a turn-rate and thus maintain a steady turn-rate or heading. Heading select was also still possible if the pilot continually, manually adjusted the DI for current compass heading. The autopilot shown is not the exact same model fitted to VH-MDX but, the 'pull-roll' knob is effectively the same (Photo: Glenn Strkalj 2002).

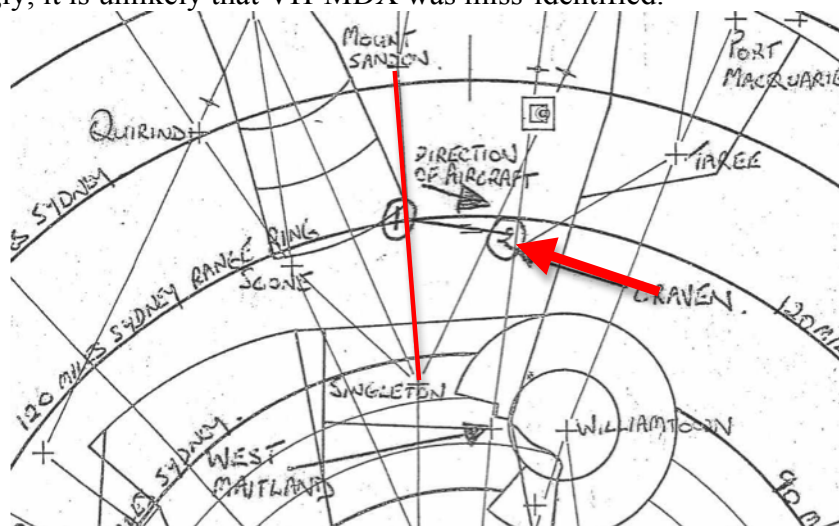
Figure 43: Sydney radar positions of VH-MDX. '1' is the initial Sydney radar position, '2' is the final observed radar position. The red line depicts the Singleton NDB-Mount Sandon NDB track. Craven intersection/waypoint is at the tip of the red arrow (Base image: Australian Government (Department of Transport Australia) 1981, additions: Glenn Strkalj 2014).

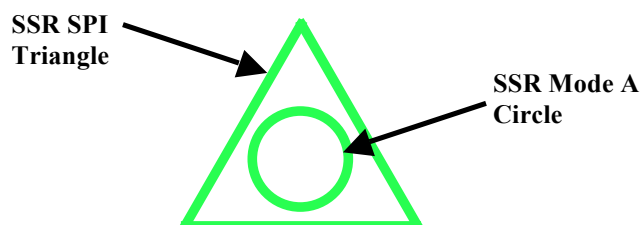
Figure 47: Observed VH-MDX returns at 0936:00UTC. The ATCO cannot recall with *complete* certainty the *type* of SSR mode A symbol that was displayed but was absolutely certain it was observed along with the SPI triangle. The ATCO recalls a circle. The SPI triangle was observed as being unclipped by the outer edge of the PPI and *not* hanging over the 44NM MTI boundary. Primary paints from VH-MDX were not discernable in the terrain clutter (Image: Glenn Strkalj 2014).

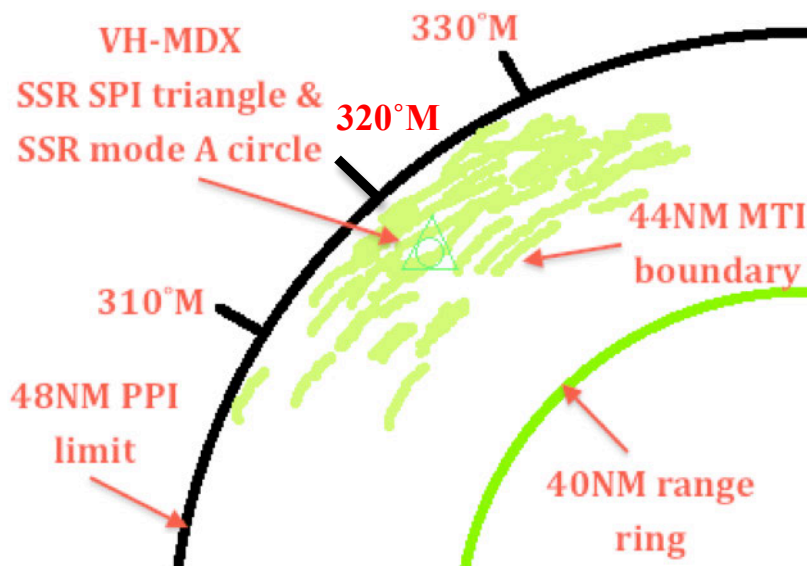
Figure 51: Reported position of the 320°M/45NM fix. SSR returns are purposely dulled down in the picture to show the effect of terrain clutter on the ability to discern returns. Regardless, the Williamtown ATCO did state that the SPI triangle and mode A squawk (circle) were ‘clearly visible’ despite the clutter due to the *shape* of the symbols cutting across the permanent echoes. 5° bearing checks are also included on the real PPI compass rose (Image: Glenn Strkalj 2014).

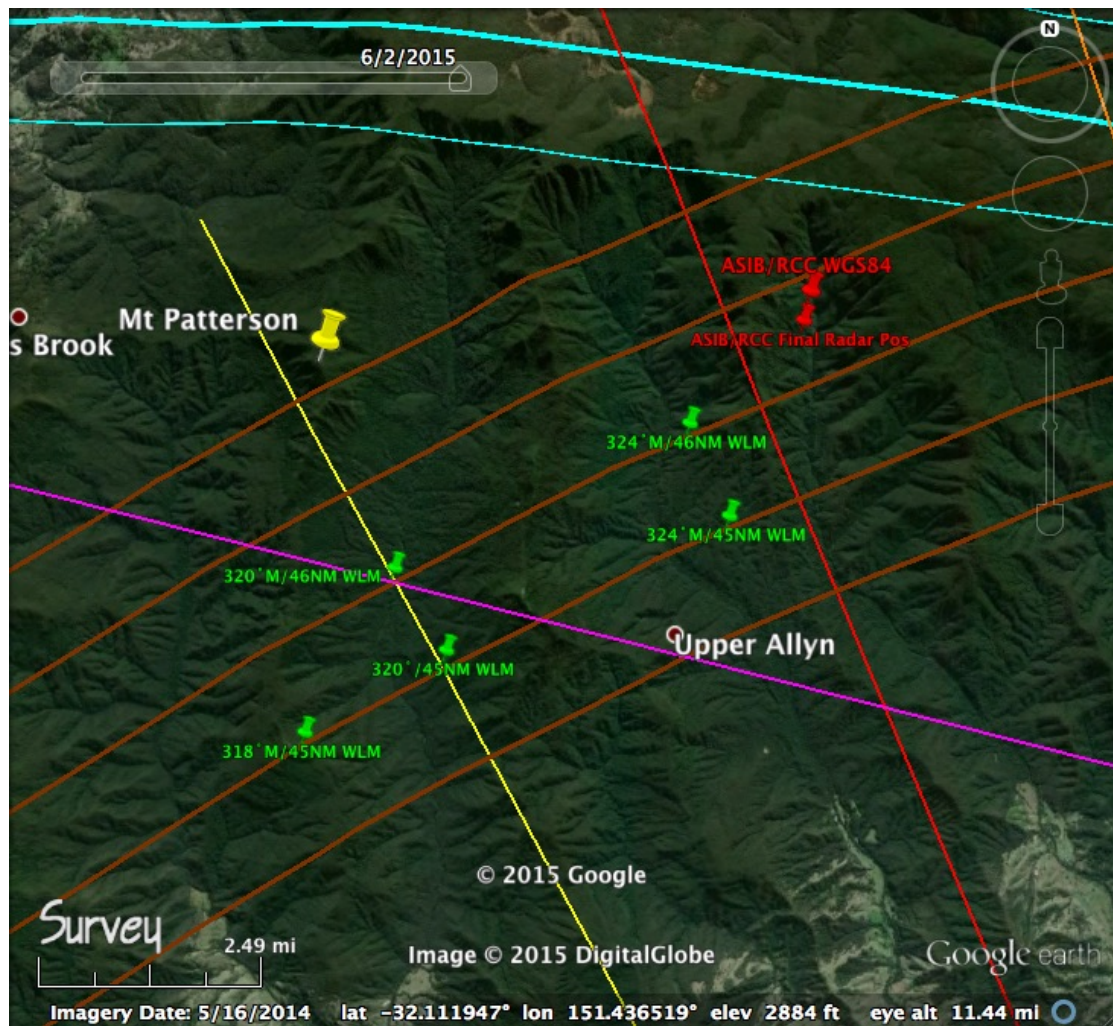
Figure 54: Gating line position and 320°M/45NM fix. Assuming reliance on SSR paints, it is unlikely VH-MDX was at the pure 320°M/45NM position considering this image. An angular position further north of 320°M and a range more than 45NM can be seen to be more probable. This supports various findings indicating the same (Image: Google Earth 2015, additions: Glenn Strkalj 2015).

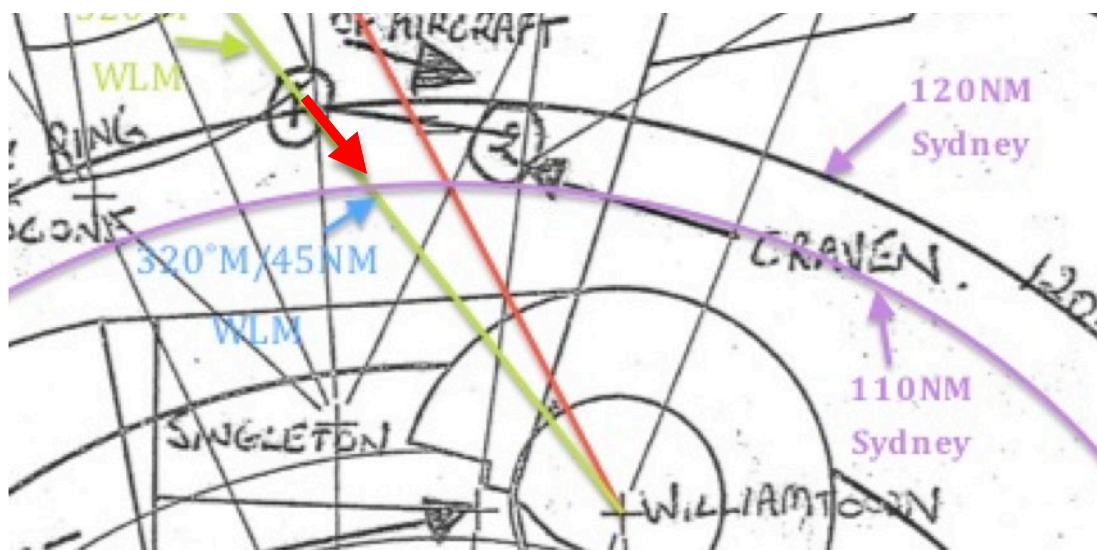
Figure 56: Overall track of 150°M. Readily seen is the overall progress of VH-MDX from the initial Sydney radar position to 320°M/46NM being close to 150° (Image: Australian Government (Department of Transport) 1981, additions Glenn Strkalj 2014).

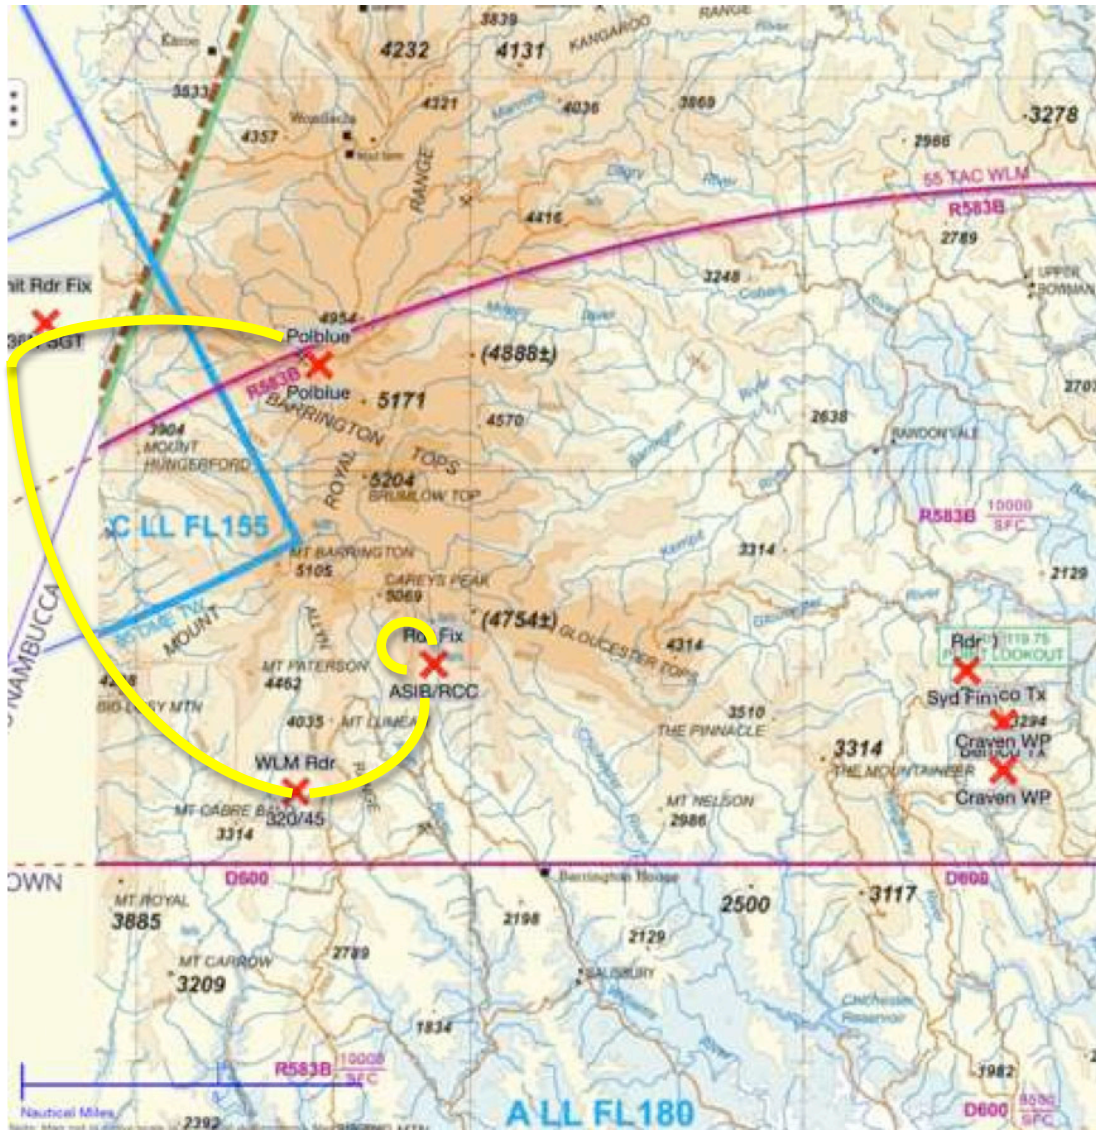
Figure 63: Possible flight path to the ASIB/RCC last radar position. The assumption made here is that a loss of directional control occurred from around 0936:00UTC resulting in a high average turn rate towards the ASIB/RCC final radar position. Communications transcripts can support this theory but they also cast doubt. A Sydney ATCO also suggests VH-MDX tracked from the initial Sydney radar position in a southerly direction followed by a slow rate turn towards the east. This observation does go against the above theory (Base image: OzRunways 2015, additions: Glenn Strkalj 2015).

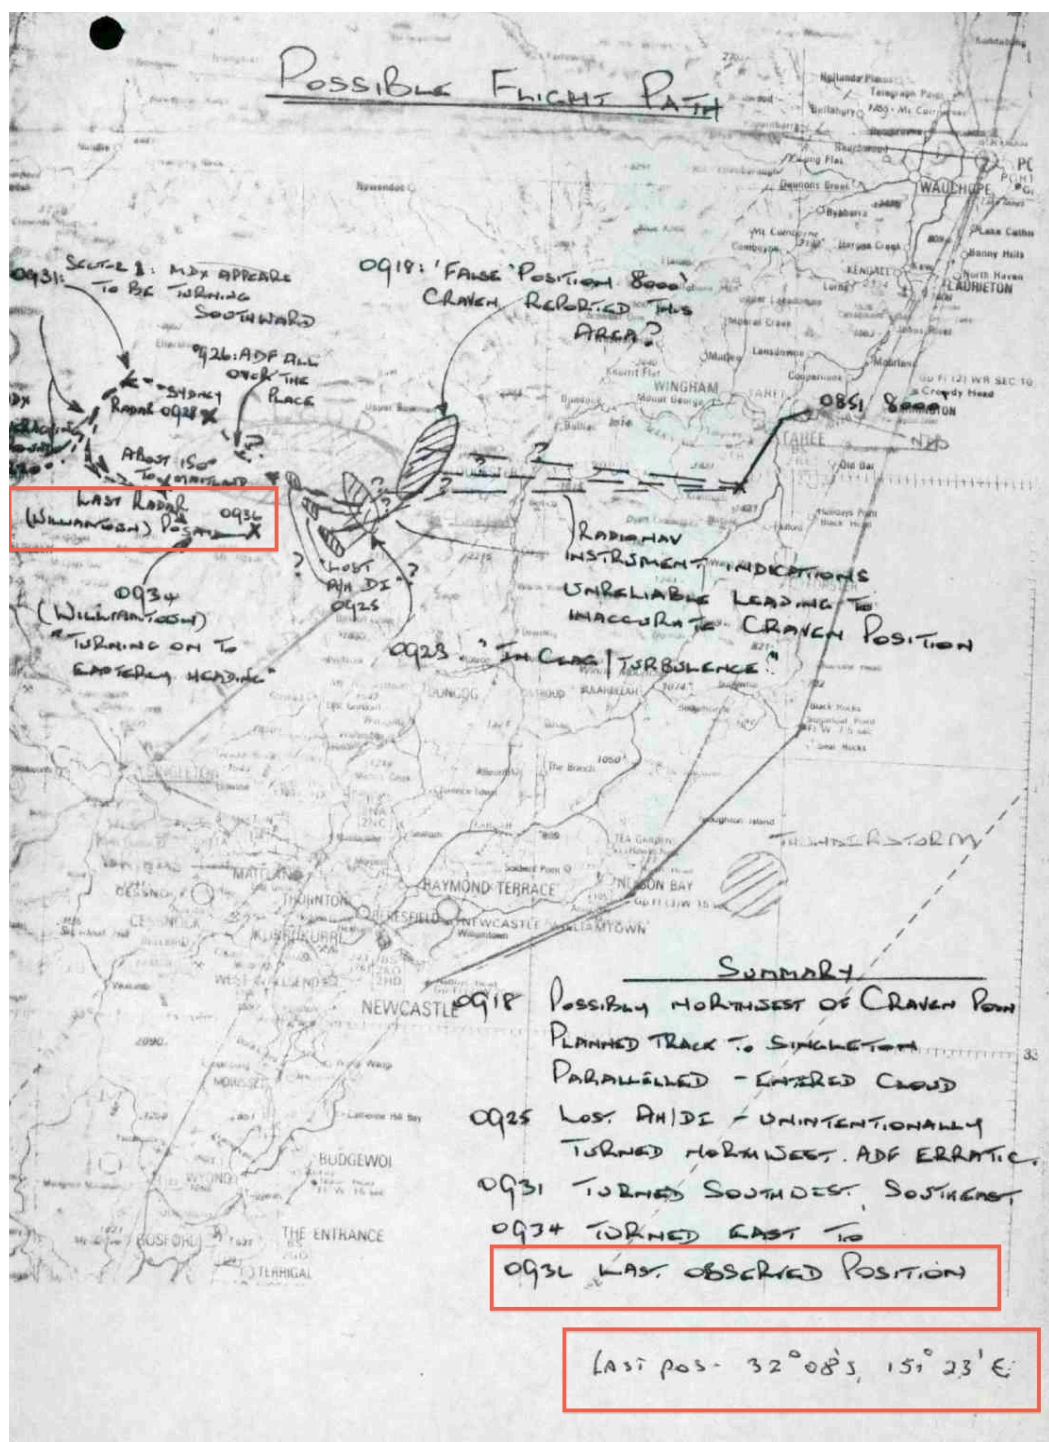
Figure 67: 1983 BASI final radar observed position. The Upper Williams River Valley ASIB/RCC final radar position is no longer classed as the final radar observed position by Williamstown in 1983; it was suggested the 320°M/45NM fix was the final Williamstown radar fix. This does make sense considering transcripts and ATCO interviews. Interestingly, no Sydney ATC final radar position is mentioned (Image: Australian Government (Bureau of Air Safety Investigation) 1981, modifications, Glenn Strkalj 2015).

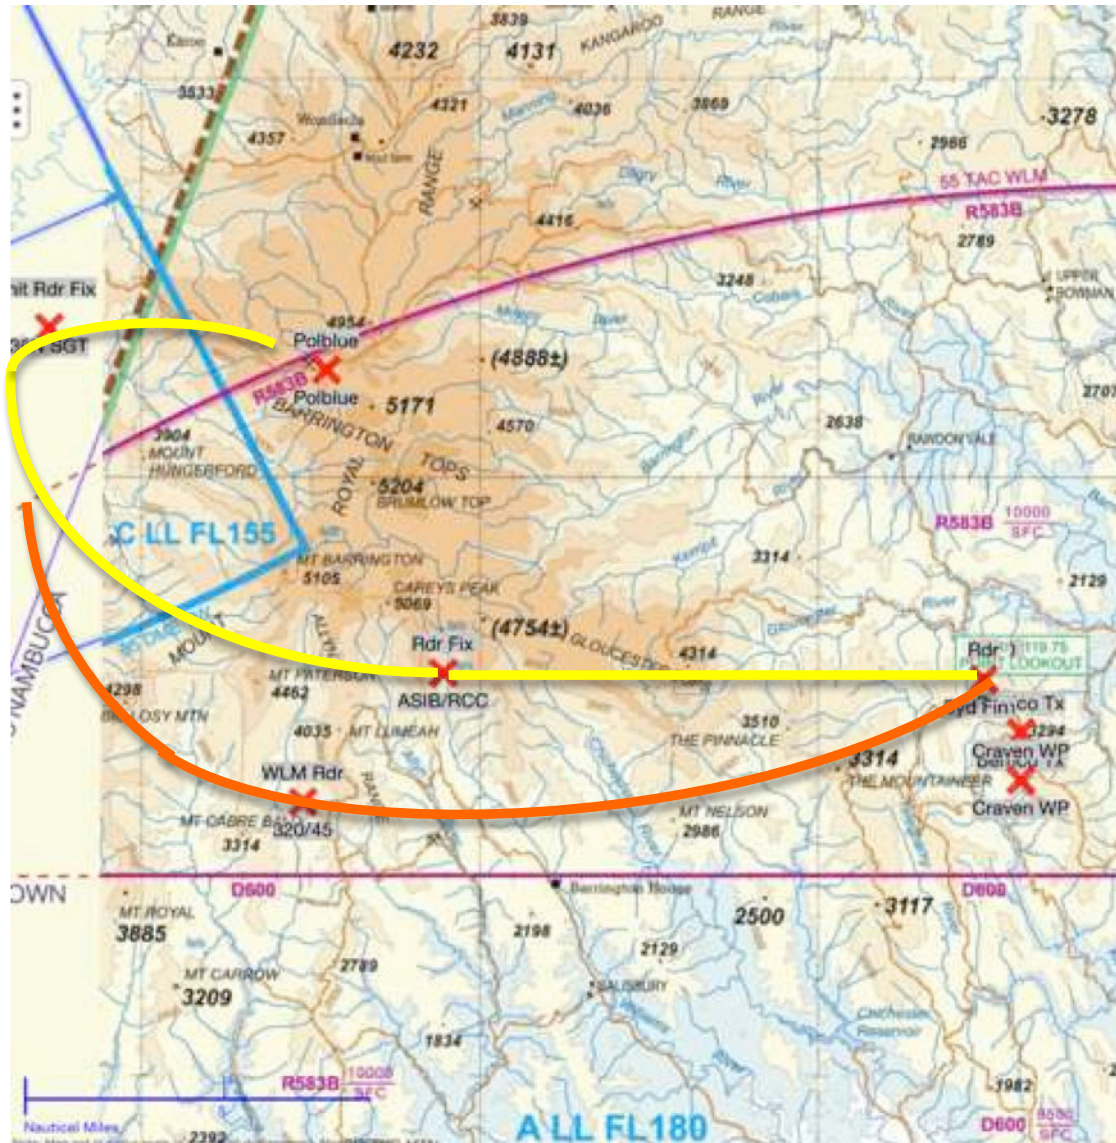
Figure 68: Approximate tracks to the Sydney final radar position. The ASIB/RCC final radar position could simply be a composite or refined version of the 0936:00UTC or 0938:30 Williamtown radar positions. There was much confusion in the RCC during the initial period following the accident and this position could simply have been miss labeled. Passing through the ASIB/RCC final position (as the fix at 0936:00UTC) would better fit the Williamtown ATCO’s description of VH-MDX being ‘...just over the top of the Barrington Tops’^[1] and resolve the issue of two ‘final’ radar positions (yellow track). Such a track would also have taken VH-MDX through the worst weather (closer to the tops). Either track fits the description by a Sydney ATCO of a slow turn towards the east observed on radar. Equally, this position could represent the 0938:30UTC 330°M bearing position (Base chart: OzRunways 2014, additions: Glenn Strkalj 2015).
