## Operation Wittenoom VH-MDX Research

### Introduction

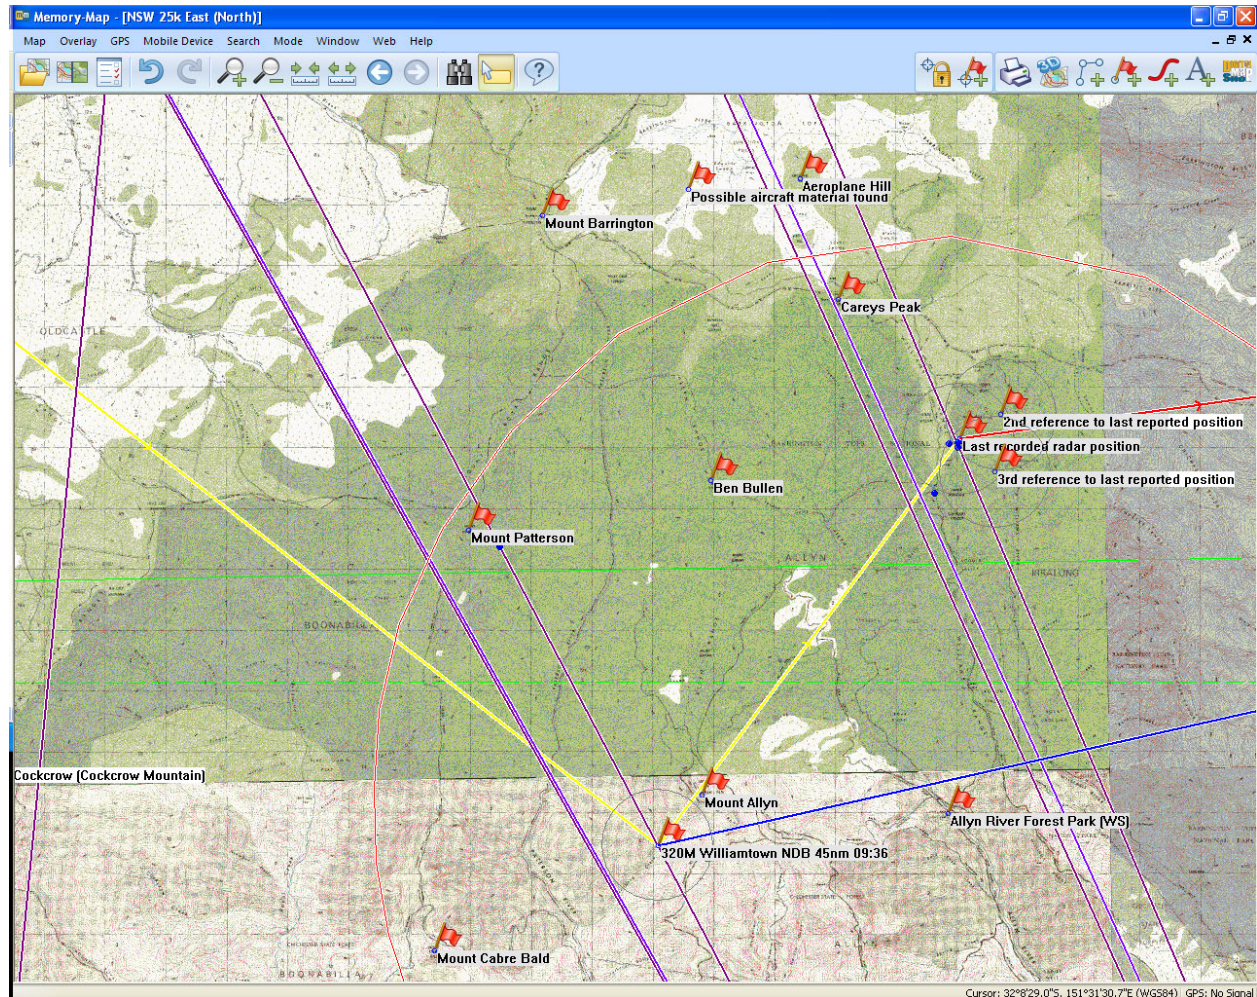
From here MDX was seen to be tracking easterly, and was descending at very high rates of descent. This here is some of the highest ground in the area (for example, Mount Patterson being about 4390 feet AMSL and Careys peak being about 4899 feet AMSL). There are several ridges and valleys parallel to each other that run roughly north/south. The aircraft was heading perpendicular to those and the wind was blowing from the west, also running roughly perpendicular to them. This would have created a phenomenon known as 'lee waves' which are a form of atmospheric standing wave. Below is a simplified diagram of a lee wave.

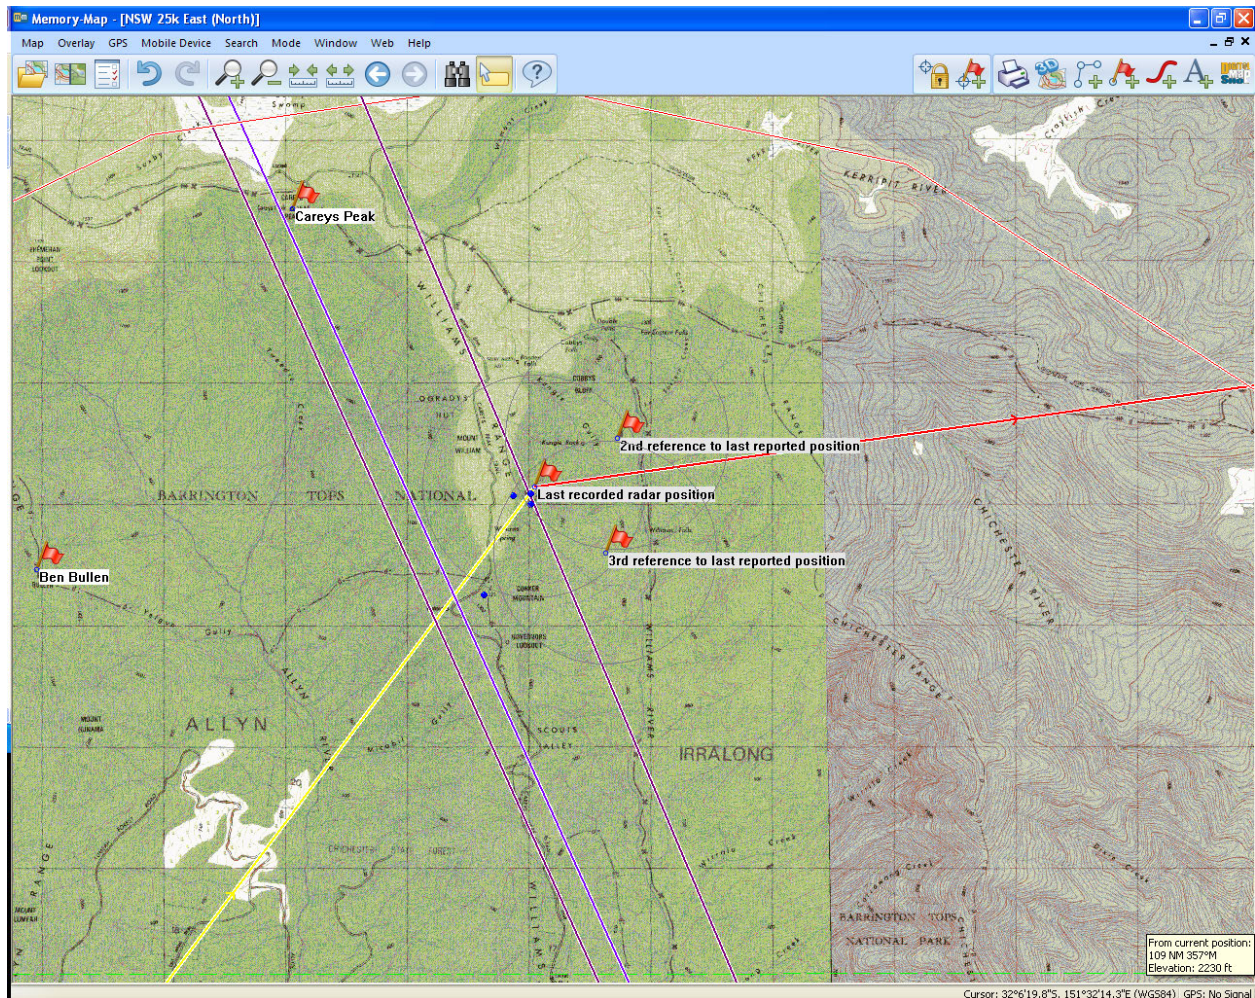
As can be seen by the above map, the last recorded radar position is just slightly east of the highest point on Williams Range. There are three references to the 'last observed radar position' in the initial investigation, and as can be seen, they are all nearly centered on this point. The circles around each flag are 1nm in diameter, and this is the size of the plot on the radar controllers screen that they would have occupied, superimposed on the map. To clarify, the controller would have seen MDX as a plot about 1 mile in diameter, as the radar cross section of such an aircraft is substantially bigger than the actual aircraft. Therefore, every radar fix needs to contain a 'tolerance' of about 1nm. The red line indicates the projected flight path, as suggested by Operation Phoenix.

As I mentioned, these are all just east of the highest point on Williams range (about 4500 feet AMSL). The aircraft was only about 500-600 feet above the terrain at this point, and well in the grip of a very powerful downdraught associated with lee waves. The ATSB fact sheet on mountain waves says –

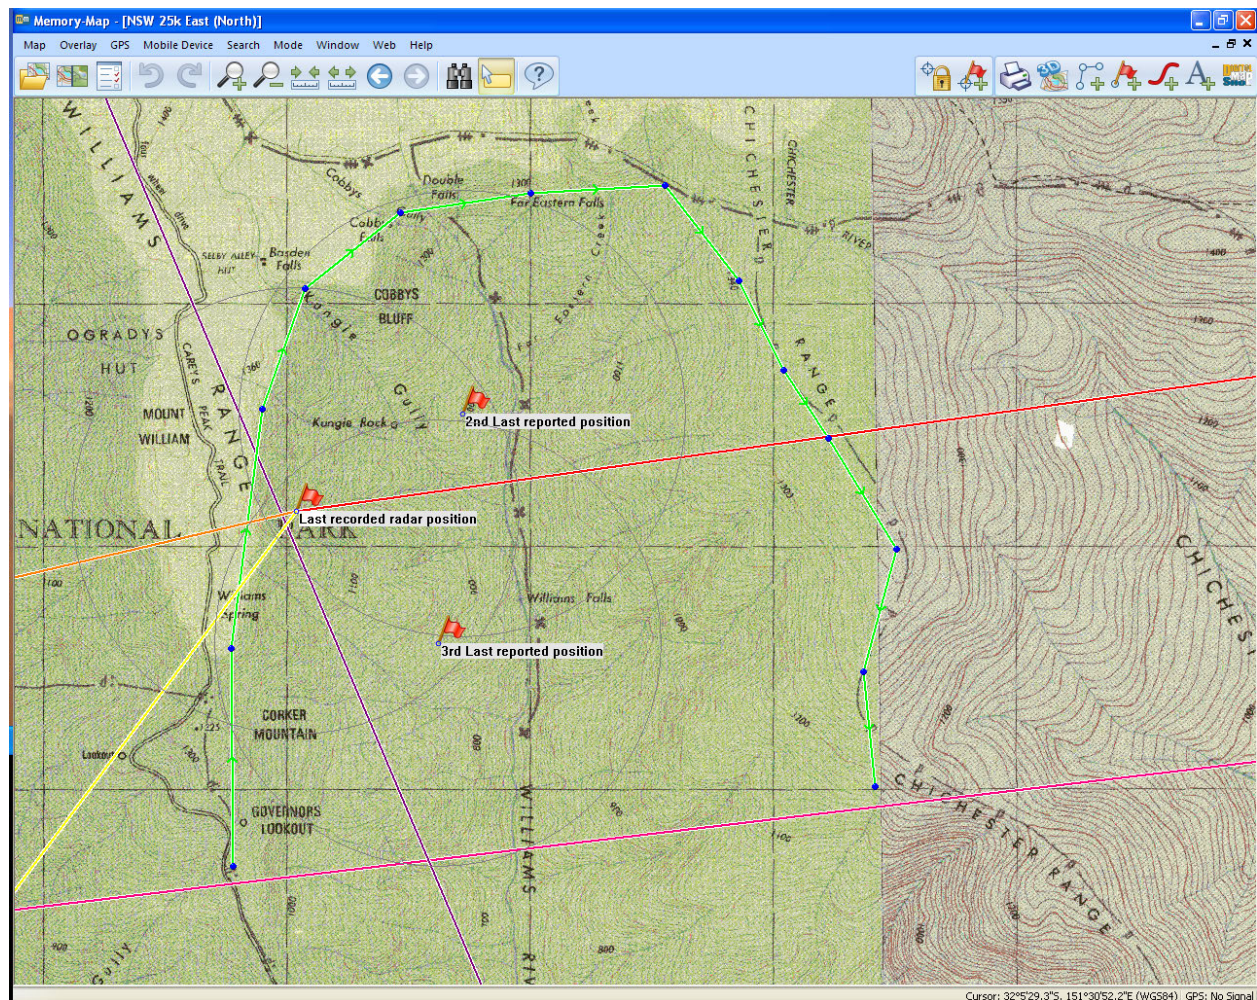
The Cessna C206 is a very similar aircraft to a 210 in terms of performance and build structure. It is therefore my opinion that the aircraft crashed somewhere in the Williams river valley, very close to where it originates.

This site, shown above on the map in bright green, has many properties appropriate to the possible crash site of MDX.

- It has high terrain on all sides, just below the last reported height of MDX.
- It would have had very strong lee waves blowing as a tailwind on MDX, pushing it down into the valley.
- It was observed to fade from radar over this point
- This area was never searched in the original foot search for the aircraft. See the GE image below which has the original search areas superimposed on it.
- It is heavily vegetated, with triple canopy forest and very steep terrain.

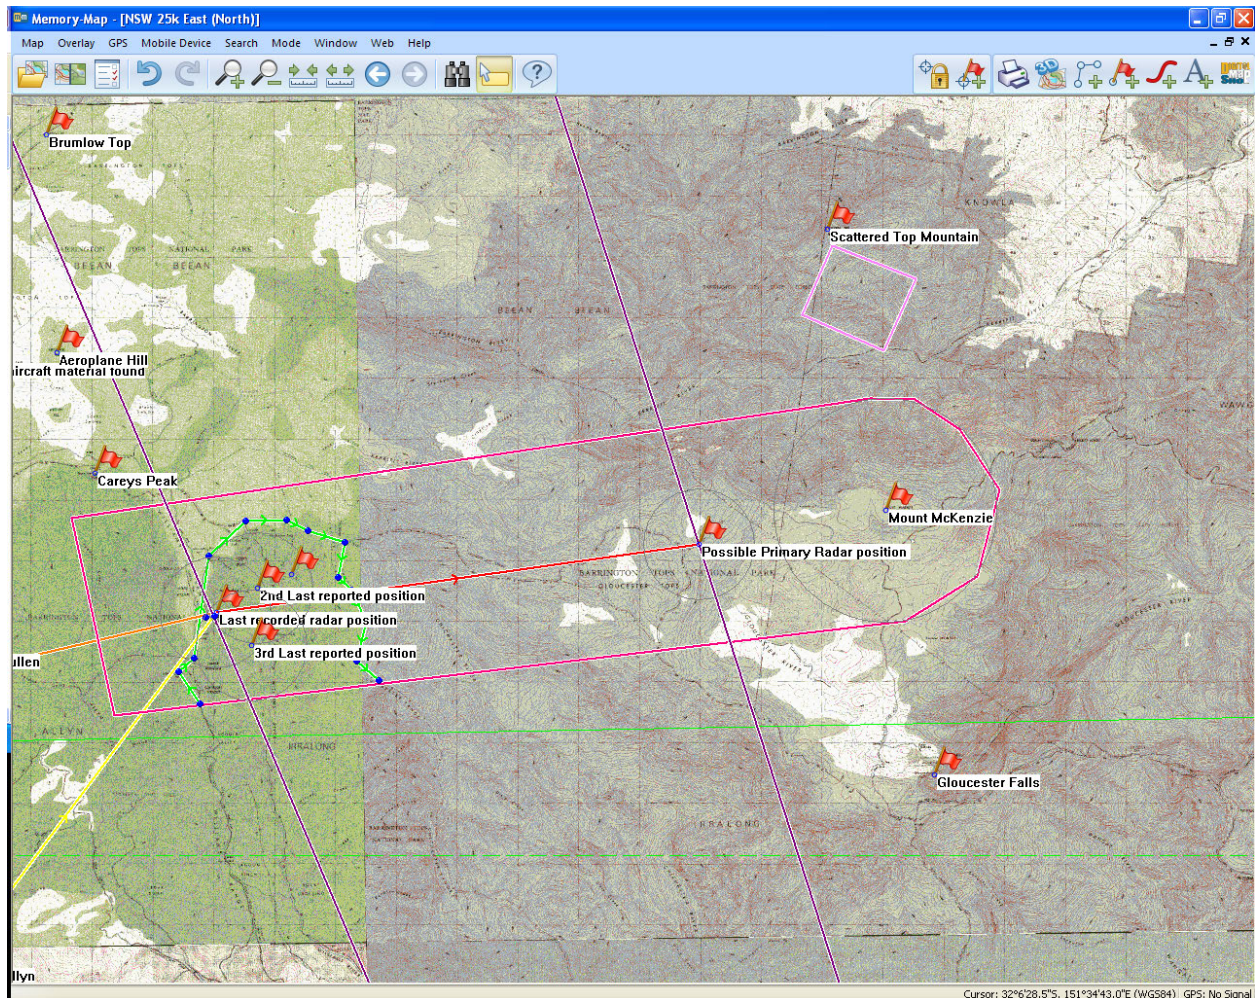
Below is a continuation beyond the final radar position that is posited by Don.

He is using a few words on the last page of the transcript where the Williamtown controller makes reference to a bearing of 330, without a range included. Before this, the controller mentions his MTI gate twice, meaning he no longer has MDX's SSR paint (which requires the transponder), but may still have the primary paint, which he mentions. As explained in the radar section, this would have been very difficult for even an experienced controller to discern from the atmospheric clutter (clouds/rain/snow/sleet) and ground clutter. It is more than likely it was this that the radar operator was seeing. There is not enough time from the final place he was identified to get to the 330 radial, and certainly not enough time to get to Scattered Top mountain. Further to this, the aircraft was descending at roughly 1700 feet per minute. Even if the final paint were accurate, MDX would not have had the required terrain clearance to go from that position to Scattered Top, as there is the high ground of Mount McKenzie to the north and east in between.

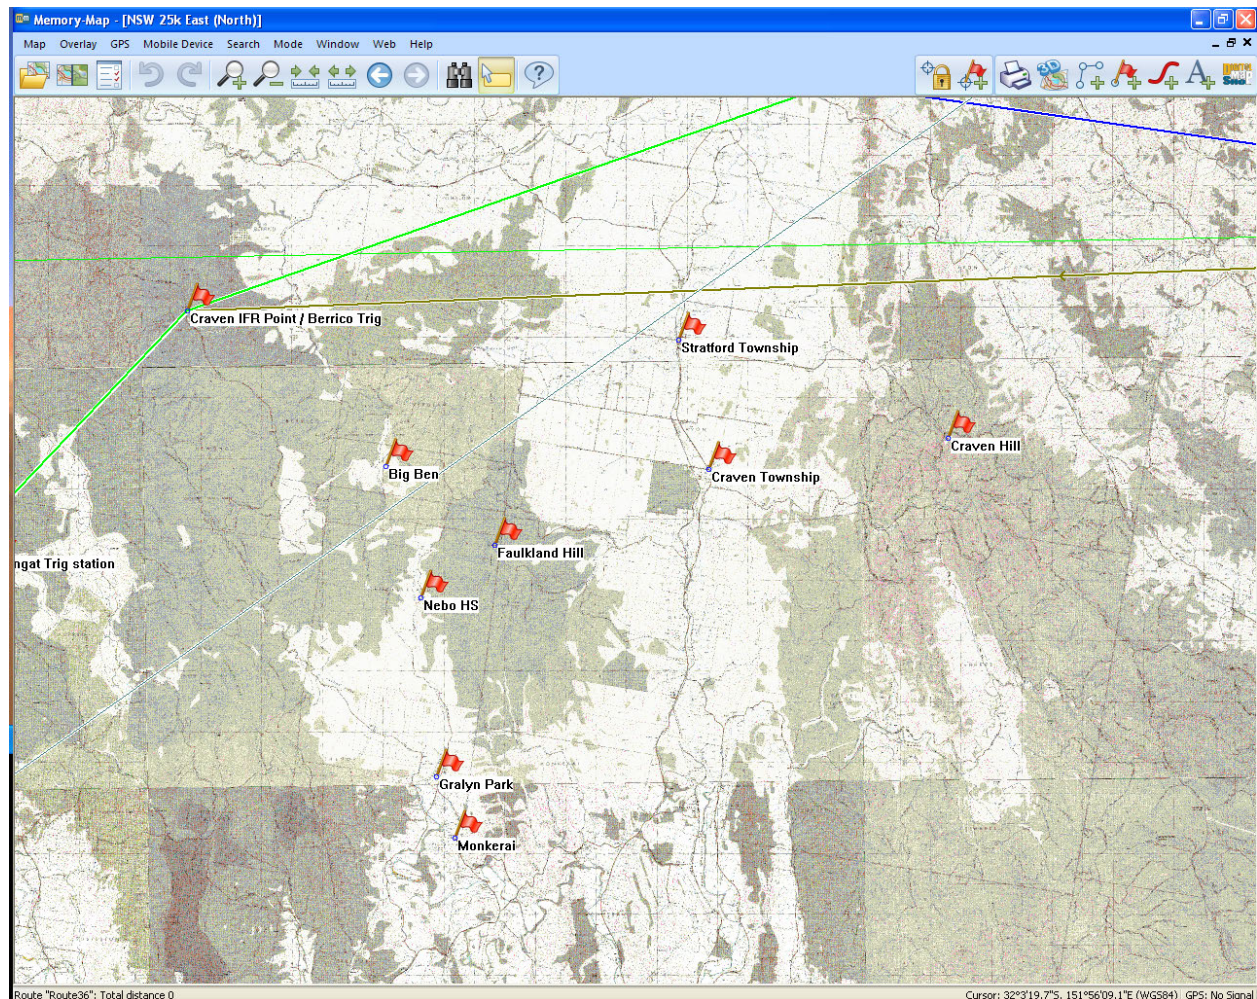
Don suggests that the aircraft was seen 5 people at flagged points on the above picture, yet no more than one person saw an aircraft in a region no more than 300 meters across and populated by 5 times that amount of people?

Add the strong wind degrading anyone's ability to hear sound makes me skeptical of that part. Don also posits a situation where the pilot of MDX, unsure of his position in relation to high and rising terrain, with failed instruments and icing, descending in cloud,

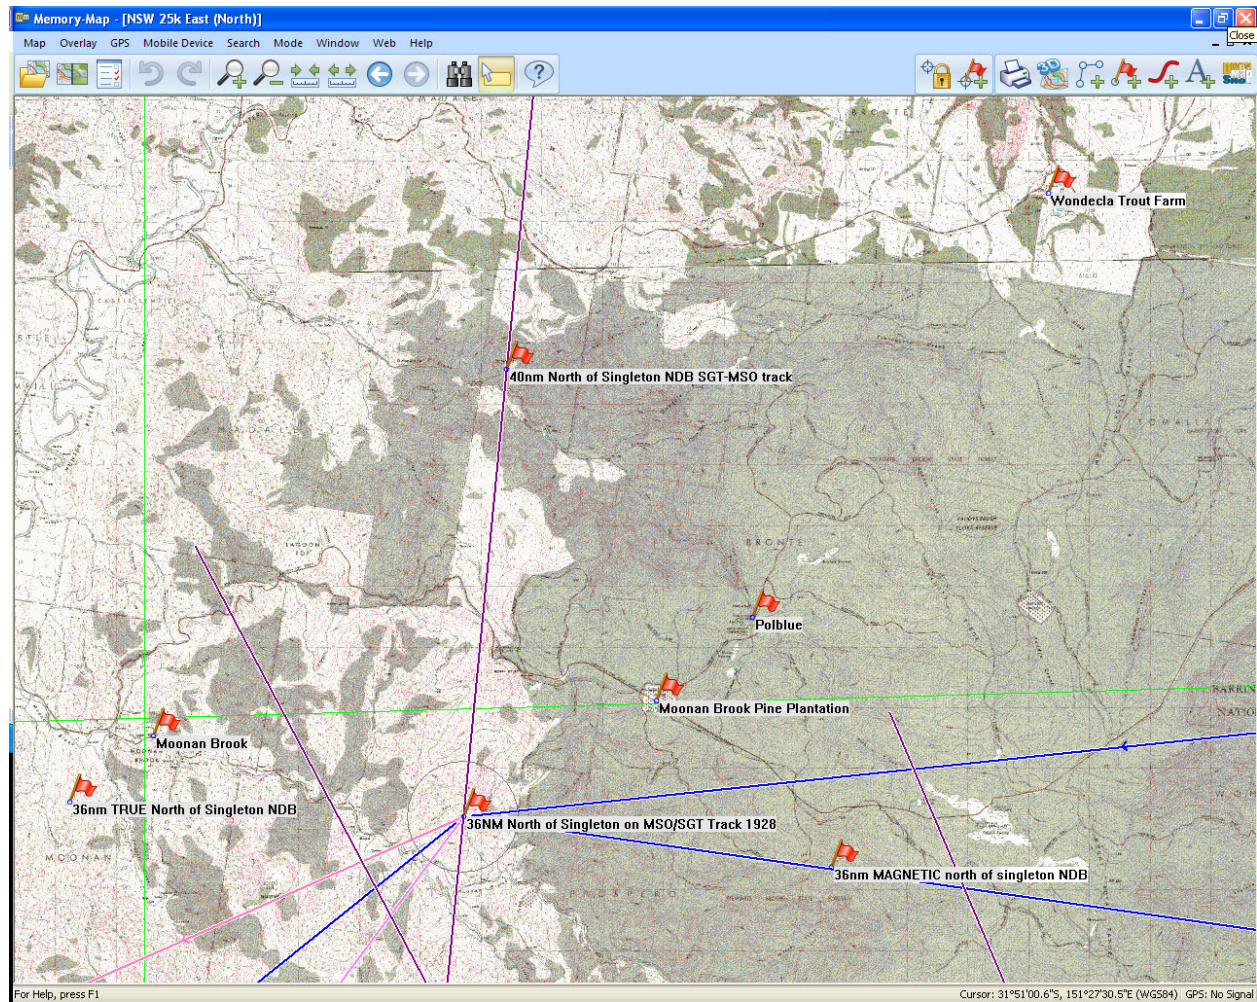
Don also suggests that MDX was identified at 40nm, on the Singleton – Mount Sandon Track, then again at 36nm due north of Singleton. This is incorrect, as the radar operator was making a more accurate estimate of the distance he first suggested of 40nm, not a second position report. Radar operators give their bearings in degrees magnetic. Radar displays are orientated magnetically, not grid or true. The point 36nm due magnetic north of Singleton, which the radar would display, and the operator would be aware of is in fact to the east of the Singleton – Mount Sandon track, not the west, as Don suggests.

This fault is illustrated below, having those two points overlayed on the map, and Don's simplified map.

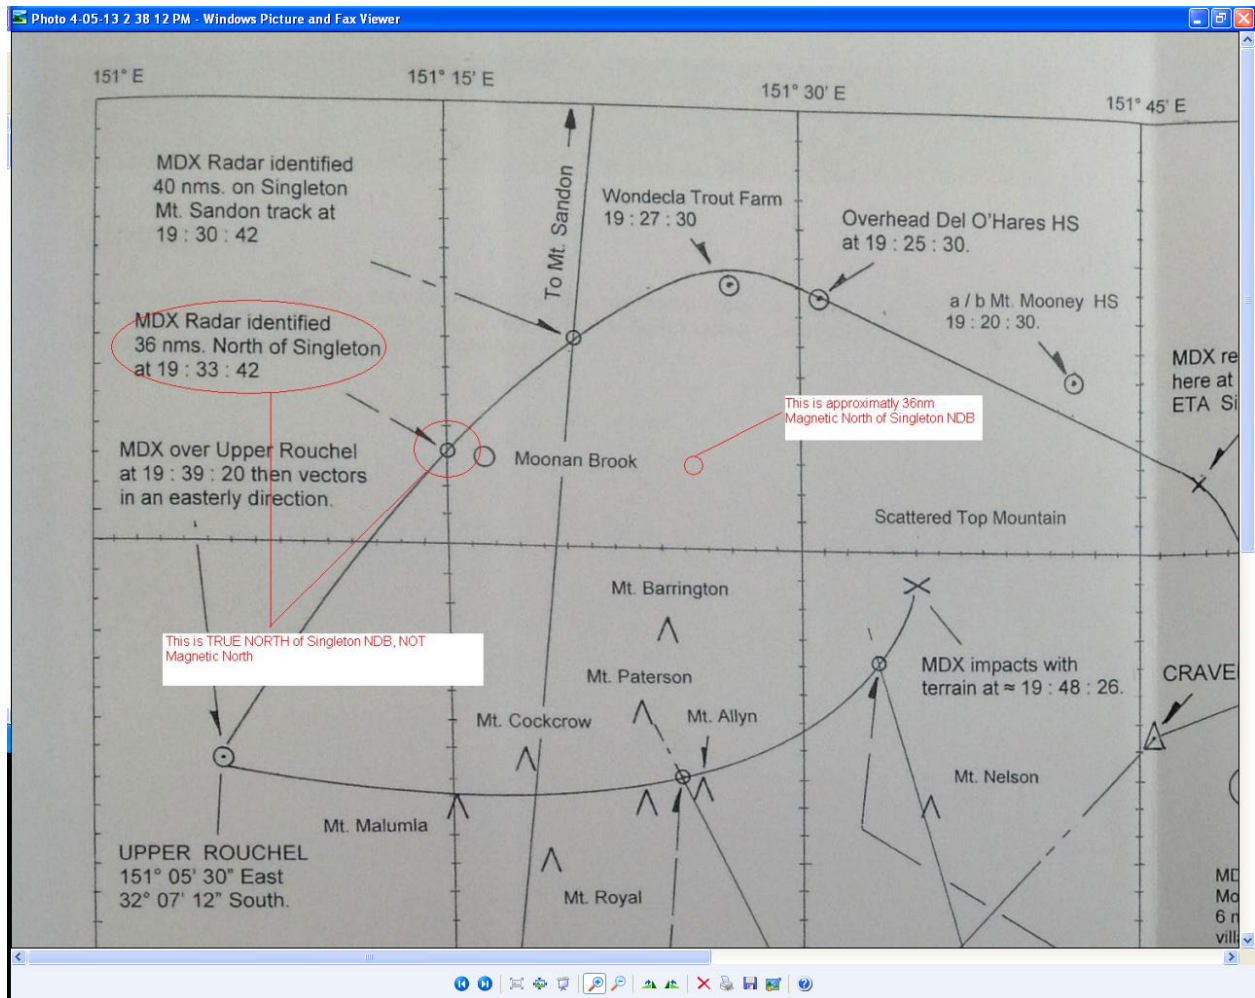
Using Don's map in his book, this fault is illustrated here –

Don goes on to suggest that there was a 6 minute interval where the radar operator tries to determine MDX's track. This is highly unlikely, as it would not take that long to derive this information. There is also no radio traffic from ANY aircraft during this 6 minute period, when there was clearly other traffic. To also suggest that there was no communication with MDX in this time period is also extremely unlikely. Another issue to add to the question of timings, and that his assertion that the timings on the transcripts are incorrect, is that there are available, all the ATC flight strips, little bits of paper used by controllers to keep track of aircraft in their sector. All these have times written on them when the controller logs various radio calls, and they also all agree with the times set out, and would require several controllers to all be using the wrong time for Don to be correct.
