RAAF Williamtown Air Traffic Control and radar 1981

**Background data, information and
investigative findings assisting
the search of aircraft VH-MDX**

Version: 4th Edition, 2nd August 2015

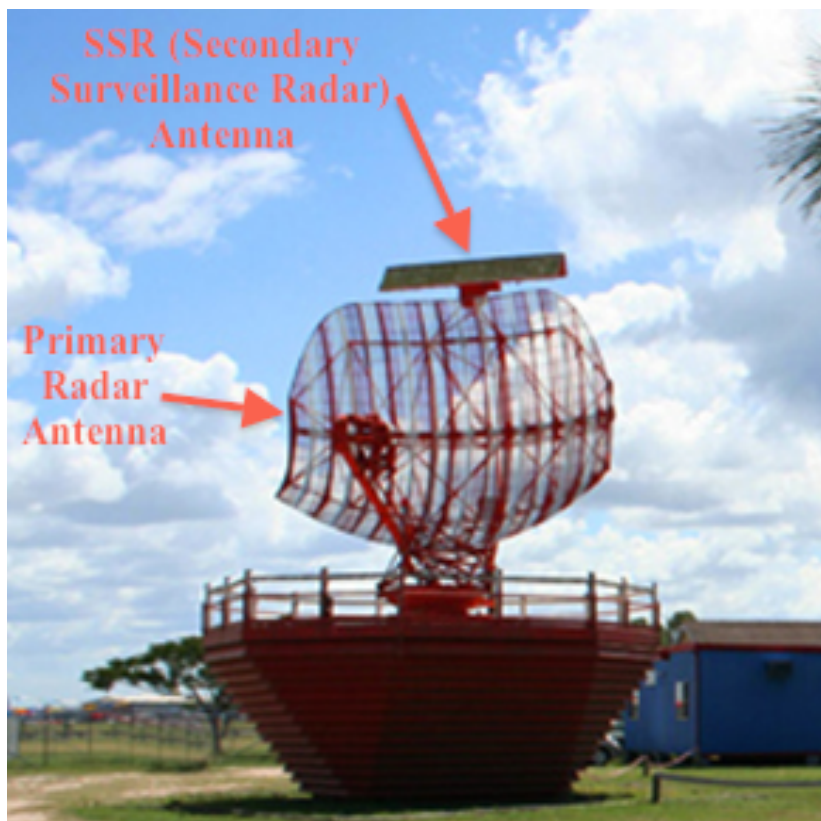
Figure 2: SURAD radar head. The main antenna or 'dish' services the PSR system and atop this is the SSR antenna. PSR is passive, relying on radio wave reflections from a target. SSR is active in that ground interrogator and aircraft transponder 'talk' to each other. The two systems, PSR and SSR are *isolated* systems other than sharing the same display screens (PPI's). The radar head would be mounted at the top of a steel tower to increase line of sight thus increasing range unlike this museum piece mounted on the ground. (Photo: Fighter World Aviation Museum 2014).

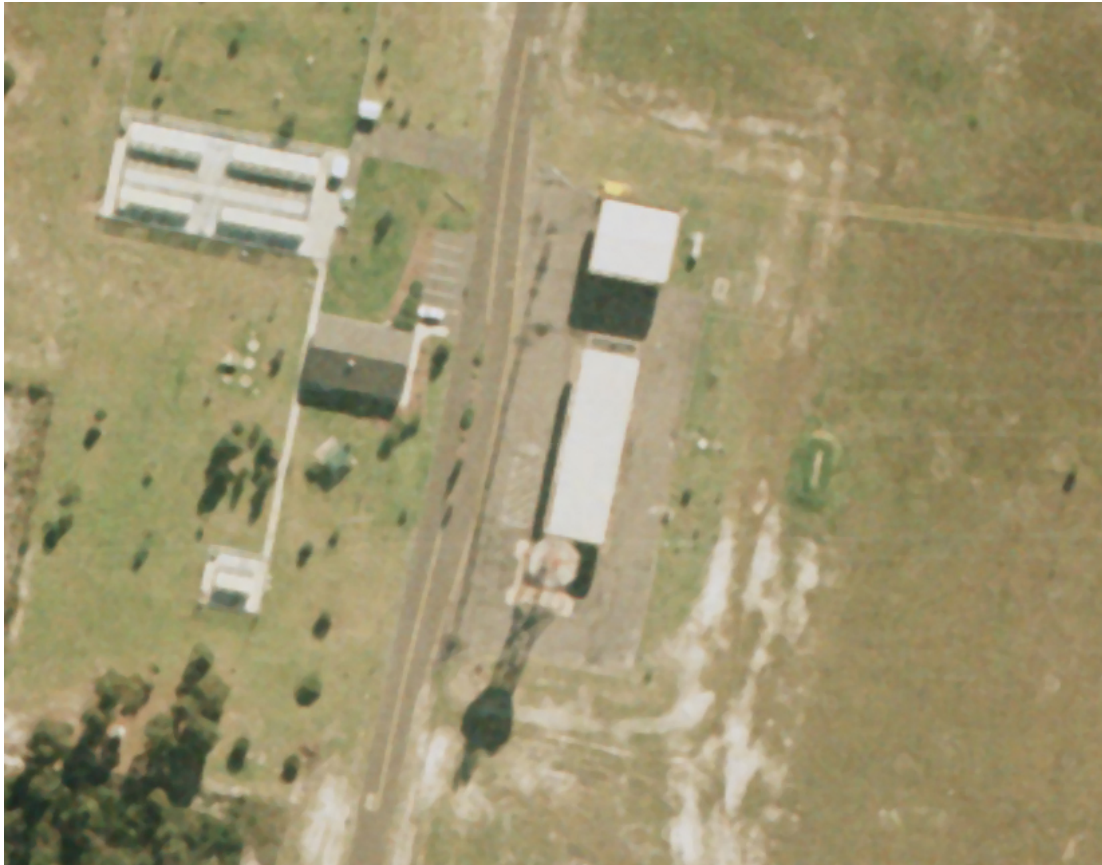
Figure 4: 1987 aerial photo of Williamstown SURAD. When comparing this photo with the SURAD photo in figure 2 the distinctive and unique shape of the head base is immediately obvious. The position of the radar head in this photo also matches the general position reported by ATCO's. SURAD was replaced by ADATS sometime from 1999 (Image: NSW Department of Land and Property Information 1987-2014).

The author has confirmed the SURAD radar head position through a 1987 aerial photo of RAAF Williamtown that displays a shadow of a radar head that is clearly SURAD in shape (unique and distinctive base at top of the tower)^[35]. Dispositions of various items of interest at RAAF Williamtown are shown below in figure 3.

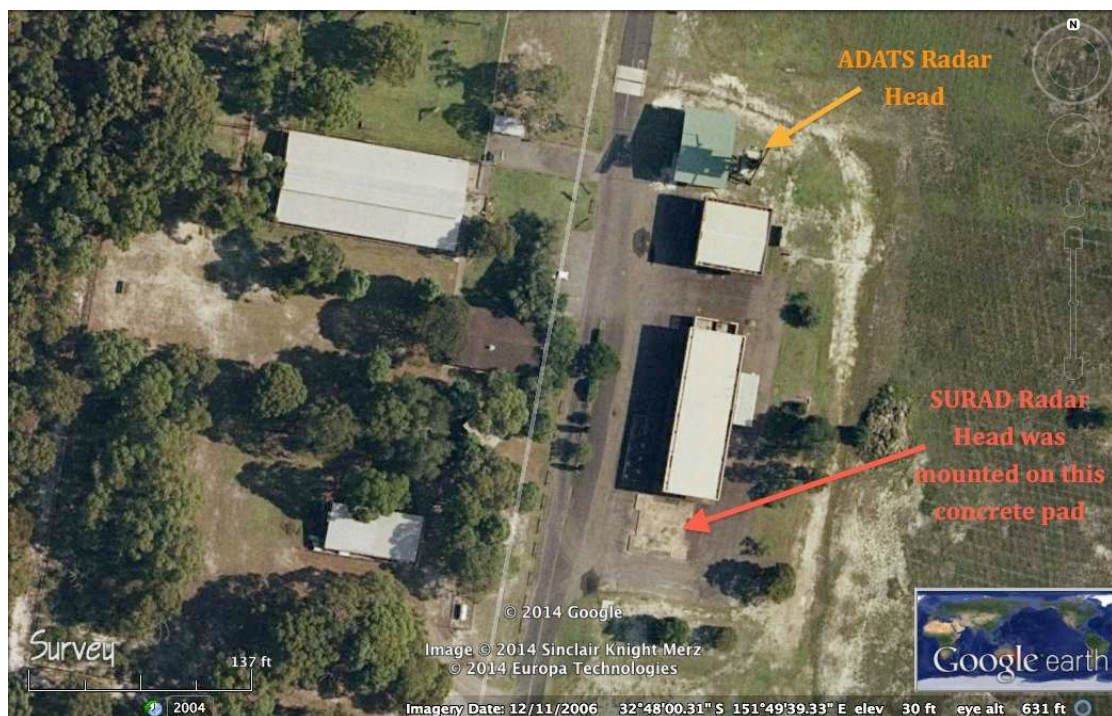
Figure 5: SURAD head position 2014. The SURAD head was mounted on the concrete pad approximately 70m to the south of the current ADATS head (Image: Europa Technologies 2014, Google Earth 2014, Sinclair, Knight, Merz, 2014).

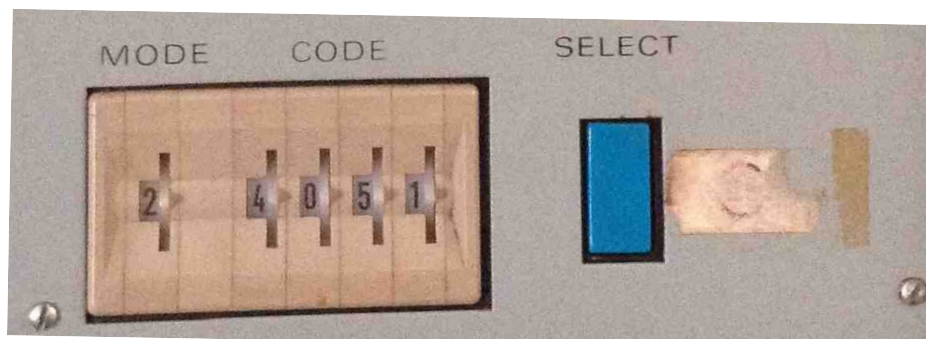
Figure 12: SSR symbol preset. Displayed SSR symbols could be allocated to a specific ATRBS mode code as preset by the thumbwheel switches shown. In this case aircraft squawking mode 2 code 4051 would be displayed by a circle (as drawn on the sticker to right) on the PPI when the 'Select' button was pushed to on. Note: mode A is also known as mode '3A' so, would be represented as mode '3' using the thumbwheel switches (Photo: Glenn Strkalj 2014, access to SURAD PPI courtesy of The Australian Aviation Heritage Centre).

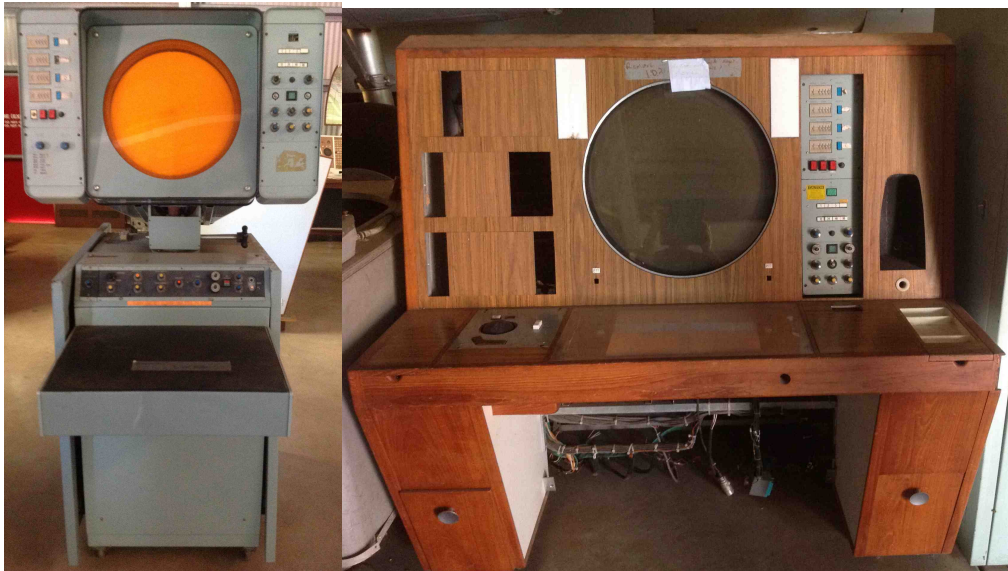
Figure 14: SURAD Maintenance PPI (left) and Approach PPI (right). (Photo: Glenn Strkalj 2014, access to SURAD PPI courtesy of The Australian Aviation Heritage Centre).

Figure 14 on the next page presents a maintenance PPI and an approach room PPI.

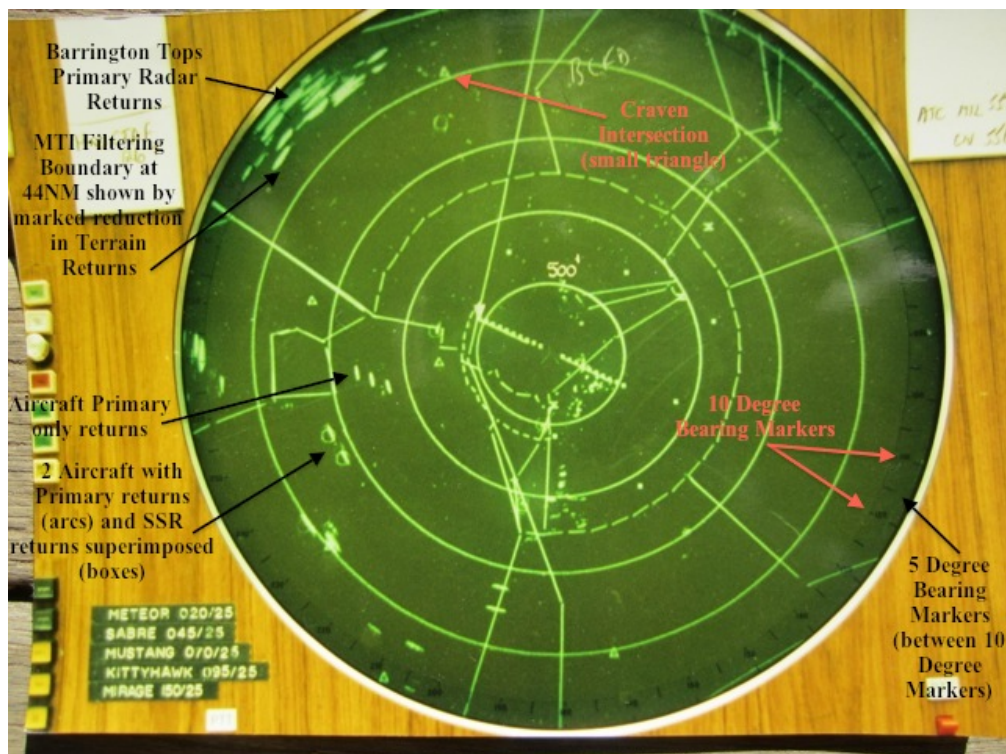
Figure 15: RAAF Williamtown Approach room SURAD PPI. North is at the top of the PPI. The compass rose on the circumference displays bearing in 10° increments with 5° markings in between. 10NM spaced rings are displayed to determine target range whilst airspace boundary markings and reporting points (small triangles) are also displayed. PSR returns show as arcs on the PPI with a good example of aircraft being at approximately 25NM west where three PSR returns are apparent. To the north-west from around 43NM are the permanent echo terrain returns of the Barrington Tops and the effects of MTI filtering can readily be seen with suppression of terrain occurring sharply from about 43NM and less. At approximately 32NM to the west-south-west are two PSR returns from aircraft that are also returning an SSR code as indicated by the symbols (circles) superimposed over the top. It can be seen from these two aircraft how SSR symbols overlay the PSR return. (Photo: H. Howard c.1983).

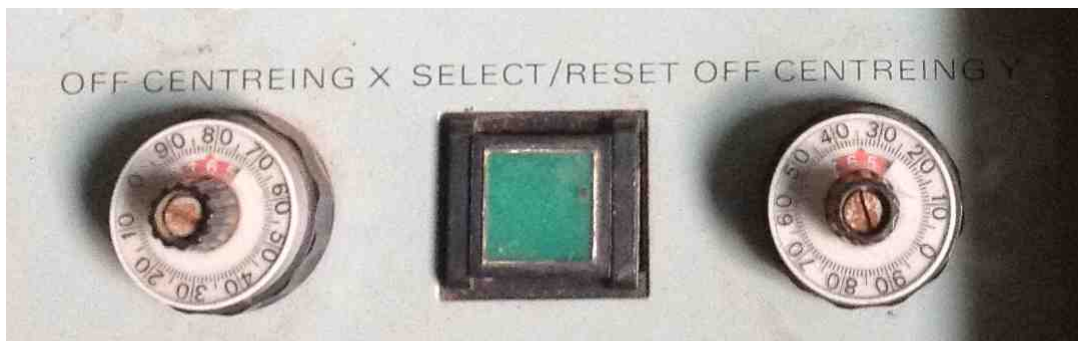
Figure 17: PPI offset controls. The displayed area on the PPI could be offset away from the radar head at origin position. Two controls were available to move the PPI origin position in both the X and Y-axis. The offset was then activated or cancelled by pressing the 'Select/Reset' button. (Photo: Glenn Strkalj 2014, access to SURAD PPI courtesy of The Australian Aviation Heritage Centre).

A button between the two offset controls reset the PPI origin back to the radar head^[5]. Figure 17 highlights the offset controls and reset button.

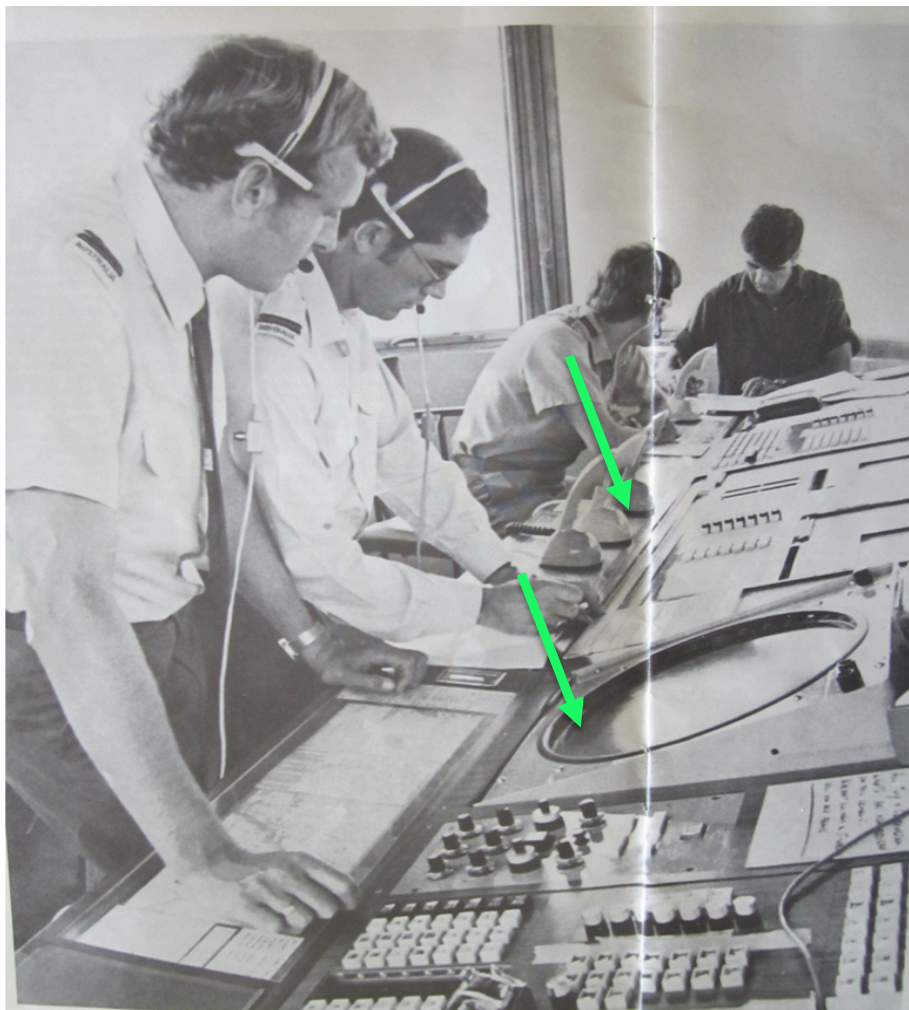
Figure 18: Williamtown control tower c.1970's. The SURAD Tower PPI is apparent albeit not the information displayed. It was reported that the angle of the PPI and low layout in the console resulted in poor ergonomics^[5]. Specifically, head movements between looking outside, strips and the PPI was unnatural^[5]. As the tower was situated south, sun glare from a rising or setting sun would restrict readability of radar returns on the PPI^[5]. Accordingly, a metal shroud was incorporated to reduce glare on the PPI^{[4][5]}. Note the locations of communication equipment and flight strips away from the PPI. The ATCO during the night of the accident would likely have operated between the two green arrows, the distance being estimated at around two meters^[5]. The main procedural area was between the second ATCO from the foreground to the position of the far arrow^[5] (Photo: H. Howard c.1970's).

To block out sun glare, a cylinder about 30 cm high surrounded the tower PPI^{[4][5]} and was reportedly only removable by technicians ^[4]. The Williamtown ATCO on duty during MDX's disappearance believed this screen was still attached but was not a factor, nor did he believe the smaller size of the tower PPI relative to the approach PPI, was detrimental in determining VH-MDX's position accurately^[4].

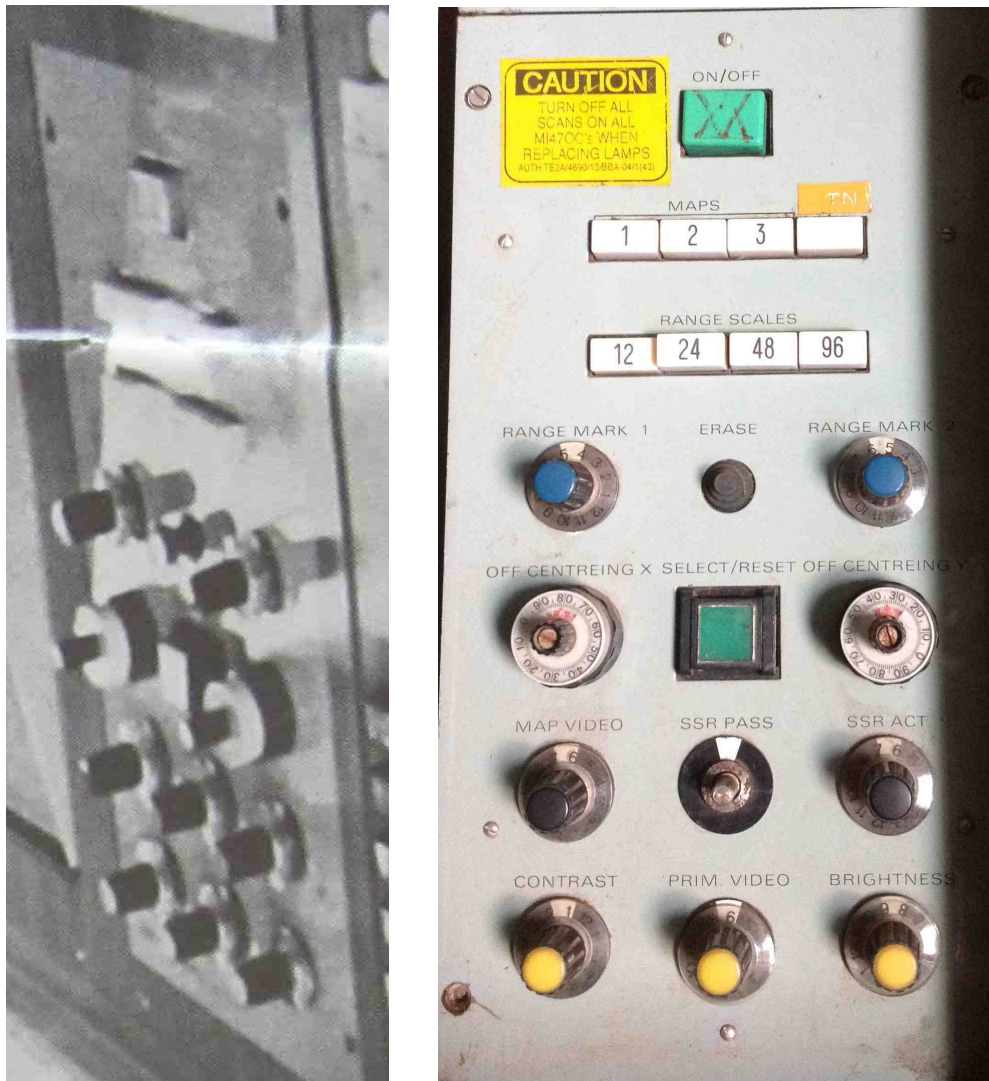
Figure 19: SURAD Tower PPI controls. Left photo is a zoom of the Williamtown Tower PPI control panel, the right photo a SURAD *approach* PPI control panel from Darwin SURAD. Both appear similar so, the Darwin SURAD panel can be used as a reference to determine controls (Left photo: H. Howard c.1983; Right photo: Glenn Strkalj 2014, access to SURAD PPI courtesy of The Australian Aviation Heritage Centre).

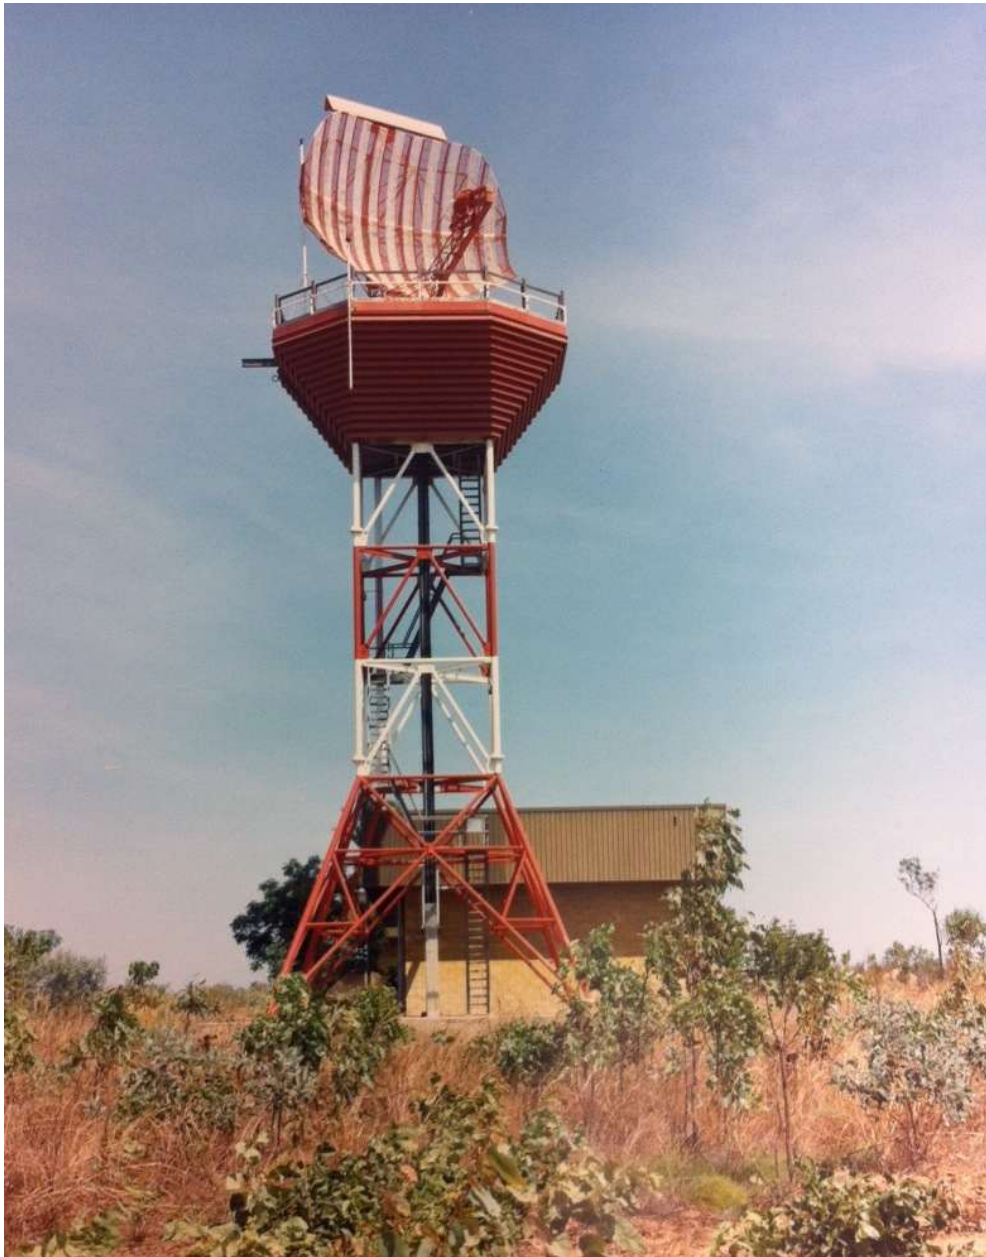
Figure 23: SURAD radar head. The PSR feed horn was estimated at being 30 meters above ground level whilst the SSR antenna was estimated at being 2 meters above the PSR feed horn. Such information is important in radio propagation studies (Photo: Australian Government (Department of Defence) c.1980).

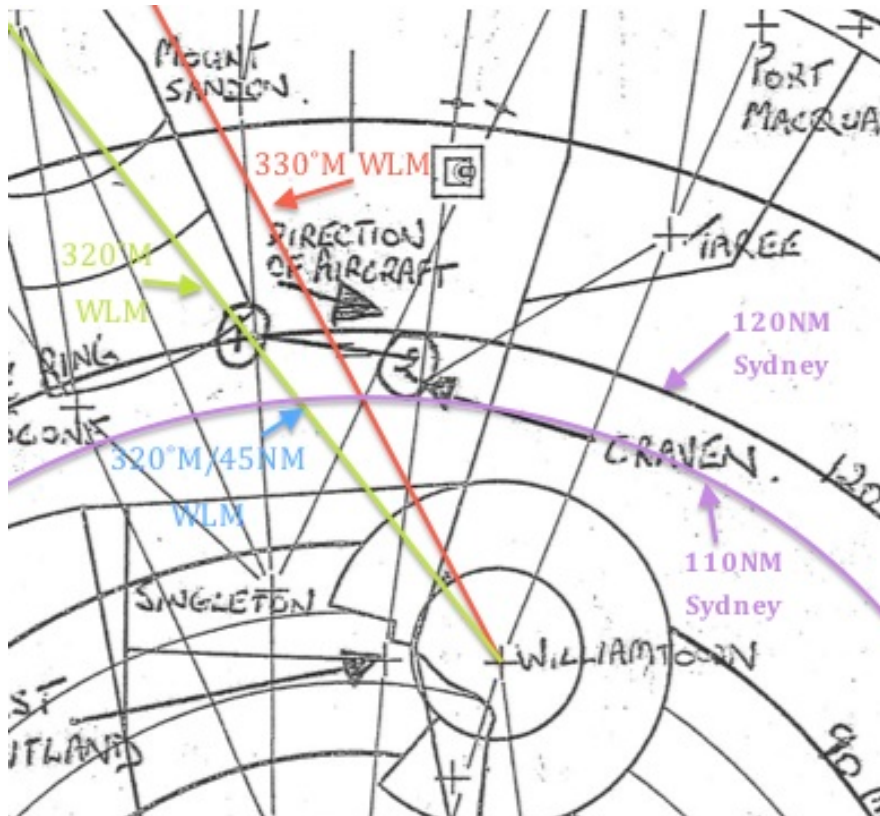
Figure 30: Sydney ATC final radar position. Position '2' was reported as the final radar position observed by one Sydney ATCO. It was deposited the position was approximately 5NM west of Craven waypoint/intersection. Of note is that the depicted straight track between both fixes was not possible given VH-MDX's track south then south-east to the 320°M/45NM fix (tip of blue arrow). The following has been approximated by the author:

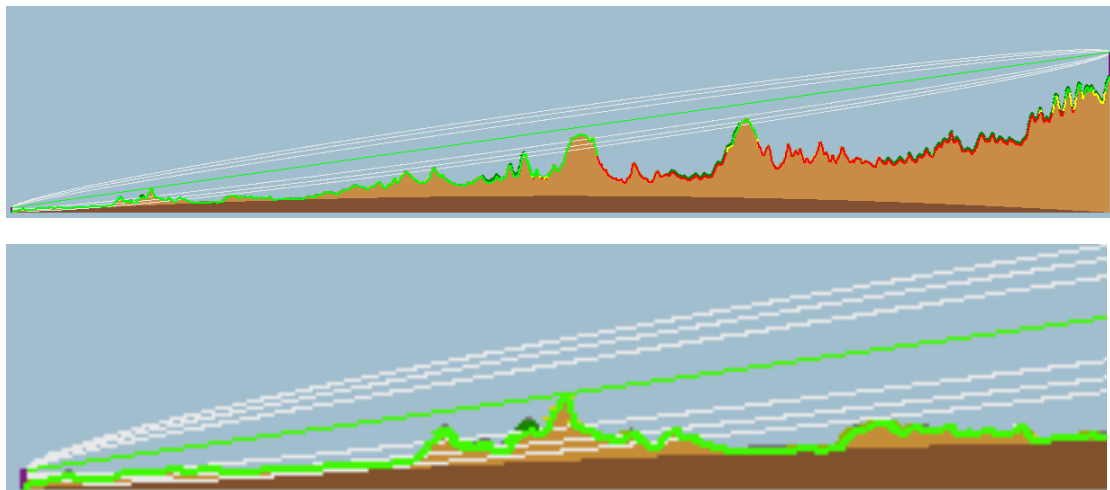
Figure 45: Williamstown TAR to ASIB/RCC final radar position prorogation at 3500'AMSL^[27]. Bottom image zooms in on the most limiting terrain.

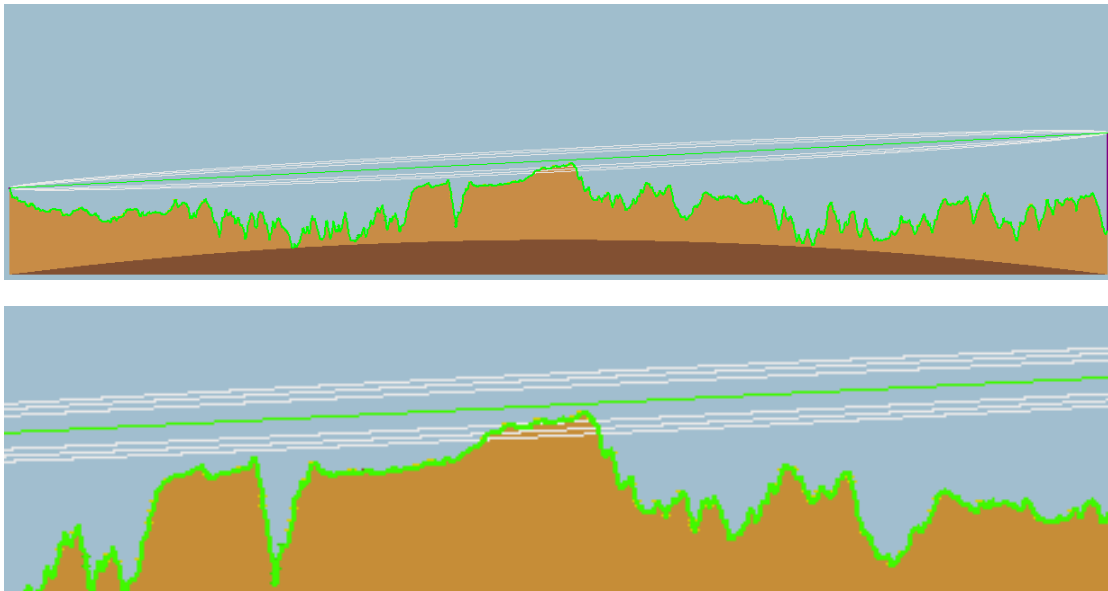
Figure 46: The Round Mountain RSR to ASIB/RCC final radar position prorogation at 8200'AMSL^[27]. Bottom image zooms in on the most limiting terrain.
