VH-MDX

Part 1:

An Initial Overview

Version: 3rd Edition (13th August 2015)

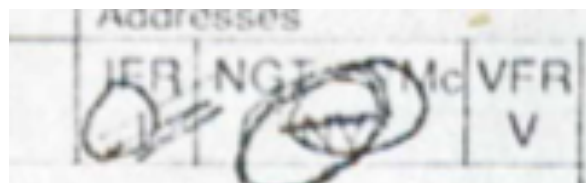
A private category flight was being conducted. Of interest is that IFR category appears to have been circled then scrubbed out for NVFR. Figure 5 below presents this.

Figure 5: VH-MDX Flight plan extract: Nominated flight rules. The flight had every reason to proceed IFR as both pilot and aircraft appear to have been certified and current for IFR and the flight was *private* category allowing single-engine IFR. The pilot displayed some confusion regarding the true meanings of the flight rule categories (Image: Australian Government (Department of Transport) 1981).

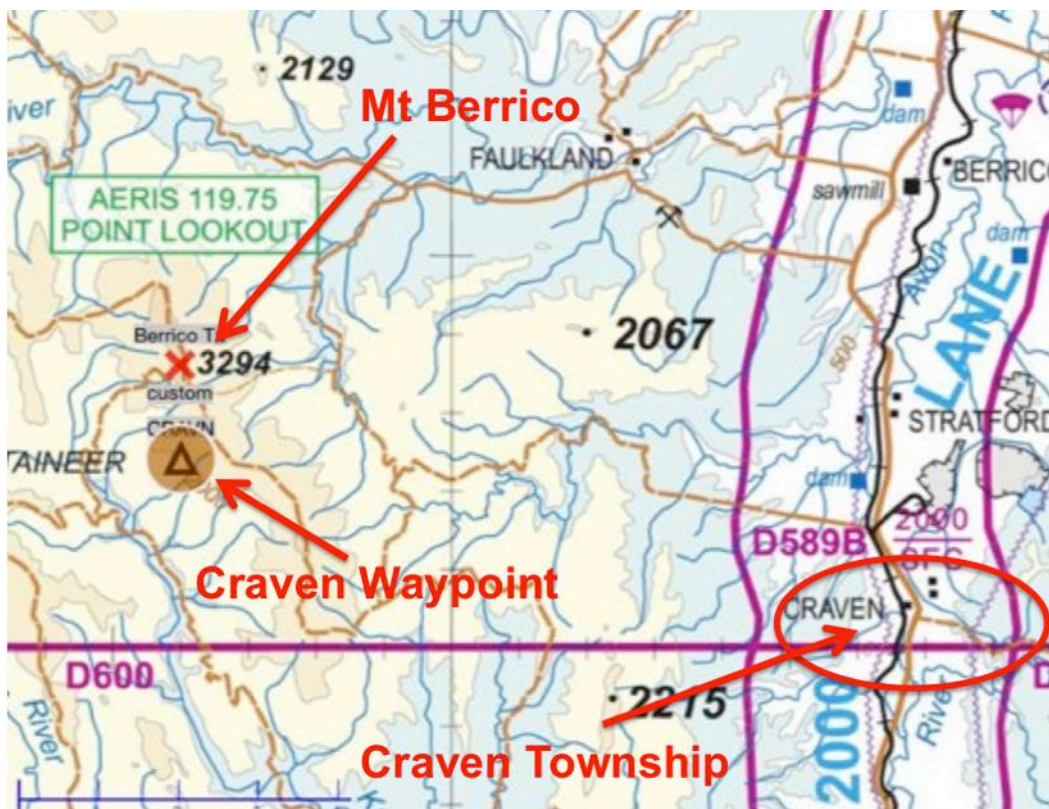
Figure 8: Craven waypoint, Mt Berrico, Craven township. Berrico transceiver station (red cross), Craven waypoint (brown triangle) and Craven township (red oval). Immediately obvious is the distance between Craven waypoint and township (about 9NM-10NM). Mt Berrico transceiver station is located approximately 1NM north of Craven waypoint (Base image: OzRunways 2014, Additions: Glenn Strkalj 2014).

Also, landing lights generally illuminate objects within a few hundred meters. It is so unlikely that these lights were capable of illuminating the Mount Berrico transceiver station at a safe distance from the aircraft.

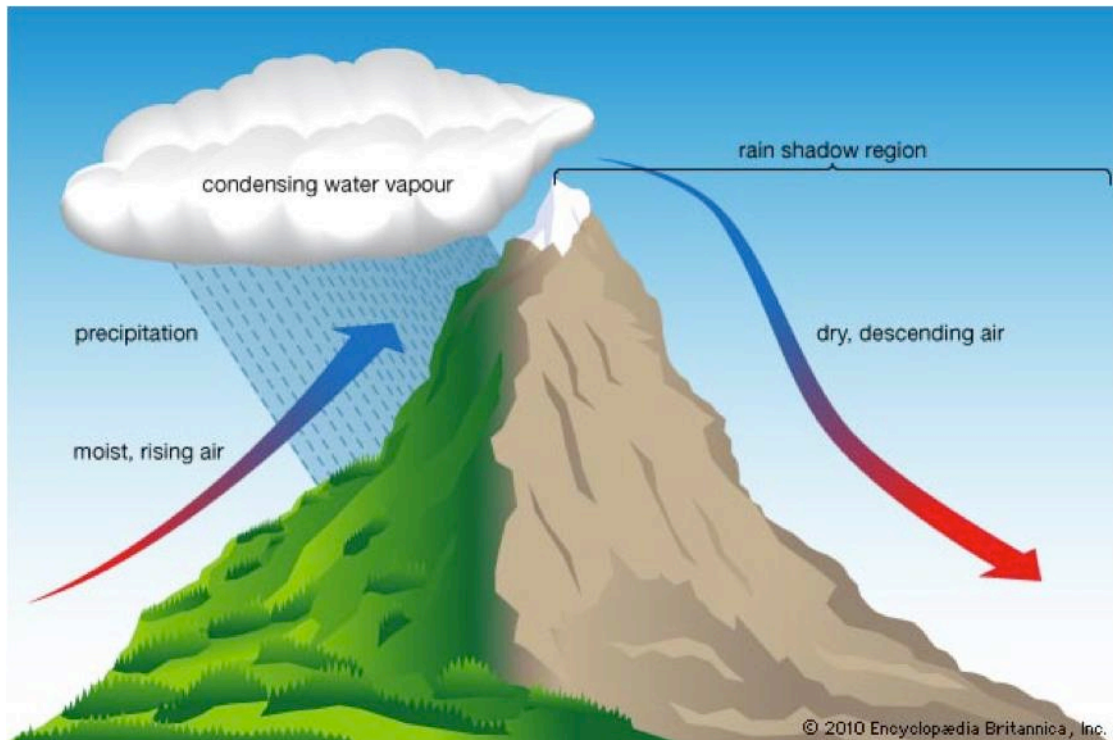
Formation of the clouds was due to forced lifting by the high terrain (orographic uplifting). Cloud formation on the lee side of the ranges is limited or prevented by the cessation of uplift coupled with the precipitation on the windward side significantly drying the air mass out^{[19][41]}. The image in figure 11 on the following page depicts this.

Figure 11: Orographic cloud formation. Orographic cloud stays 'stationary' on the windward side of and on, mountain tops. The lee side is generally clear of cloud or small roll type clouds may be apparent. VH-MDX flew into such cloud over the Barrington Tops area, this being some of the only cloud in the general area (Image: Encyclopædia Britannica 2010).

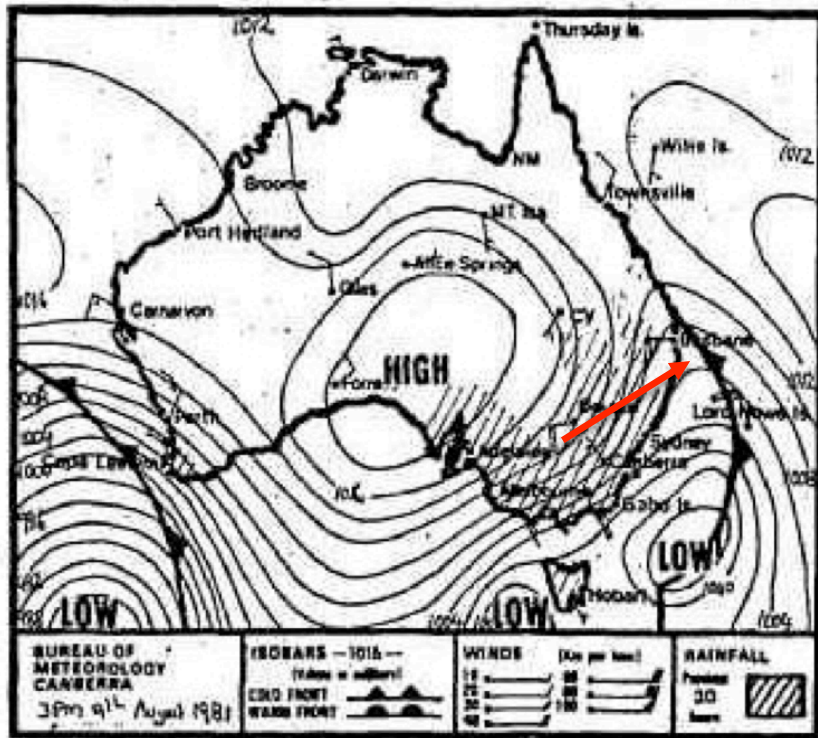
Figure 13: Synoptic MSL chart 1500EST (0500UTC) 9th August 1981. VH-MDX entered the Barrington Tops area approximately four and a half hours after 1500EST (1930EST/0930UTC). The author has included the red arrow to indicate very approximately the aloft wind direction in the Barrington Tops region. A south-west flow is indicated. Reasonably close isobars suggest strong winds. The cold front had well and truly passed by the time of the accident resulting in winds backing and generally clear skies. Although rain is depicted, *specific* area and location forecasts in addition to actual reports show that rain seemed only to be associated with localized orographic uplift. It must be remembered clear skies were predominate (Australian Government (Bureau of Meteorology) 1981).

Figure 13 shows the weather synoptic situation approximately four and one half hours before the accident. The cold front is clearly out to sea in the mid to northern NSW area. By the accident time, the cold front would have moved further east seaward.

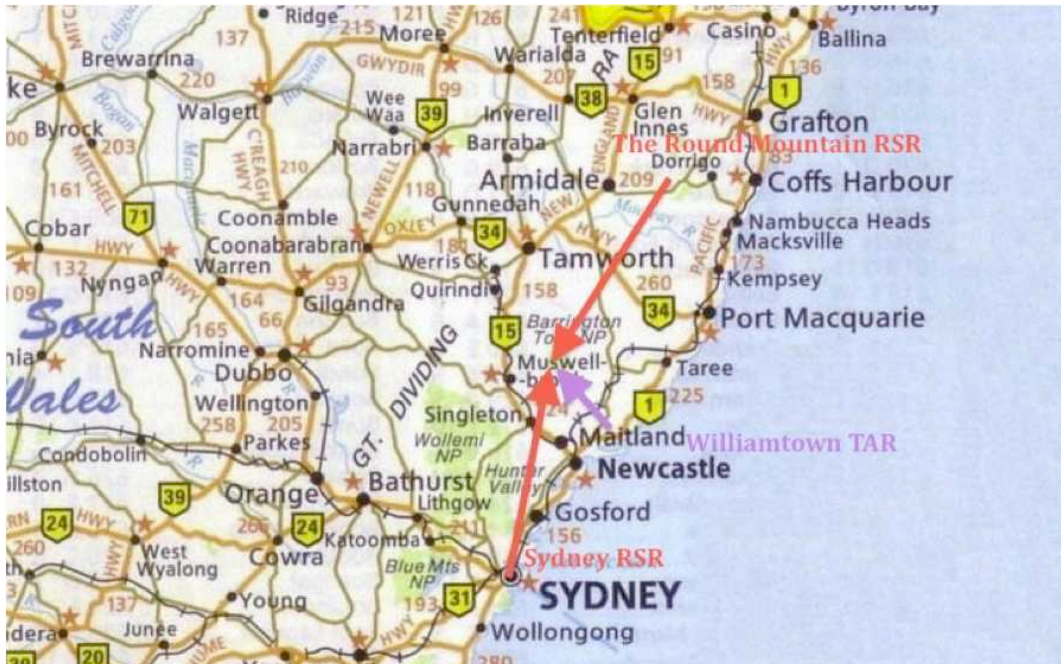
Figure 16: Relevant radar head locations. The Round Mountain RSR and Sydney RSR were operated by Sydney ATC (red arrows). Immediately obvious is how much closer to VH-MDX Williamstown TAR was. Despite this, only a single *complete* radar fix was obtained from the Williamstown TAR (Base Map: Melway Publishing Pty Ltd 2014, additions: Glenn Strkalj 2014).

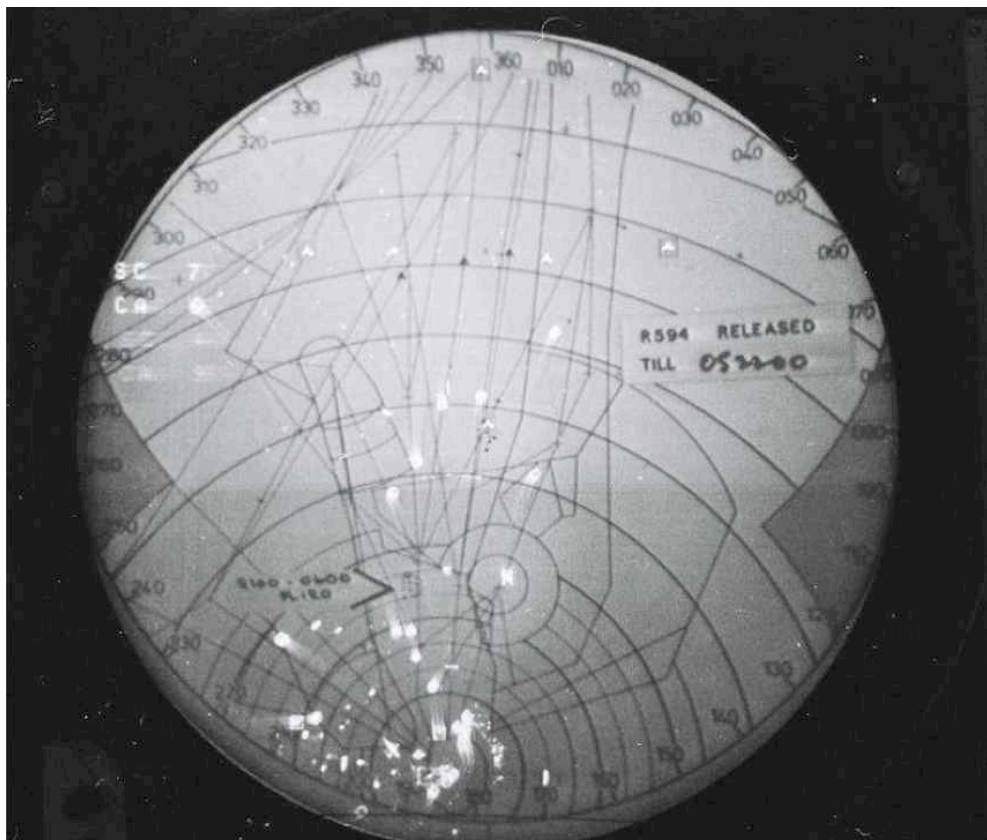
The confirmed *display* 'program' used by Sydney Sector 1 during the accident was the *Northern Mosaic* shown in figure 17^[20]. This program combined the information from both Sydney and The Round Mountain RSR's to be displayed on one display^[20].

Figure 17: Northern Mosaic display program. Both the Sydney RSR and The Round Mountain RSR were used to 'feed' this particular display program although, if both radar heads painted a single target, only one radar head was selected to provide display information at any *single time*. Range rings from Sydney are displayed at 10NM increments to 90NM. 30NM rings are displayed throughout. Control area boundaries are also displayed (Photo: M. Price c.1983).

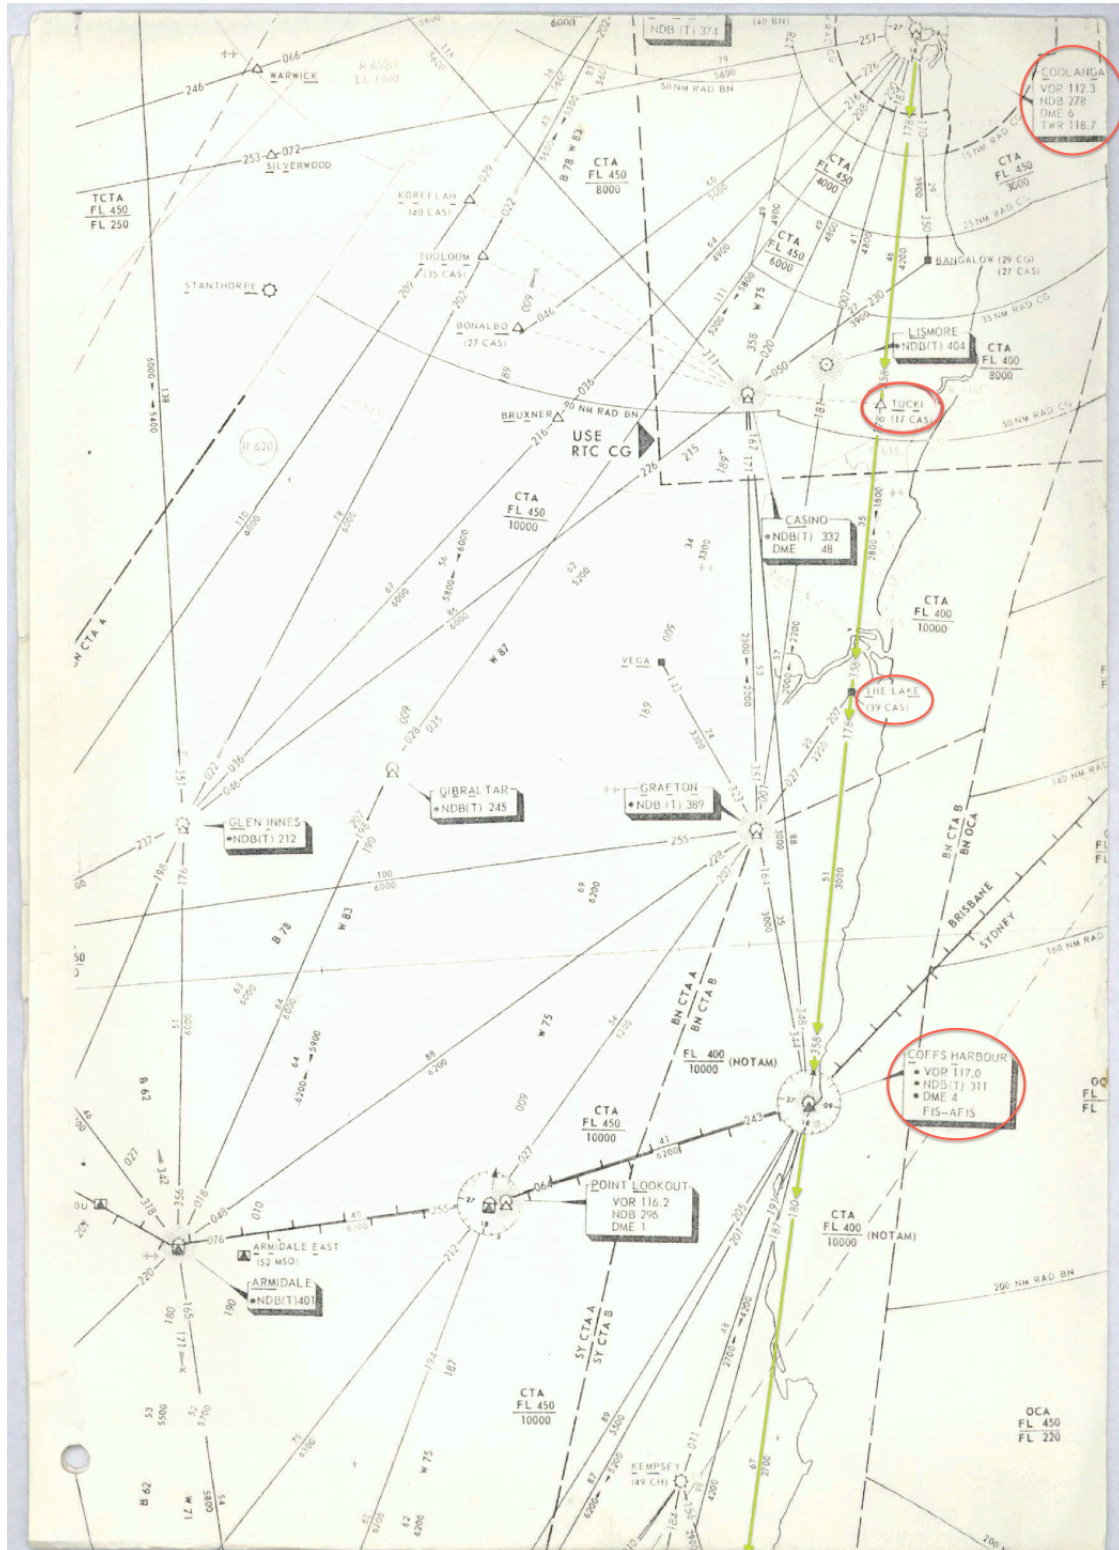
Figure 21: Flight progress Coolangatta-Coffs Harbour. Green arrows represent VH-MDX's track. VH-MDX appeared to progress normally between Coolangatta and Coffs Harbour. Tracks and distances are marked on the chart from each waypoint/navaid. Tracks marked are in degrees *magnetic* whilst distances are in Nautical Miles (NM) (Base image: Australian Government (Department of Transport Australia) c.1981).

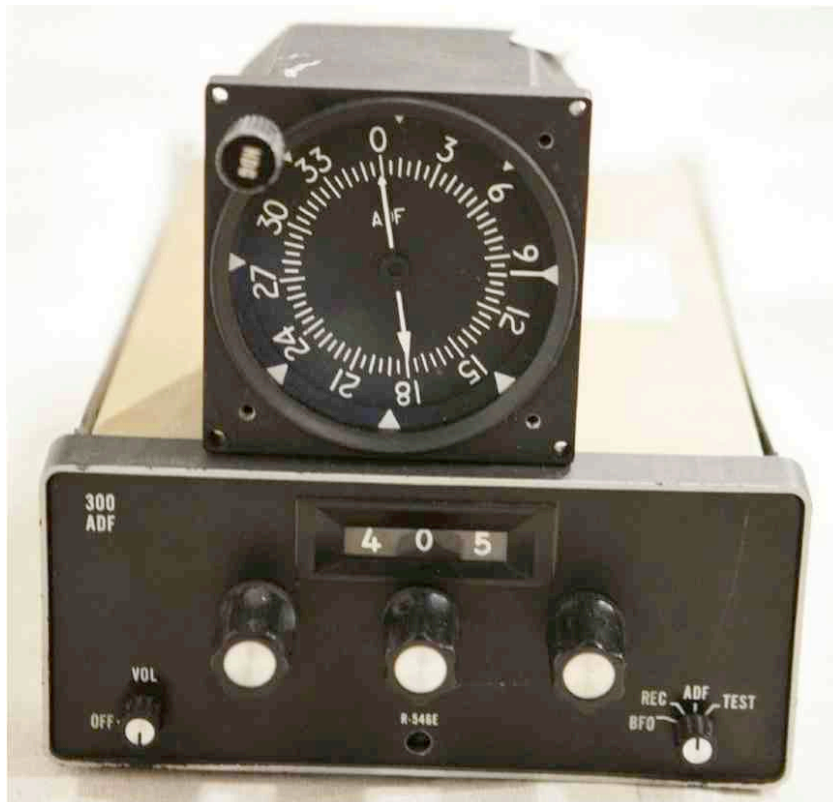
As the Directional Indicator (DI) was reported as unserviceable^[1], the direct reading compass had to have been used.

Figure 30: IN-346A fixed card ADF indicator and ARC R546E ADF receiver. These particular units were likely onboard VH-MDX during the accident. 'Fixed card' refers to the fact that the compass rose is not continually slaved to magnetic north as in some indicators. Despite this, the pilot is still able to manually rotate the card to any position. This is handy when transposing compass headings to the fixed card indicator in order to convert the displayed *relative* bearings to *magnetic* bearings.

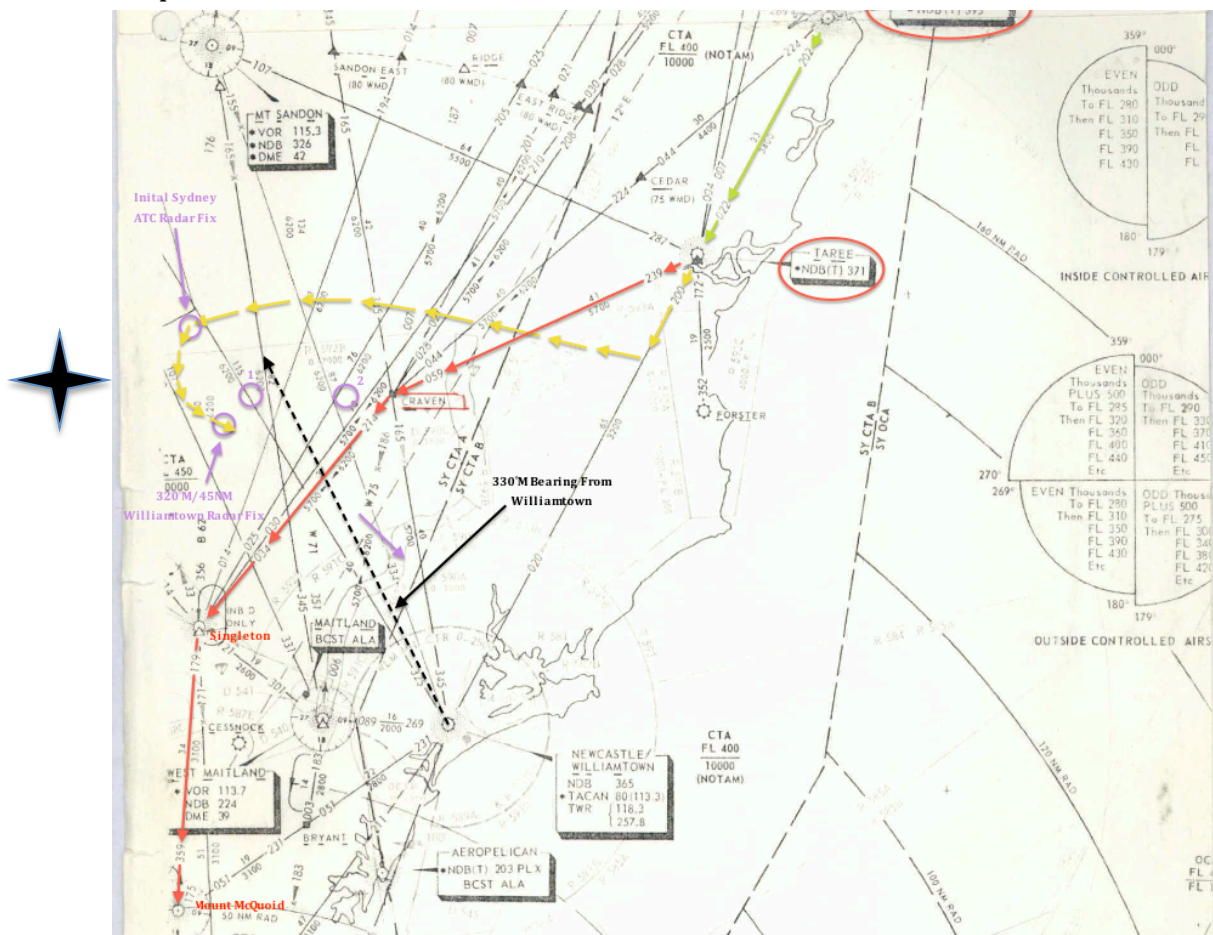
Many including Don Chessor^[26] and John Watson^[42] have suggested that the Scone NDB was mistakenly tuned instead of the Singleton NDB given the similarities in frequency and ident (209kHz vs. 290kHz).

If the ADF was mistakenly tuned to Scone NDB instead of Singleton NDB and the Scone NDB 'homed' (needle on nose), it can be seen in figure 35 how VH-MDX arrived at the initial Sydney radar position. Additionally, VH-MDX would likely pass a few NM north of Craven waypoint. More of this will be discussed later.

Figure 35: Scone NDB theory. Readily obvious on this chart is the co-incident alignment of Scone NDB (black star) when considering tracking between just south of Taree NDB to the initial Sydney radar position. If this NDB were homed, a track north of the direct course (black dashed horizontal line) would be expected (Base image: Australian Government, (Department of Transport Australia) c.1981).

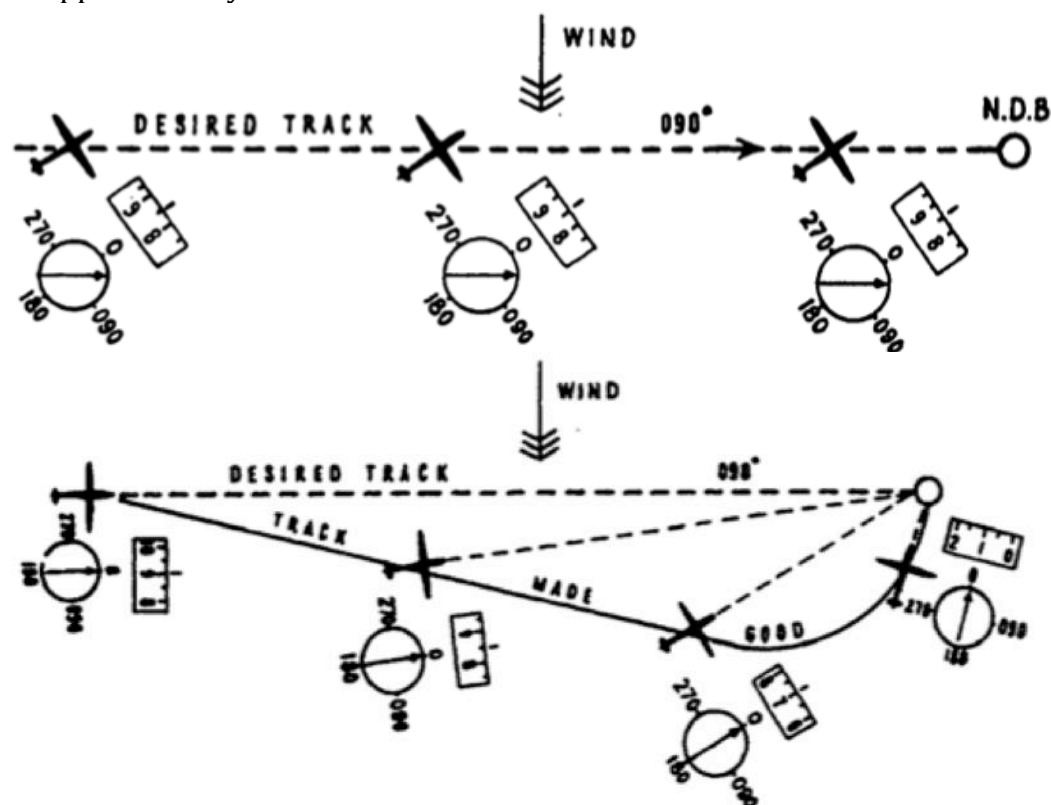
If the pilot of VH-MDX simply used 'homing' techniques (needle on nose) to track to the NDB then it can be seen in figure 40 that combined with the force of the prevailing south-westerly to westerly wind, VH-MDX could easily end up at the position of initial radar identification (approximately 36NM north of Singleton).

If indeed the pilot of VH-MDX were *homing* on Scone NDB then constant heading adjustment towards the left (south) would have been required to maintain the needle approximately on the nose.

Figure 40: Tracking vs. homing. Normally, a pilot 'tracks' a particular ADF bearing in that appropriate drift correction for wind is held achieving a constant track (top image). The aim is to continually maintain a *particular* bearing inbound or outbound relative to the NDB (top image) rather than drift onto other bearing lines (bottom image). A less tidy way of tracking to an NDB is by *homing*. Basically the pilot adjusts the aircraft heading continually to keep the ADF needle on the nose (0° *relative* bearing). The prevalent wind will push the aircraft downwind and as the pilot adjusts the heading for zero *relative* bearing it can be seen the aircraft passes through a multitude of *magnetic* bearings to arrive at the NDB. Not only is this an inefficient way to arrive overhead an NDB but aviation charts specify particular tracks between nav aids with information such as Lowest Safe Altitudes (LSALT) and leg distance. Such information is invalidated by not maintaining a *particular* track (Images: Australian Government (Civil Aviation Authority) c.1980's).

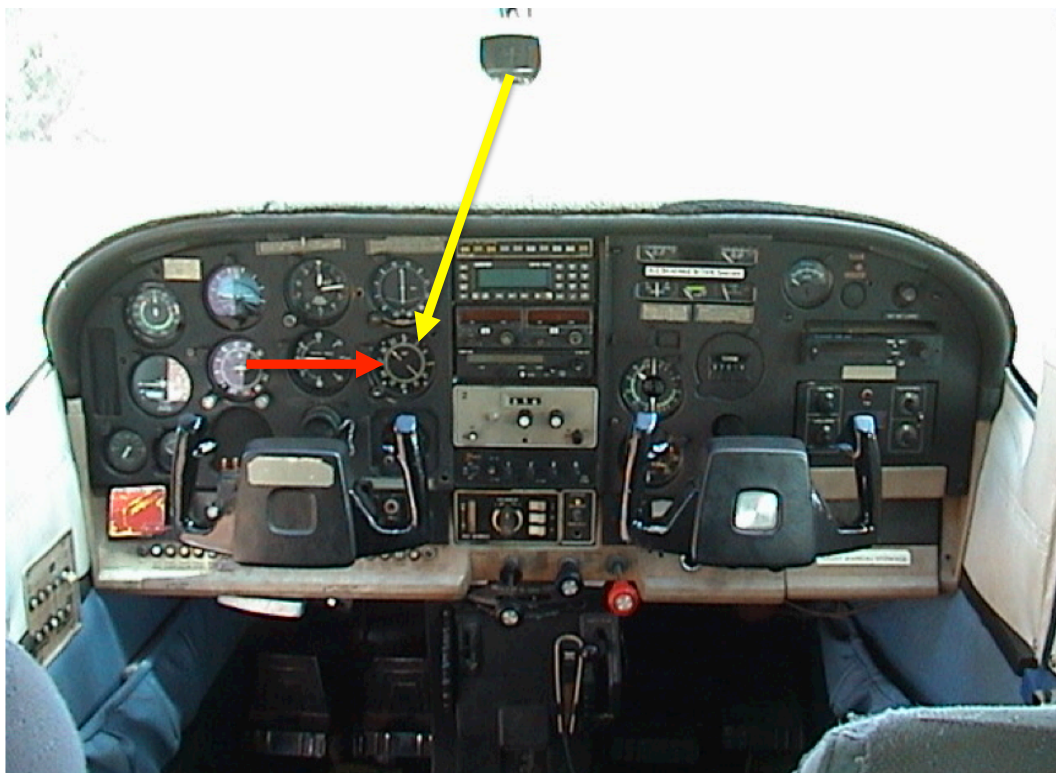
About 40 seconds after reporting in cloud, the pilot of VH-MDX advises that he had lost his AH and DI. These are both vacuum powered gyroscopic instruments crucial for flight in instrument conditions such as cloud^[1]. Both gyro's operated on a single vacuum pump source^{[1][2]}.

This failure would have made tracking accurate bearings with the ADF rather difficult as the pilot would have to scan the small sized *direct indicating compass* located near the roof for a heading and transpose this on the ADF rose that was displaying *relative* bearings: *regularly*. Figure 41 shows the distance involved in scanning the direct reading compass.

Adding the effects of turbulence bouncing the compass around and the darkness of night, it can be seen that maintenance of *accurate* bearings would have been highly challenging.

Figure 41: Bearing transposition onto the ADF. VH-MDX was likely fitted with a *fixed card* type ADF (located at the *heads* of the two arrows above) that displayed only *relative* bearings of the NDB to the aircraft. Pilots are required to mentally transpose heading information onto the relative bearing card of the ADF to yield *magnetic* bearings that are then useable for navigation. This is normally done by reference of the Direction Indicator (DI) positioned two instruments to the left of the ADF indicated by the origin of the red arrow. With the DI unserviceable, the pilot is forced to include the direct reading compass located at the top of the windscreen (indicated at origin of yellow arrow) into the scan that forces the pilot away from 'flying' the aircraft. Throw in the additional challenges of attempting to read the compass bouncing around in turbulence at night and it can be seen that maintenance of accurate NDB bearings is very challenging (Photo: Glenn Strkalj 2002).

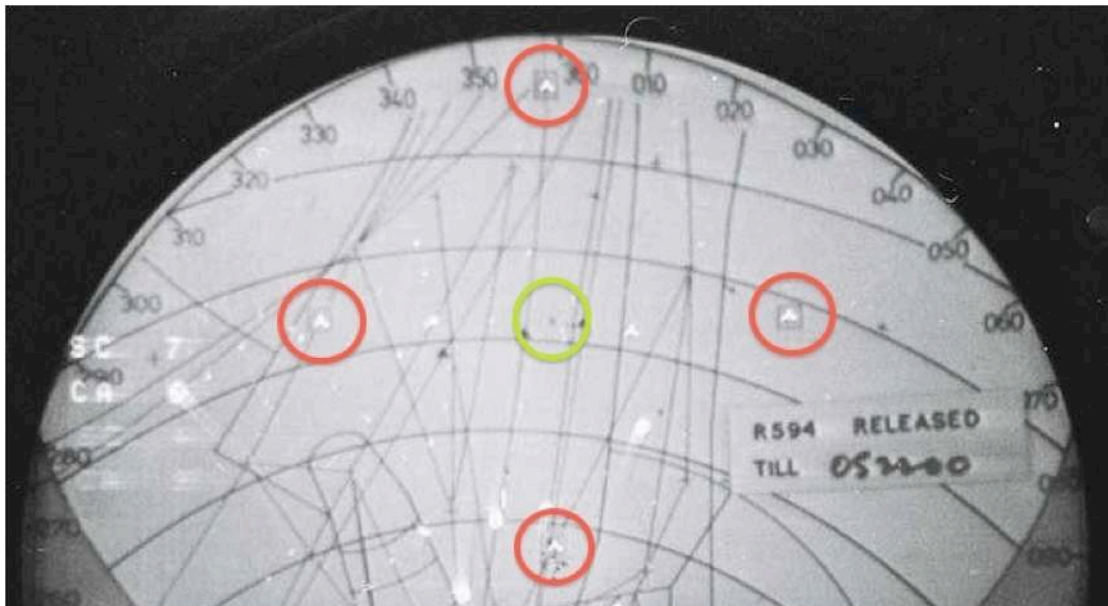
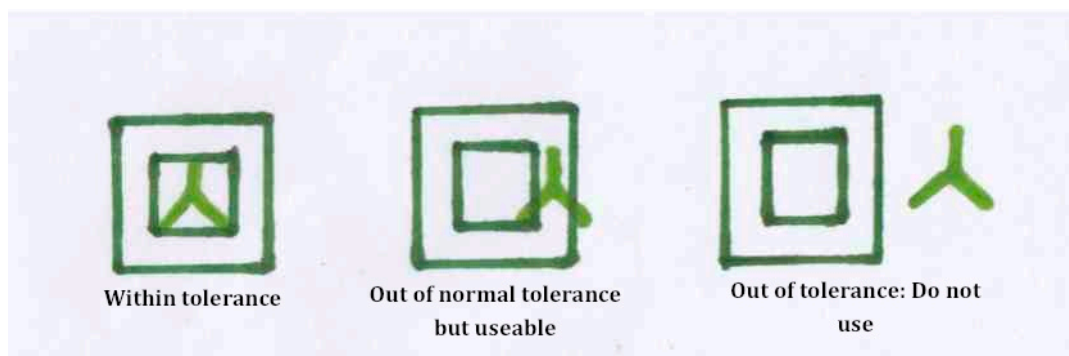
A DoT Officer involved in the accident investigation did recall that the radar system at Sydney for the Sector 1 position was verified as being well within tolerance and that aircraft during the night of the accident were radar observed over positions they were calling in over the radio^[20].

Until further clarification is found regarding actual calibration during the accident, Sydney's radars are assumed to be within tolerance given the reportedly robust monitoring and maintenance of tolerances.

Figure 44: Northern Mosaic alignment markers (red circles). The ATCO would check if the illuminated inverted 'Y' was located within inner and outer boxes. Various levels of tolerance determined serviceability: This was only one of many calibration checks performed. Equipment was reportedly calibrated to very tight tolerances and there is no reason to suspect equipment was significantly out of tolerance during the VH-MDX accident. Despite this, it would be prudent to confirm calibration if applicable information ever presents. (Photo: M. Price c.1983, tolerance box drawing: Glenn Strkalj 2015).

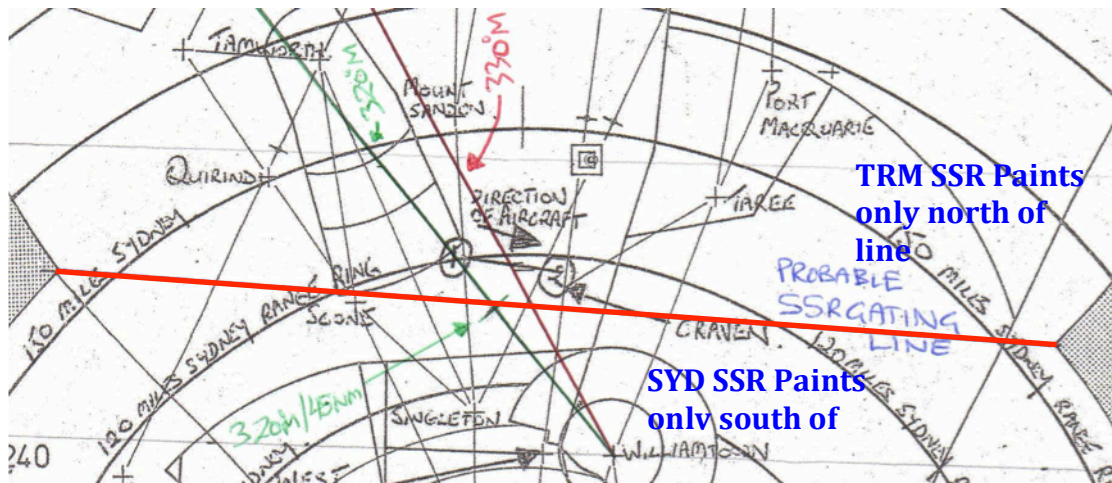
Figure 45: SSR gating line. The electronic gating line was not visible on the display and formed a hard barrier determining the RSR SSR source that would be displayed. North of the gating line only The Round Mountain RSR SSR information was displayed, south of the gating line only Sydney RSR SSR information was displayed. (Image: Australian Government (Department of Transport) 1981, additions: Glenn Strkalj 2015).

As VH-MDX was highly unlikely able to be interrogated by the Sydney RSR, this means that if VH-MDX tracked south of the gating line the aircraft's SSR paints would likely disappear from the Bright display. Accordingly, this knowledge can be applied to flight path analysis.

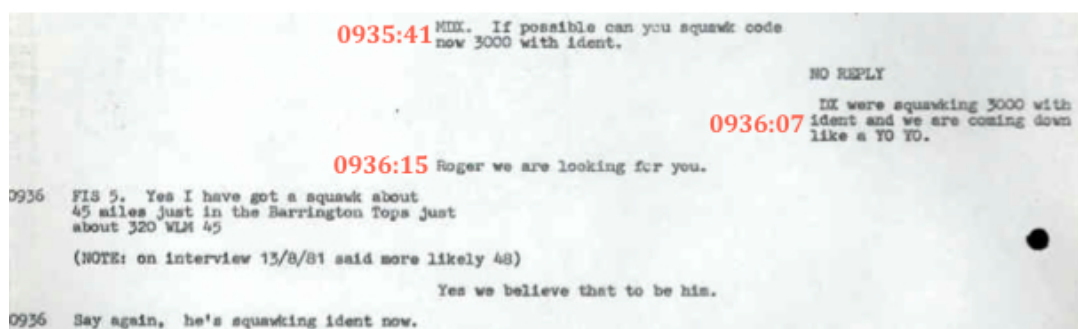
Cross-referencing transcripts suggests that the 320°M/45NM Williamtown fix occurred around 0936:15UTC.

Figure 52: Time of 320°M/45NM Williamtown radar fix. Cross-referencing communications transcripts reveals the fix was verbalised at some time after 0936:15UTC (Image: Australian Government (Air Safety Investigation Branch) 1981).

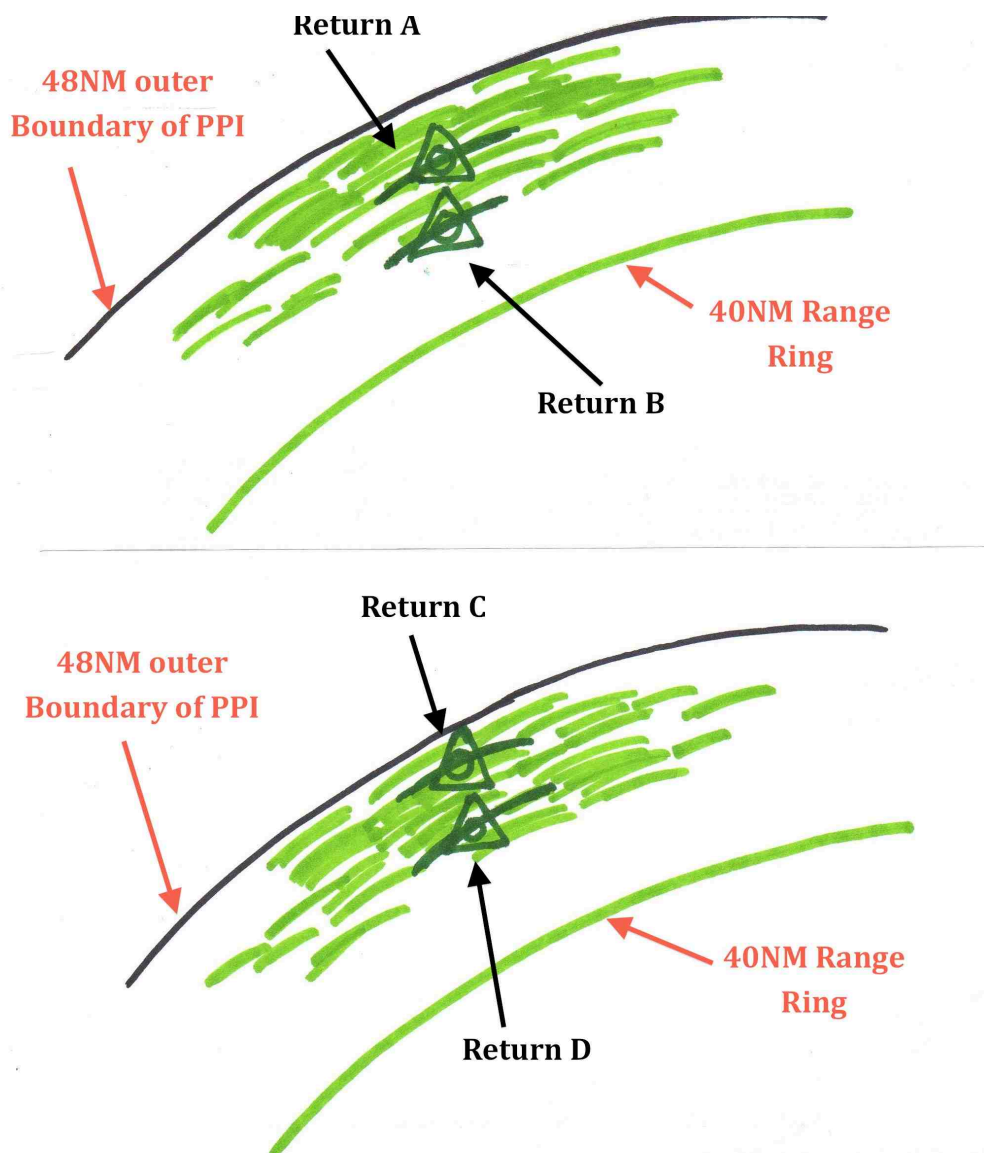
Considering the points above and in section 2, the 320°M/45NM Williamtown ATC radar fix is clearly the most reliable, accurate and precise *latest* radar position of VH-MDX available.

Figure 55: Multi choice options considering range for the 320°M/45NM fix. A gross error check of reported VH-MDX paints was carried out by asking the ATCO to select the most appropriate positioned paint separately for range and bearing (2014). Only terrain clutter was displayed for reference. Terrain clutter was a known quantity on the Williamtown TAR. Despite the permanent terrain clutter, the SSR symbols of the returns were readily apparent to the Williamtown ATCO due to their shape cutting across the clutter direction. A 44NM MTI filter boundary and 48NM outer edge brackets the range of the returns. The ATCO was quite confident that the SPI triangle was not clipped by the outer edge of the PPI (48NM) nor was it hanging over the 44NM MTI clutter boundary (return B). The ATCO 'feels' there was a gap between the SPI triangle and the PPI outer edge rather than the paints touching the outer edge as in return C. Return A was chosen to represent what the ATCO observed. Considering the distance between outer edge and MTI boundary and probable SSR symbol sizes, VH-MDX was likely around 46NM when using this rough method. Referencing VH-MDX paints to the clutter only gives a *gross error check* to the reported position. 320°/45NM, +4°/-2°, +2NM/-0NM is still viewed as the fix position. (Image: Glenn Strkalj 2014).

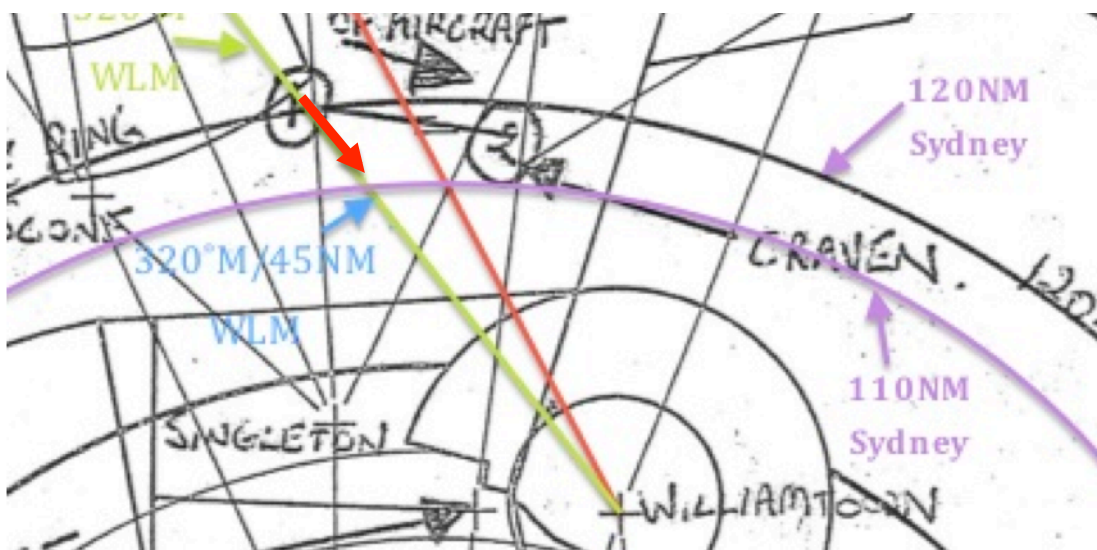
The 150°M track advice could very possibly be an appreciation of the overall track of VH-MDX to this point that was close to 150°M as shown in figure 56. Such an advice can be seen as relevant considering the Sector 1 ATCO was conducting a position and situation briefing to the Williamtown ATCO^[20].

Figure 56: Overall track of 150°M. Readily seen is the overall progress of VH-MDX from the initial Sydney radar position to 320°M/46NM being close to 150° (Image: Australian Government (Department of Transport) 1981, additions Glenn Strkalj 2014).

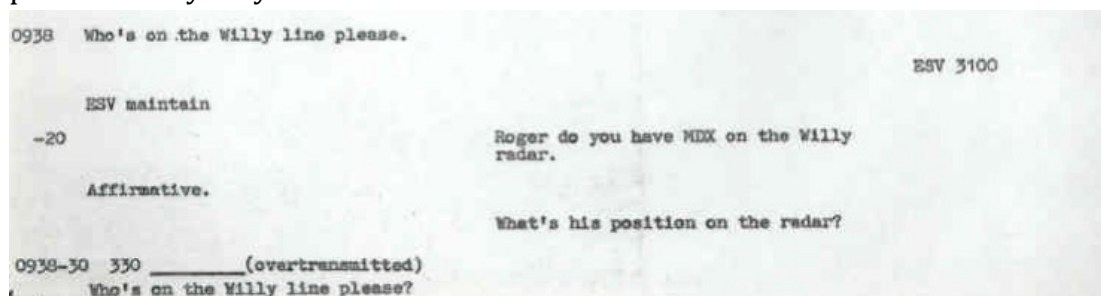
Even if the Williamtown ATCO did not make the 330 bearing call the important point is that someone did and they were highly likely talking of VH-MDX. It is also possible that the 330 call was made by a Sydney ATCO based on observed position on Sydney ATC radar.

Figure 58: 330 Call ASIB transcript. The columns from left to right depict the transmitting agency and are Williamtown, Sydney and 'aircraft' respectively. What must be remembered is that the transcripts reflect what ASIB *interpreted* the recordings as. Because Williamtown ATC audio recordings around this time frame have not been located, it has been impossible to verify what was actually said and by who (Image: Australian Government (Bureau of Air Safety) 1981).

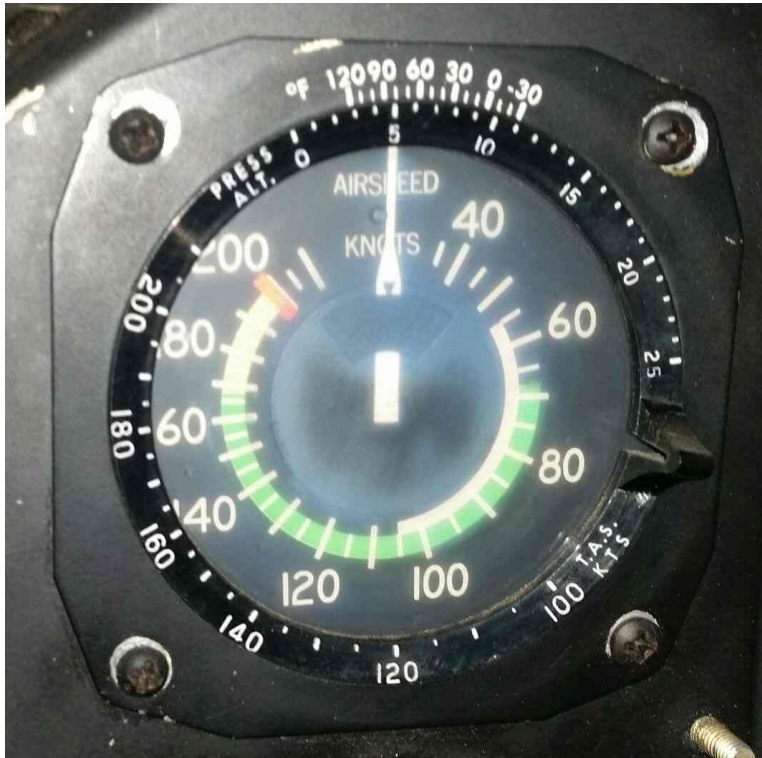
As cruise IAS's are below V_{no} in the Cessna 210M, it can be seen how a cruise speed could have been intentionally flown to rapidly exit icing conditions and provide a good buffer to increased stall speed.

Figure 62: Cessna 210M Air Speed Indicator (ASI). It can be seen that reference to *rounded off* numbers would be simpler in turbulence. The beginning of the yellow band represents the speed at which a symmetrical 3000fpm gust would induce a load factor in excess of the aircraft's design load limit: V_{no} (Maximum structural cruising speed). Should a pilot control input be applied at the same time as a gust is experienced below 168KIAS, overstress is still possible as V_{no} only considers the *gust*. Maneuvering (V_a) and Turbulence Penetration (V_b) speeds are not normally marked on the ASI but are normally placarded on the instrument panel. For the C-210M V_a equals V_b and varies with weight being 119KIAS at MTOW. V_a (normally) considers the effects on structure from only a single control input at one time in one control axis. Any of the following or combinations thereof; simultaneous multiple axis and/or reversing control inputs and/or gusts, will invalidate the protection of V_a . The C-210M normally cruises at IAS's around 145KIAS: about 25knots above MTOW V_a and 15 knots below V_{no} (Photo: N. McGlone 2015).

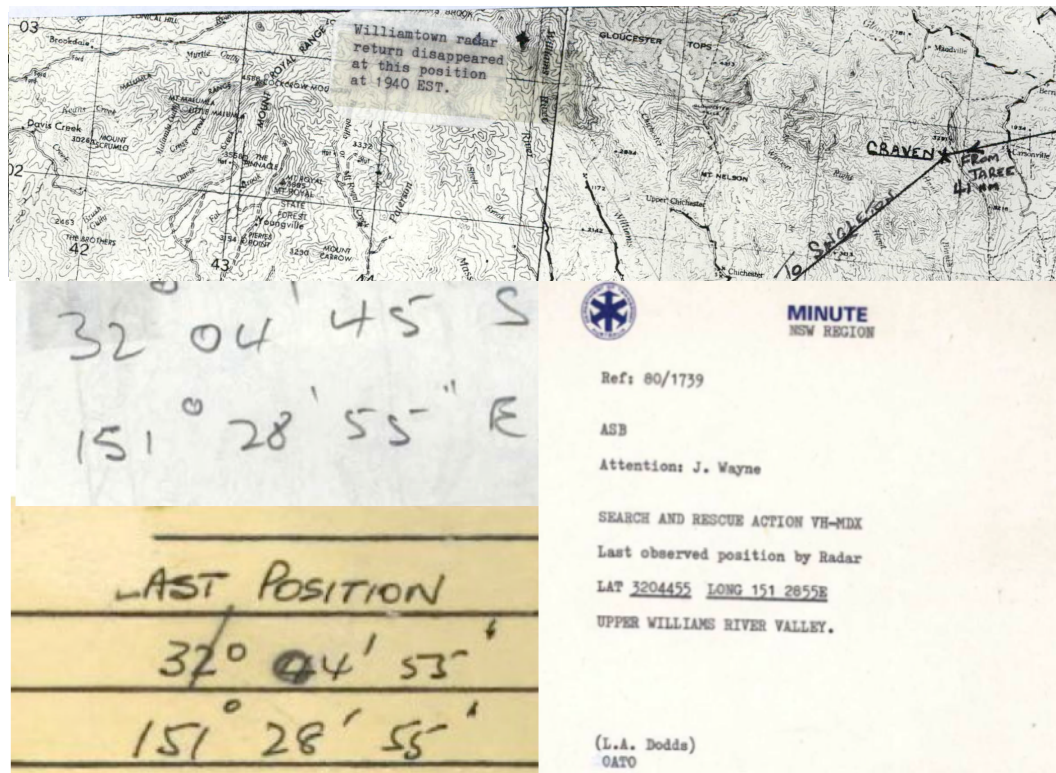
Other than the references to '*Williamtown radar returns disappeared at this position at 1940 EST*'^[1] and '*Last observed position by Radar*'^[1] there are no explanatory notes or expansion as to how the position was derived.

If this position was determined by the information that the Williamtown ATCO gave, then a *bearing/ range definition of this position must have been given*. No such bearing/range definition has been found so far^[21].

Figure 63: ASIB final Williamtown radar position references. The middle left lat/long was located on the flip side of the map displayed at top. Bottom left was located on the back of the folio cover. The Minute displays the position given from RCC to the person undersigned. The origins of these positions in terms of radar derived base data are unknown (Images: Australian Government (Air Safety Investigation Branch) 1981).

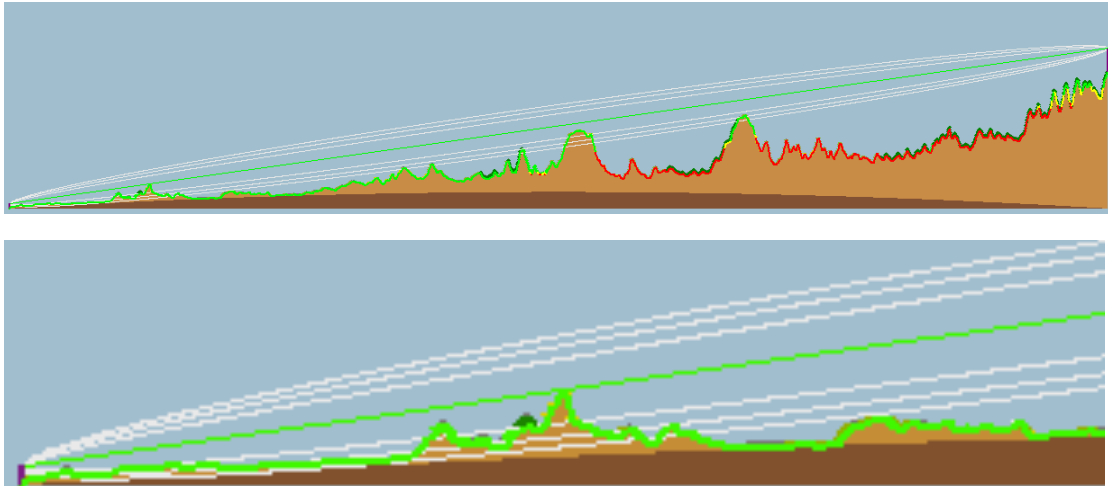
VH-MDX at 3500' AMSL Williamtown TAR

Radar propagation analysis showed that it was possible for Williamtown TAR to interrogate VH-MDX down to 3500'AMSL in this position^[21]. Figure 64 on the next page presents propagation analysis results. This is approximately 500' above terrain level.

Figure 64: Williamtown TAR to ASIB/RCC final radar position prorogation at 3500'AMSL^[27]. The top image zooms in on the most limiting terrain (Image: Radio Mobile Online 2014, analysis Glenn Strkalj 2014).

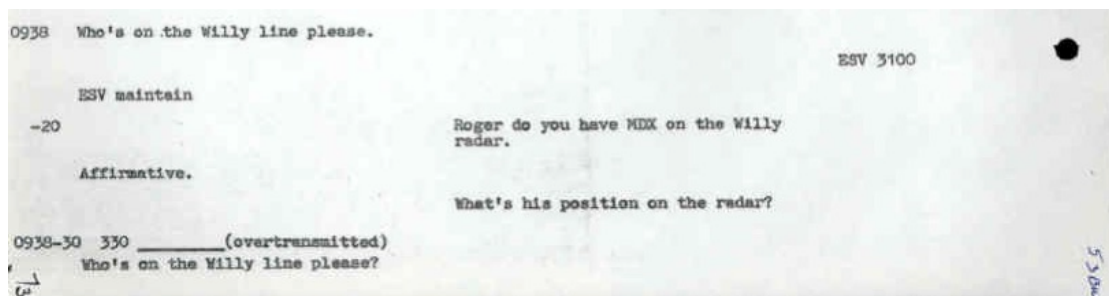
As the ASIB/RCC final fix was only 4° away from the 330°M bearing from Williamtown the question must be asked if the ASIB/RCC final radar fix represents the 330°M bearing based position.

As there is no transcribed distance, the question arises as to how such a distance would have been determined for the map position.

Figure 70: Clipped range at 330°M bearing call. (Image: Australian Government (Air Safety Investigation Branch) 1981).

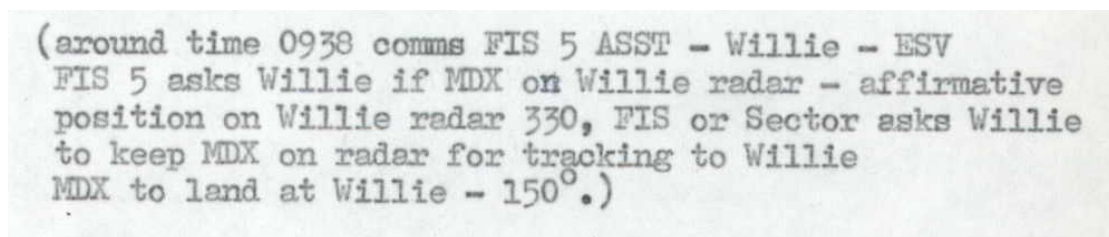
Figure 71: ASIB notes regarding the 330°M call. (Image: Australian Government (Air Safety Investigation Branch) 1981).

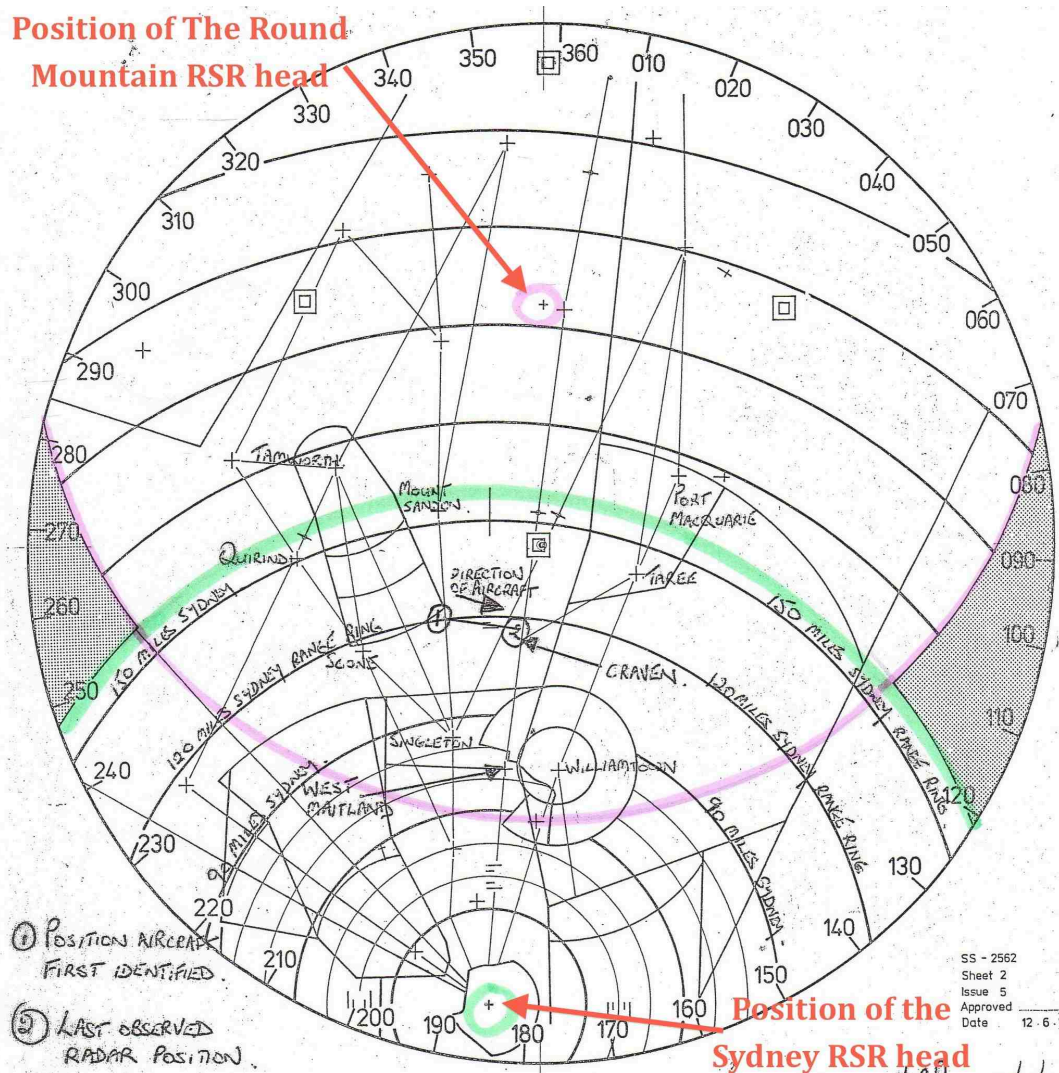
The ATCO's radar plot sheet shows the final radar position of VH-MDX to be approximately 4-5NM north-west of Craven waypoint^[35]. This is indicated as position '2' in figure 73 and 74 on the next page. No time is given for this specific position.

Figure 73: Sydney Northern Mosaic plot sheet. This plot sheet represents what one ATCO observed at the Sector 1 Radar position during the VH-MDX accident. Information from two radars was combined and presented for this particular display 'program'. The position of both radar heads is highlighted. The Round Mountain RSR certified radar range is highlighted in pink, Sydney RSR certified range is highlighted in green, both being 160NM. Obviously, terrain masking yields a practical range at lower levels less than nominal (Image: Australian Government (Department of Transport) 1981).

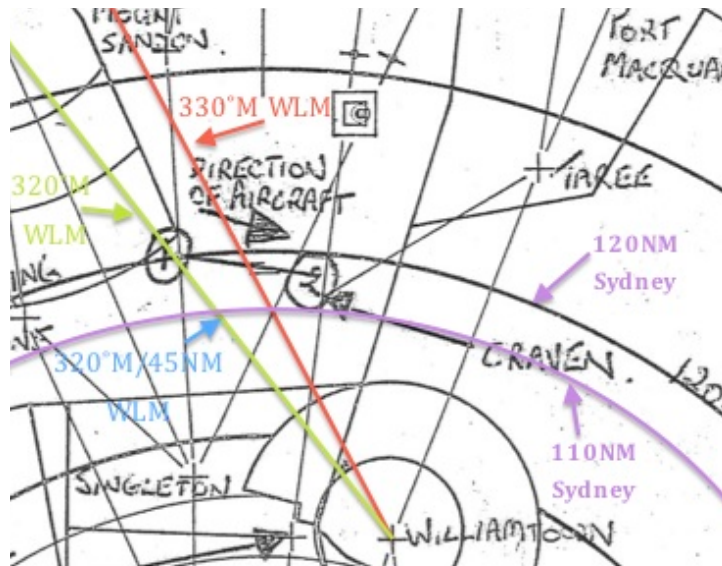
Figure 74: Sydney ATC final radar position. Position '2' was depicted as the final radar position observed by one Sydney ATCO. It was depicted the position was approximately 5NM west of Craven waypoint/intersection. Of note is that the depicted straight track between both fixes was not possible given VH-MDX's track south then south-east to the 320°M/45NM fix. The reason for the straight track appears to be because this ATCO only observed the initial few and last few paints as he was assisting the Sector 1 ATCO with other tasks. The following has been approximated by the author: 320°M radial from Williamtown (green), 330°M radial from Williamtown (red), 320°M/45NM position marked at the tip of the blue arrow, 110NM arc from Sydney (purple) (Base image: Australian Government (Department of Transport) 1981, Additions: Glenn Strkalj 2014).

This position is approximately 10NM east of the ASIB/RCC final observed radar position described in the previous sub-section.
