VH-MDX

Part 1:

An Initial Overview

Version: 3rd Edition (13th August 2015)

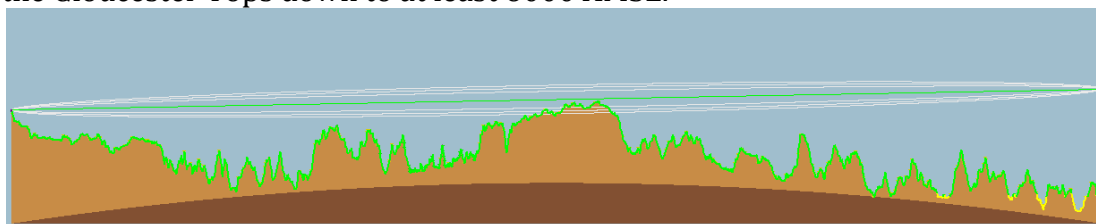
Radar propagation analysis has shown that radar coverage by *The Round Mountain RSR* was likely at this position (figure 76) and indeed generally east of the Gloucester Tops down to at least 6000'AMSL.

Figure 76: Radar propagation from The Round Mountain RSR to VH-MDX at 6000'AMSL located at the deposited final Sydney radar position (centroid of deposited radar plot). Radar coverage was probably possible at altitudes *slightly* below 6000'AMSL (Image: Radio Mobile Online 2014, analysis Glenn Strkalj 2015).

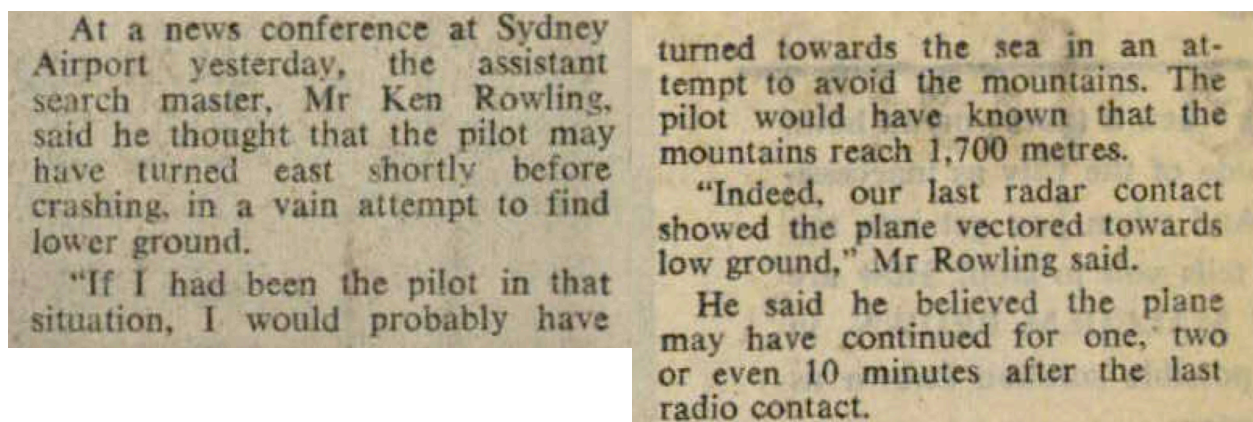
A news conference involving the Assistant Searchmaster a few days after the accident reveals that the 'last' radar contact made with VH-MDX *'.....showed the plane vectored towards low ground'*.

It was stated that the Assistant Searchmaster *'.....thought that the pilot may have turned east shortly before crashing, in a vain attempt to find lower ground'*. The relevant newspaper clipping is presented in figure 77.

Figure 77: VH-MDX tracking east. The opinion of the Assistant Searchmaster is contrary to the initial high area of interest around the 320°M/45NM Williamtown position (Image: The Sydney Morning Herald, Wednesday 12th August 1981).

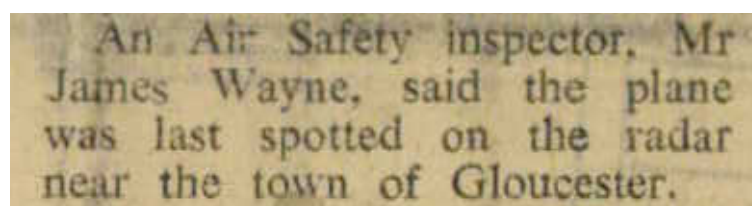
An ASIB Inspector was quoted as stating the last observed radar position was near the town of Gloucester.

Figure 78: Suggestion of easterly track from radar information (Image: The Sydney Morning Herald, 6th September 1981).

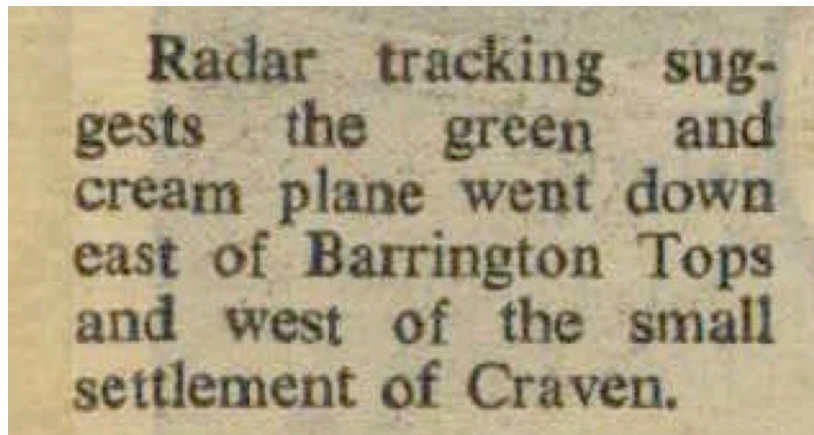
Another newspaper article (figure 79) suggests 'radar tracking' indicates that VH-MDX impacted terrain east of the Barrington Tops and west of Craven township.

Figure 79: Suggestion of an easterly track. (Image: The Sun, Friday 18th September 1981).
