VH-MDX

Part 1:

An Initial Overview

Version: 2nd Edition (2nd July 2015)

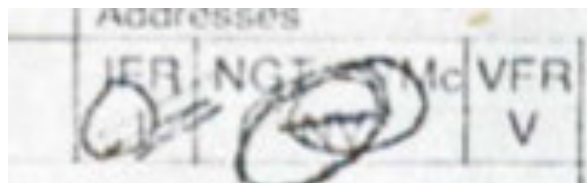
A private category flight was being conducted. Of interest is that IFR category appears to have been circled then scrubbed out for NVFR. Figure 5 below presents this.

Figure 5: VH-MDX Flight plan extract: Nominated flight rules. The flight had every reason to proceed IFR as both pilot and aircraft appear to have been certified and current for IFR and the flight was *private* category allowing single-engine IFR. The pilot displayed some confusion regarding the true meanings of the flight rule categories (Image: Australian Government (Department of Transport) 1981).

The flight had every ability to proceed IFR at night as both pilot and aircraft appear to have been certified and current for IFR^[1] and the flight was *private* category allowing single-engine IFR.

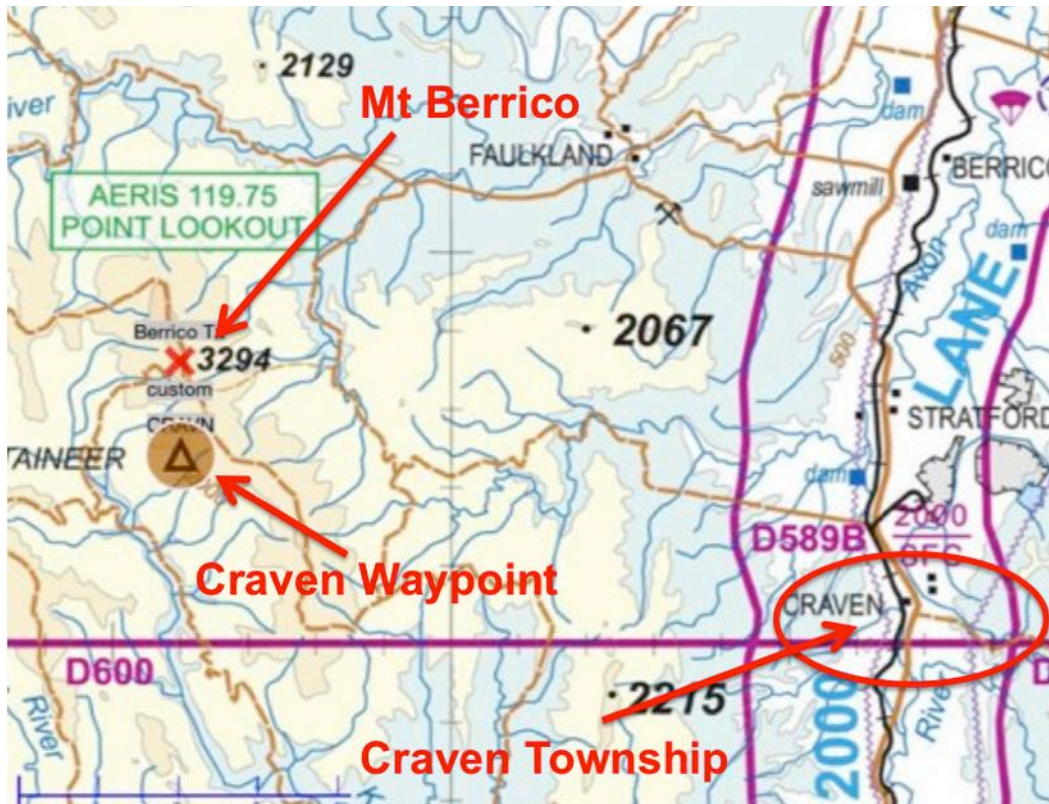
Craven waypoint is approximately 1NM south of Mount Berrico, not directly over Mount Berrico as is stated^[14] in one VH-MDX analysis. Accordingly, Mt Berrico transceiver station does not offer an exact position reference for Craven waypoint as was suggested^[14].

Figure 8: Craven waypoint, Mt Berrico, Craven township. Berrico transceiver station (red cross), Craven waypoint (brown triangle) and Craven township (red oval). Immediately obvious is the distance between Craven waypoint and township (about 9NM-10NM). Mt Berrico transceiver station is located approximately 1NM north of Craven waypoint (Base image: OzRunways 2014).

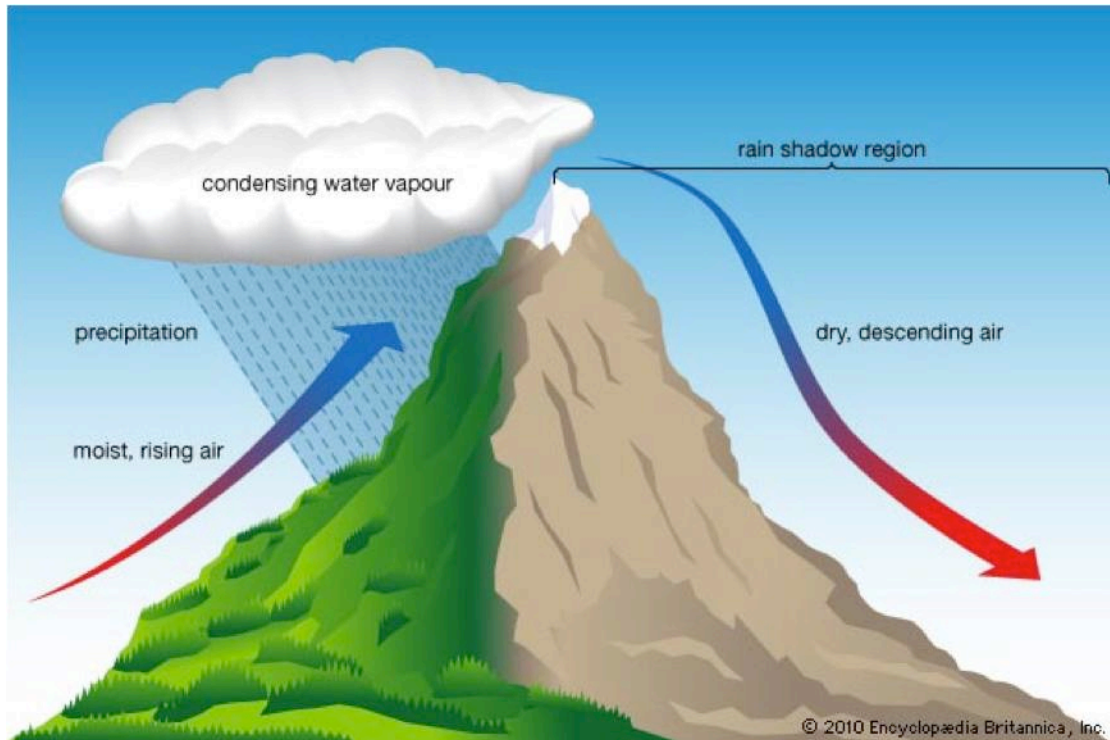
Formation of the clouds was due to forced lifting by the high terrain (orographic uplifting). Cloud formation on the lee side of the ranges is limited or prevented by the cessation of uplift coupled with the precipitation on the windward side significantly drying the air mass out^{[19][41]}. The image in figure 11 on the following page depicts this.

Figure 11: Orographic cloud formation. Orographic cloud stays ‘stationary’ on the windward side of and on, mountain tops. The lee side is generally clear of cloud or small roll type clouds may be apparent. VH-MDX flew into such cloud over the Barrington Tops area, this being some of the only cloud in the general area (Image: Encyclopedia Britannica 2010).

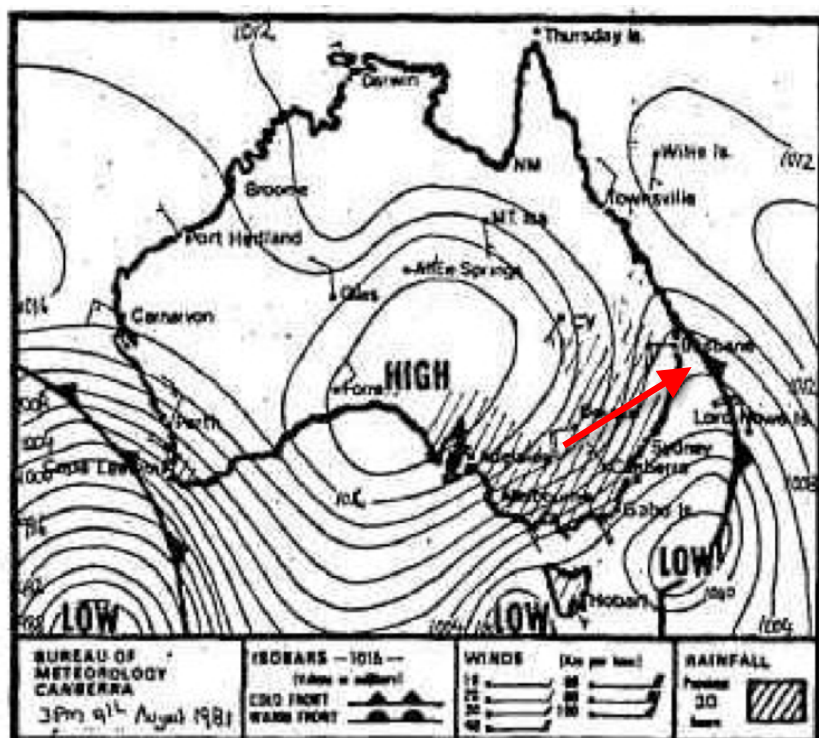
Figure 13: Synoptic MSL chart 1500EST (0500UTC) 9th August 1981. VH-MDX entered the Barrington Tops area approximately four and a half hours after 1500EST (1930EST/0930UTC). The author has included the red arrow to indicate very approximately the aloft wind direction in the Barrington Tops region. A south-west flow is indicated. Reasonably close isobars suggest strong winds. The cold front had well and truly passed by the time of the accident resulting in winds backing and generally clear skies. Although rain is depicted, *specific* area and location forecasts in addition to actual reports show that rain seemed only to be associated with localized orographic uplift. It must be remembered clear skies were predominate (Australian Government (Bureau of Meteorology) 1981).

Figure 13 shows the weather synoptic situation approximately four and one half hours before the accident. The cold front is clearly out to sea in the mid to northern NSW area. By the accident time, the cold front would have moved further east seaward.

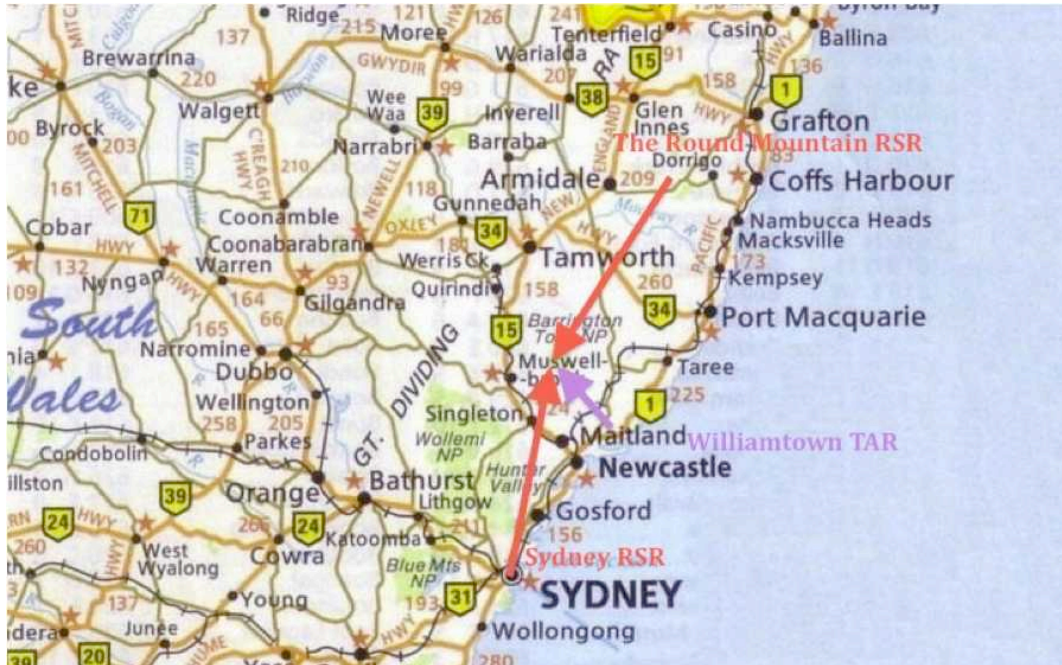
Figure 16: Relevant radar head locations. The Round Mountain RSR and Sydney RSR were operated by Sydney ATC (red arrows). Immediately obvious is how much closer to VH-MDX Williamtown TAR was. Despite this, as will be discussed only a single *complete* radar fix was obtained by Williamtown TAR (Base Map: Melway Publishing Pty Ltd 2014, additions: Glenn Strkalj 2014).

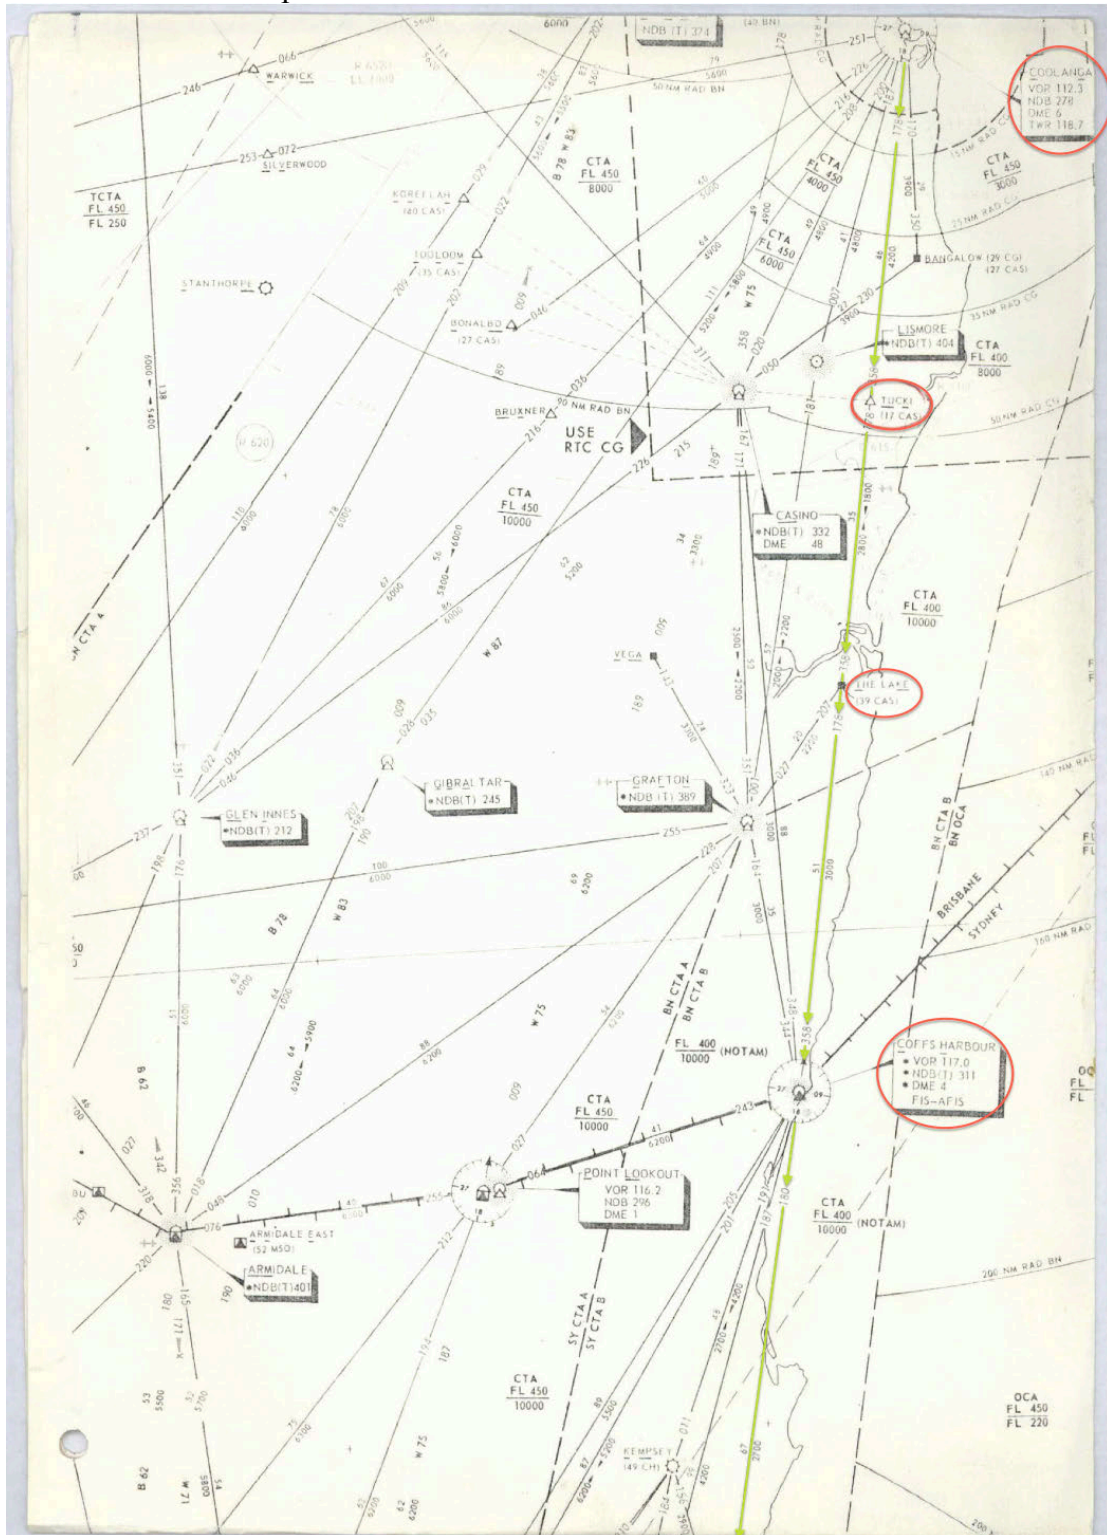
Figure 21: Flight progress Coolangatta-Coffs Harbour. Green arrows represent VH-MDX's track. VH-MDX appeared to progress normally between Coolangatta and Coffs Harbour. Tracks and distances are marked on the chart from each waypoint/navaid. Tracks marked are in degrees *magnetic* whilst distances are in Nautical Miles (NM) (Base image: Australian Government (Department of Transport Australia) c.1981).

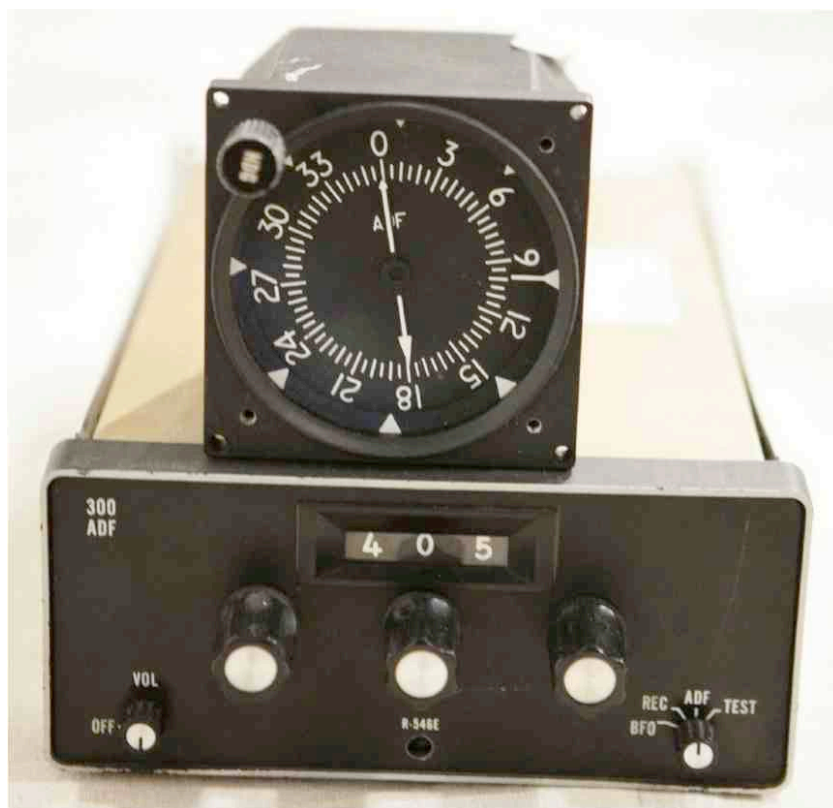
As the Directional Indicator (DI) was reported as unserviceable^[1], the direct reading compass had to have been used.

Figure 30: IN-346A fixed card ADF indicator and ARC R546E ADF receiver. These particular units were likely onboard VH-MDX during the accident. 'Fixed card' refers to the fact that the compass rose is not continually slaved to magnetic north as in some indicators. Despite this, the pilot is still able to manually rotate the card to any position. This is handy when transposing compass headings to the fixed card indicator in order to convert the displayed *relative* bearings to *magnetic* bearings.

Indeed unstable ADF indications were reported in the Barrington Tops area by the pilots of VH-ESV and VH-MDX^[1].

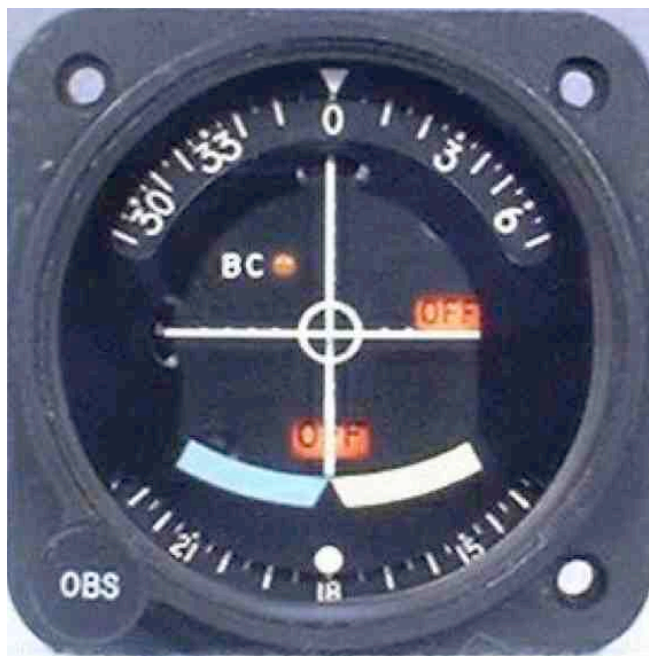
Figure 32: IN-525R VOR Omni Bearing Indicator (OBI). This indicator was listed in BASI archives as being fitted on board VH-MDX when delivered to Australia in 1977. Unlike the fixed card ADF, the OBI presents *magnetic* bearing information to the pilot. This simplifies obtaining magnetic bearing information to the pilot compared to the ADF. The knob on the bottom left is turned until the vertical needle is centered. The magnetic bearing is simply read off the top scale; in this case 000°M. A small ‘to/from’ indicator (not visible in the photo) indicates if the aircraft is positioned on the hemisphere that is going ‘to’ the indicated bearing (selected bearing is on the other side of the VOR ground station) or ‘from’ the selected bearing (selected bearing is on same side as the aircraft relative to the ground station). (Photo: Bennett Avionics 2001-2014).

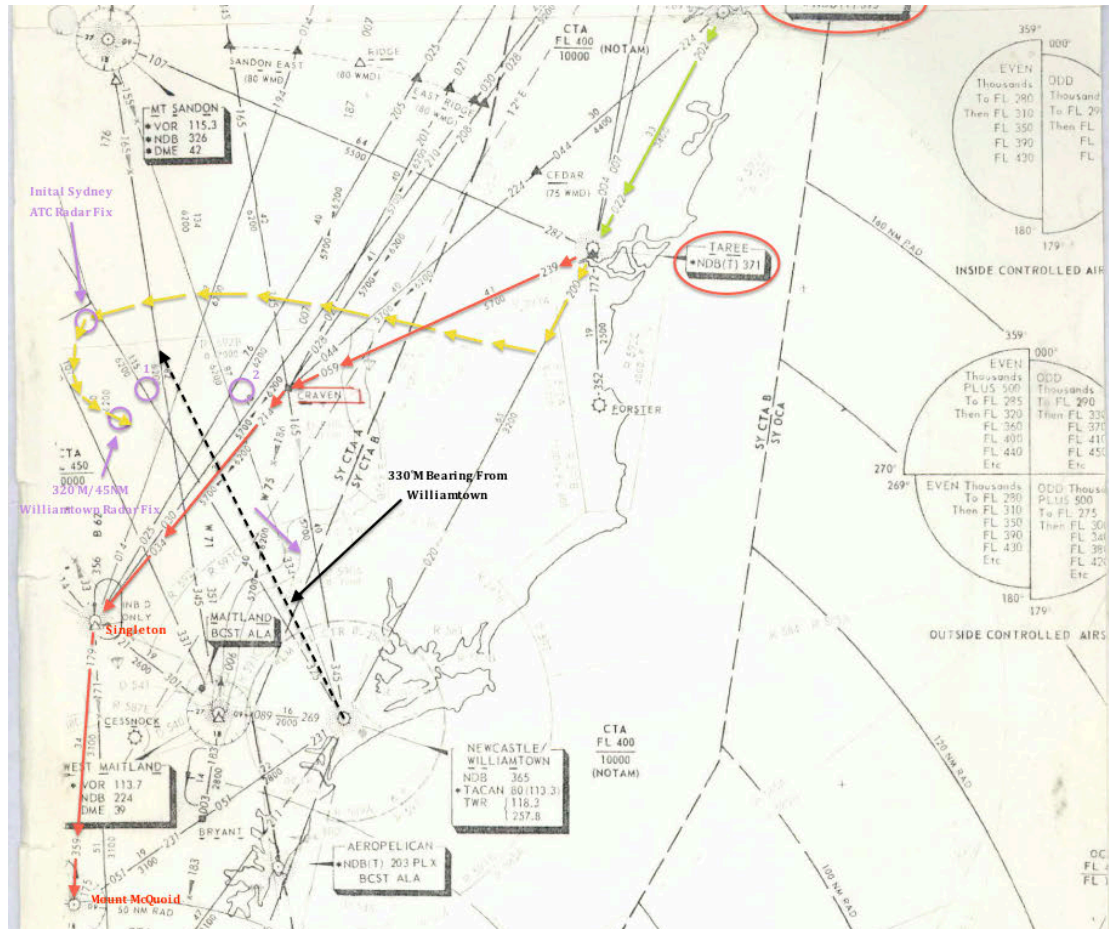
Many including Don Chessor^[26] and John Watson^[42] have suggested that the Scone NDB was mistakenly tuned instead of the Singleton NDB given the similarities in frequency and ident (209kHz vs. 290kHz).

If the ADF was mistakenly tuned to Scone NDB instead of Singleton NDB and the Scone NDB ‘homed’ (needle on nose), it can be seen in figure 35 how VH-MDX arrived at the initial Sydney radar position. Additionally, VH-MDX would likely pass a few NM north of Craven waypoint. More of this will be discussed later.

Figure 35: Scone NDB theory. Readily obvious on this chart is the co-incident alignment of Scone NDB when considering tracking between just south of Taree NDB to the initial Sydney radar position. If this NDB were homed, a track north of the direct course (black dashed horizontal line) would be expected (Base image: Australian Government, (Department of Transport Australia) c.1981).

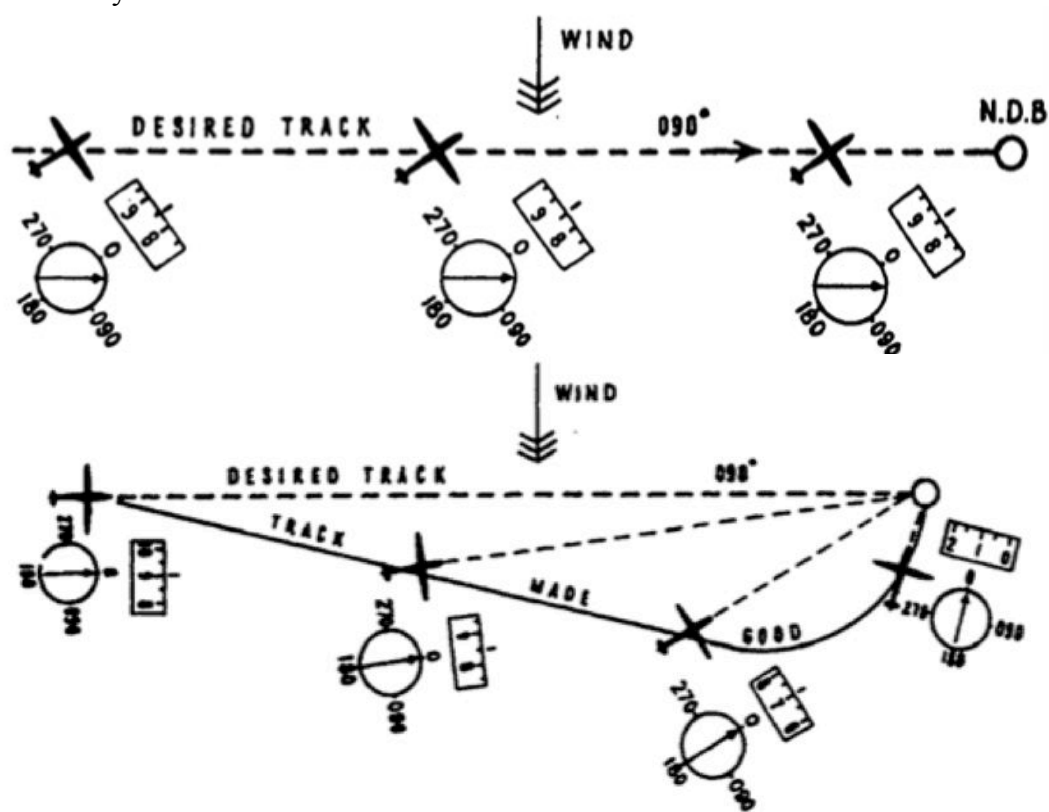
If the pilot of VH-MDX simply used 'homing' techniques (needle on nose) to track to the NDB then it can be seen in figure 40 that combined with the force of the prevailing south-westerly to westerly wind, VH-MDX could easily end up at the position of initial radar identification (approximately 36NM north of Singleton).

If indeed the pilot of VH-MDX were *homing* on Scone NDB then constant heading adjustment towards the left (south) would have been required to maintain the needle approximately on the nose.

Figure 40: Tracking vs. homing. Normally, a pilot 'tracks' a particular ADF bearing in that appropriate drift correction for wind is held achieving a constant track (top image). The aim is to continually maintain a *particular* bearing inbound or outbound relative to the NDB (top image) rather than drift onto other bearing lines (bottom image). A less tidy way of tracking to an NDB is by *homing*. Basically the pilot adjusts the aircraft heading continually to keep the ADF needle on the nose (0° *relative* bearing). The prevalent wind will push the aircraft downwind and as the pilot adjusts the heading for zero *relative* bearing it can be seen the aircraft passes through a multitude of *magnetic* bearings to arrive at the NDB. Not only is this an inefficient way to arrive overhead an NDB but aviation charts specify particular tracks between nav aids with information such as Lowest Safe Altitudes (LSALT) and leg distance. Such information is invalidated by not maintaining a *particular* track (Images: Australian Government (Civil Aviation Authority) c.1980's).

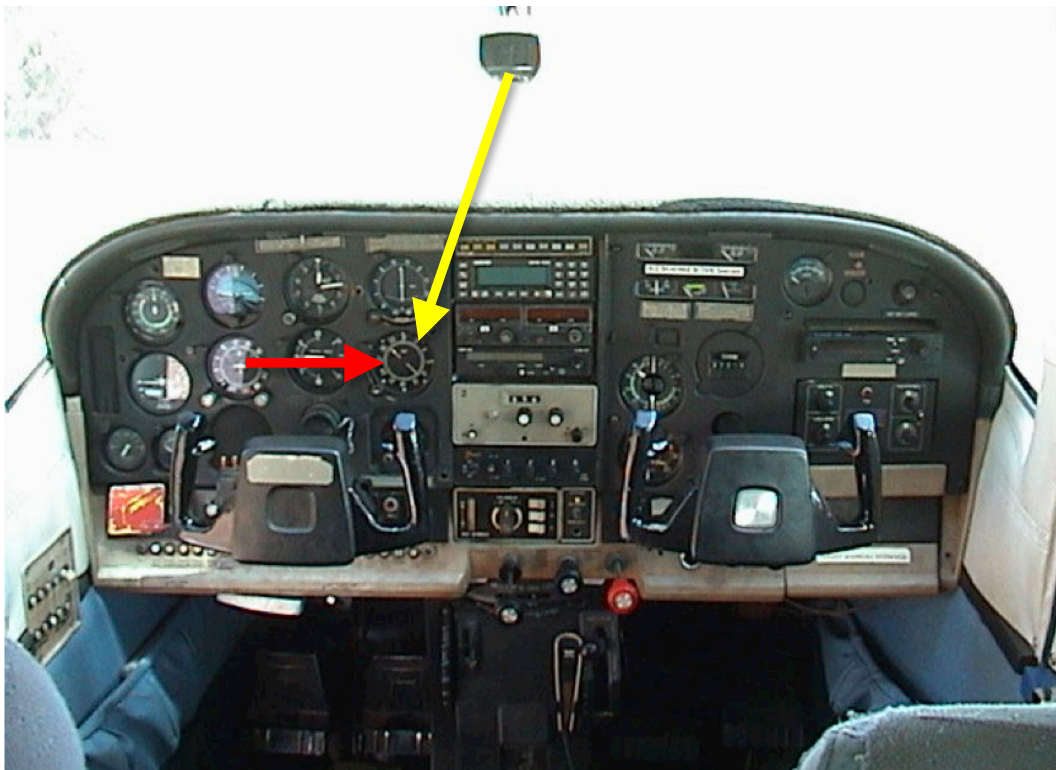
About 40 seconds after reporting in cloud, the pilot of VH-MDX advises that he had lost his AH and DI. These are both vacuum powered gyroscopic instruments crucial for flight in instrument conditions such as cloud^[1]. Both gyro's operated on a single vacuum pump source^{[1][2]}.

This failure would have made tracking accurate bearings with the ADF rather difficult as the pilot would have to scan the small sized *direct indicating compass* located near the roof for a heading and transpose this on the ADF rose that was displaying *relative* bearings: *regularly*. Figure 41 shows the distance involved in scanning the direct reading compass.

Adding the effects of turbulence bouncing the compass around and the darkness of night, it can be seen that maintenance of *accurate* bearings would have been highly challenging.

Figure 41: Bearing transposition onto the ADF. VH-MDX was likely fitted with a *fixed card* type ADF (located at the *heads* of the two arrows above) that displayed only *relative* bearings of the NDB to the aircraft. Pilots are required to mentally transpose heading information onto the relative bearing card of the ADF to yield *magnetic* bearings that are then useable for navigation. This is normally done by reference of the Direction Indicator (DI) positioned two instruments to the left of the ADF indicated by the origin of the red arrow. With the DI unserviceable, the pilot is forced to include the direct reading compass located at the top of the windscreen (indicated at origin of yellow arrow) into the scan that forces the pilot away from ‘flying’ the aircraft. Throw in the additional challenges of attempting to read the compass bouncing around in turbulence at night and it can be seen that maintenance of accurate NDB bearings is very challenging (Photo: Glenn Strkalj 2002).

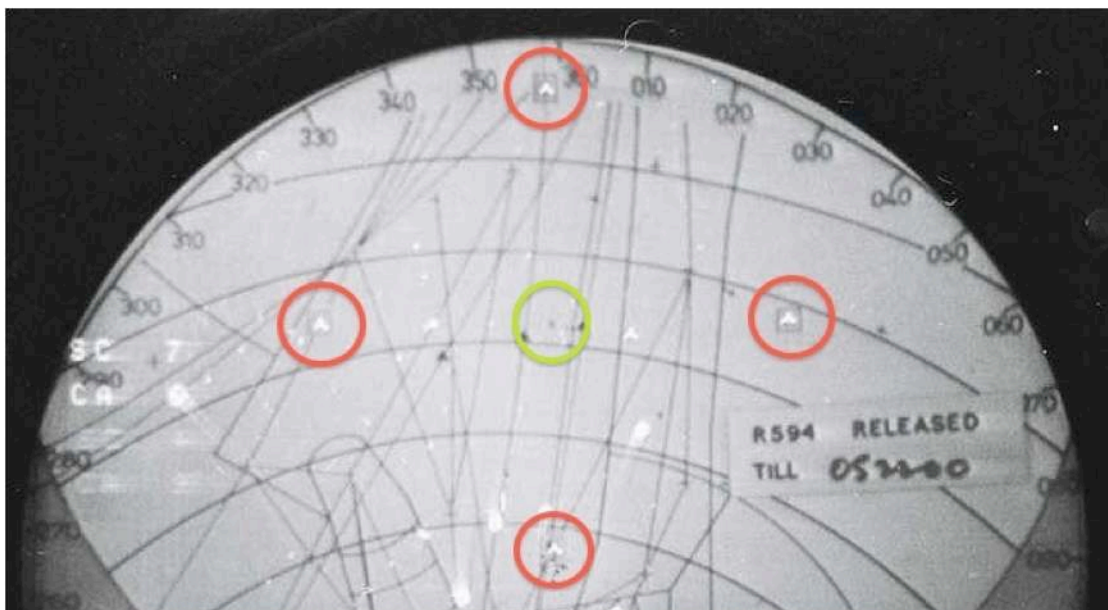
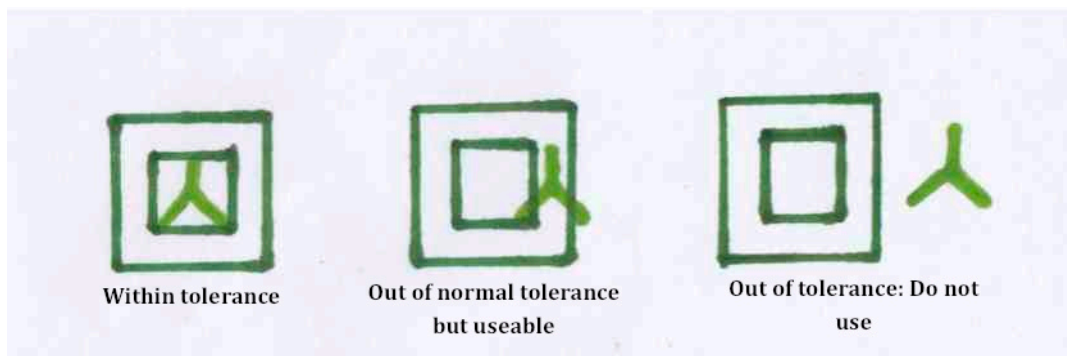
A DoT Officer involved in the accident investigation did recall that the radar system at Sydney for the Sector 1 position was verified as being well within tolerance and that aircraft during the night of the accident were radar observed over positions they were calling in over the radio^[20].

Until further clarification is found regarding actual calibration during the accident, Sydney's radars are assumed to be within tolerance given the reportedly robust monitoring and maintenance of tolerances.

Figure 44: Northern Mosaic alignment markers (red circles). The ATCO would check if the illuminated inverted 'Y' was located within inner and outer boxes. Various levels of tolerance determined serviceability: This was only one of many calibration checks performed. Equipment was reportedly calibrated to very tight tolerances and there is no reason to suspect equipment was significantly out of tolerance during the VH-MDX accident. Despite this, it would be prudent to confirm calibration if applicable information ever presents. (Photo: M. Price c.1983, tolerance box drawing: Glenn Strkalj 2015).

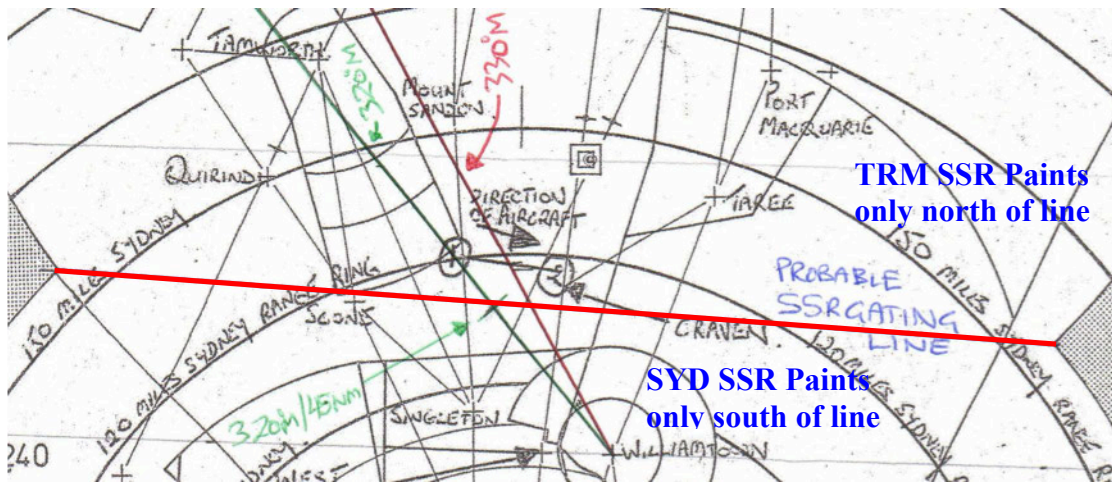
Figure 45: SSR gating line. The electronic gating line was not visible on the display and formed a hard barrier determining the RSR SSR source that would be displayed. North of the gating line only The Round Mountain RSR SSR information was displayed, south of the gating line only Sydney RSR SSR information was displayed. (Image: Australian Government (Department of Transport) 1981, additions: Glenn Strkalj 2015).

As VH-MDX was highly unlikely able to be interrogated by the Sydney RSR, this means that if VH-MDX tracked south of the gating line the aircraft's SSR paints would likely disappear from the Bright display. Accordingly, this knowledge can be applied to flight path analysis.

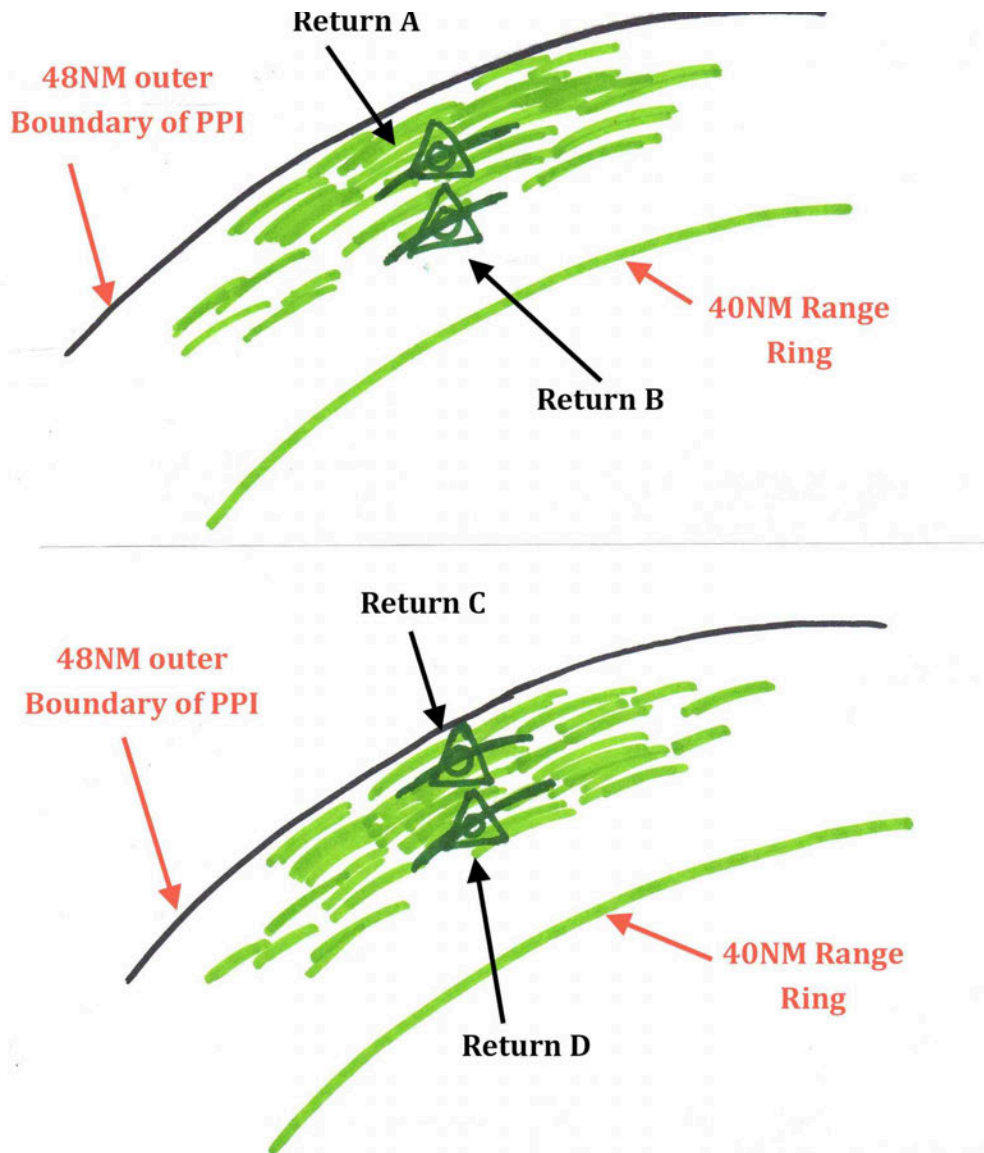
Figure 55: Multi choice options considering range for the 320°M/45NM fix. A gross error check of reported VH-MDX paints was carried out by asking the ATCO to select the most appropriate positioned paint separately for range and bearing (2014). Only terrain clutter was displayed for reference. Terrain clutter was a known quantity on the Williamtown TAR. Despite the permanent terrain clutter, the SSR symbology of the returns were readily apparent to the Williamtown ATCO due to their shape cutting across the clutter direction. A 44NM MTI filter boundary and 48NM outer edge brackets the range of the returns. The ATCO was quite confident that the SPI triangle was not clipped by the outer edge of the PPI (48NM) nor was it hanging over the 44NM MTI clutter boundary (return B). The ATCO ‘feels’ there was a gap between the SPI triangle and the PPI outer edge rather than the paints touching the outer edge as in return C. Return A was chosen to represent what the ATCO observed. Considering the distance between outer edge and MTI boundary and probable SSR symbol sizes, VH-MDX was likely around 46NM when using this rough method. Referencing VH-MDX paints to the clutter only gives a *gross error check* to the reported position. 320°/45NM, +4°/-2°, +2NM/-0NM is still viewed as the fix position. (Image: Glenn Strkalj 2014).

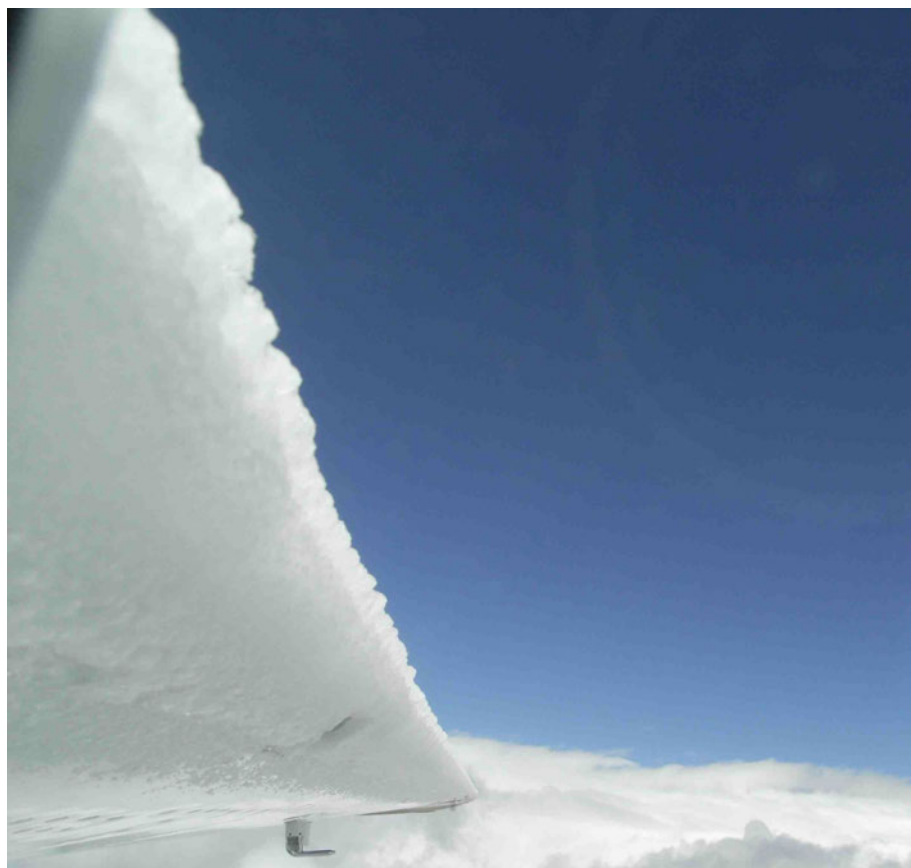
Figure 57 on the next page shows an excellent example of a Cessna 210 with significant icing accumulation on the wing. The change in wing profile is immediately obvious.

- Increase in stall speed due to changing the aerodynamic shape of the wing and tail and also weight increase
- Destroy smooth airflow over the aircraft
- Reduce lift and increase drag: icing no thicker or rougher than a piece of coarse sandpaper has been demonstrated to reduce lift by 30% and increase drag by 40%
- Jammed control surfaces
- Engine failure
- Propeller vibrations
- Erroneous airspeed, vertical speed and altitude instrument indications
- Interfere with communications systems
- Reduce visibility.

Figure 57: Icing accumulation: Cessna 210 wing leading edge. Significant ice has accumulated on the leading edge and immediately aft and underneath. The pilot's view from the Cessna 210 cockpit does not allow inspection of the critical upper surface of the wing. The effects of the rough and jagged ice on laminar airflow of the wing is readily predictable when viewing this photo. It can be seen why stall speed and drag increases. Additionally, the extra weight of the ice can be significant further burdening performance. The pitot tube under the wing is free of ice indicating that pitot heating was probably selected during this ice encounter.

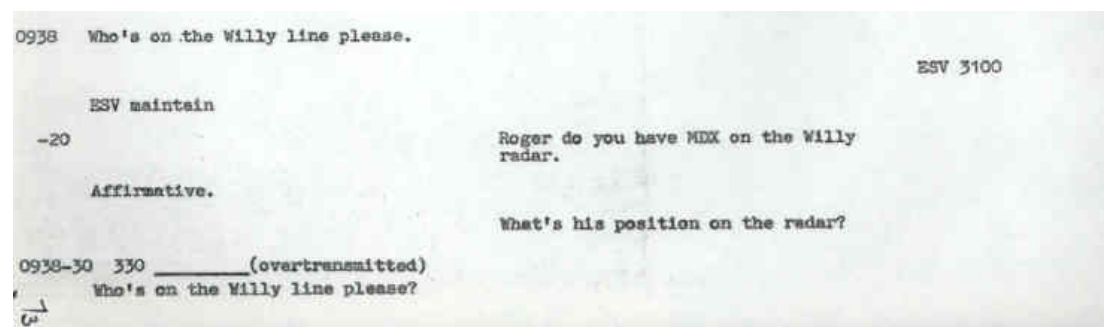
Regarding the 330 bearing call, the Williamtown ATCO does not remember making this call nor consciously observing the PPI but suggests if he did make the call then he would have done so with an information source i.e. radar observation^[21].

Even if the Williamtown ATCO did not make the 330 bearing call the important point is that someone did and they were highly likely talking of VH-MDX. It is also possible that the 330 call was made by a Sydney ATCO based on observed position on Sydney ATC radar.

Figure 58: 330 Call ASIB transcript. The columns from left to right depict the transmitting agency and are Williamtown, Sydney and ‘aircraft’ respectively. What must be remembered is that the transcripts reflect what ASIB *interpreted* the recordings as. Because Williamtown ATC audio recordings around this time frame have not been located, it has been impossible to verify what was actually said and by who (Image: Australian Government (Bureau of Air Safety) 1981).

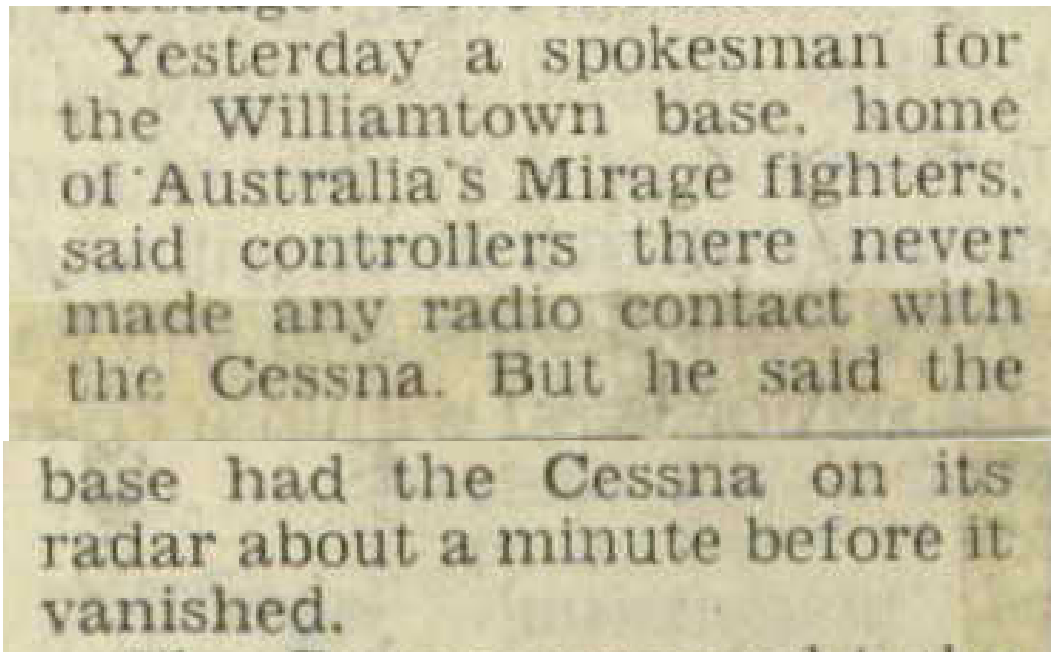
Furthermore, a words from a RAAF Williamtown spokesperson within days of the accident was quoted as stating Williamtown had VH-MDX on radar about one minute before the aircraft vanished: see below in figure 59.

Figure 59: RAAF Williamtown suggesting the 330° bearing was observed at Williamtown radar. As the last received radio call from VH-MDX was around 0939:30UTC, one minute prior is 0938:30UTC: the time of the 330°M call. (Image: The Weekend Australian, 15th-16th August 1981).

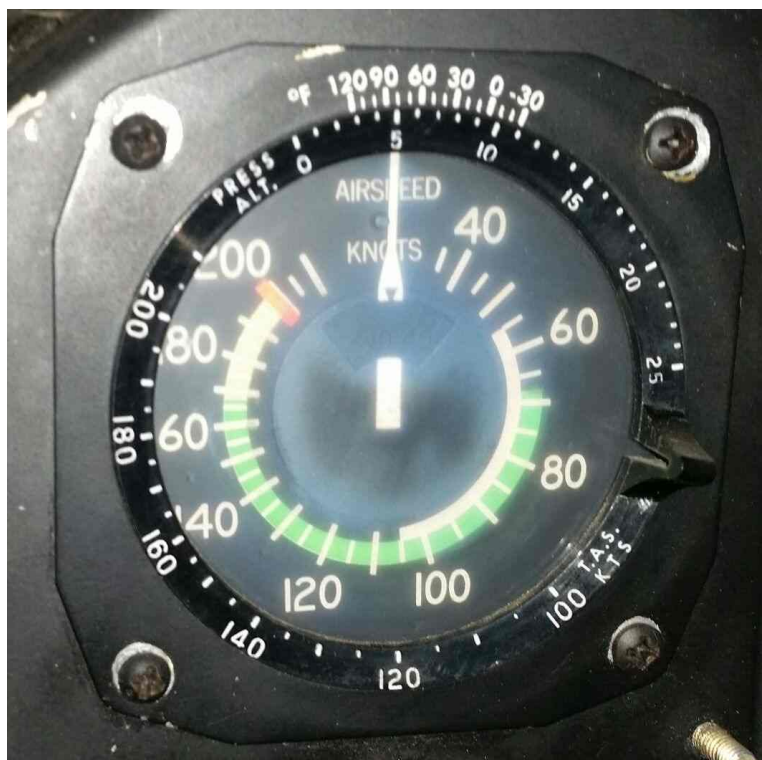
Of immediate reference to the pilot is V_{no} at the beginning of the yellow ASI band and it is viewed that most pilots would not intentionally exceed this speed in severe turbulence. As cruise IAS's are below V_{no} in the Cessna 210M, it can be seen how a cruise speed could have been intentionally flown to rapidly exit icing conditions and provide a good buffer to increased stall speed.

Figure 45: Cessna 210M Air Speed Indicator (ASI). It can be seen that reference to *rounded off* numbers would be simpler in turbulence. The beginning of the yellow band represents the speed at which a symmetrical 3000fpm gust would induce a load factor in excess of the aircraft's design load limit: Vno (Maximum structural cruising speed). Should a pilot control input be applied at the same time as a gust is experienced below 168KIAS, overstress is still possible as Vno only considers the *gust*. Maneuvering (Va) and Turbulence Penetration (Vb) speeds are not normally marked on the ASI but are normally placarded on the instrument panel. For the C-210M Va equals Vb and varies with weight being 119KIAS at MTOW. Va considers the effects on structure from only a single control input at one time in one control axis. Any of the following or combinations thereof, of simultaneous multiple axis and/or reversing control inputs and/or gusts will invalidate the protection of Va. The C-210M normally cruises at IAS's around 145KIAS: about 25knots above MTOW Va and 15 knots below Vno (Photo: N. McGlone 2015).

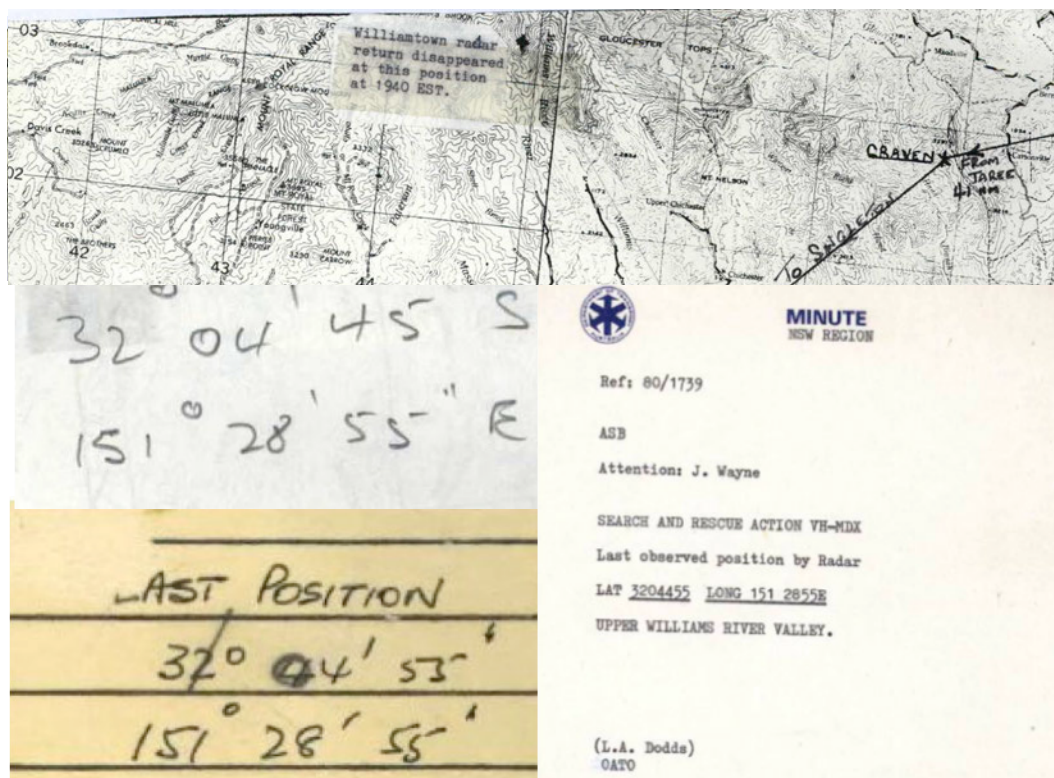
Other than the references to ‘*Williamtown radar returns disappeared at this position at 1940 EST*’^[1] and ‘*Last observed position by Radar*’^[1] there are no explanatory notes or expansion as to how the position was derived.

If this position was determined by the information that the Williamtown ATCO gave, then a *bearing/ range definition of this position must have been given*. No such bearing/range definition has been found so far^[21].

Figure 61: ASIB final Williamstown radar position references. The middle left lat/long was located on the flip side of the map displayed at top. Bottom left was located on the back of the folio cover. The Minute displays the position given from RCC to the person undersigned. The origins of these positions in terms of radar derived base data are unknown (Images: Australian Government (Air Safety Investigation Branch) 1981).

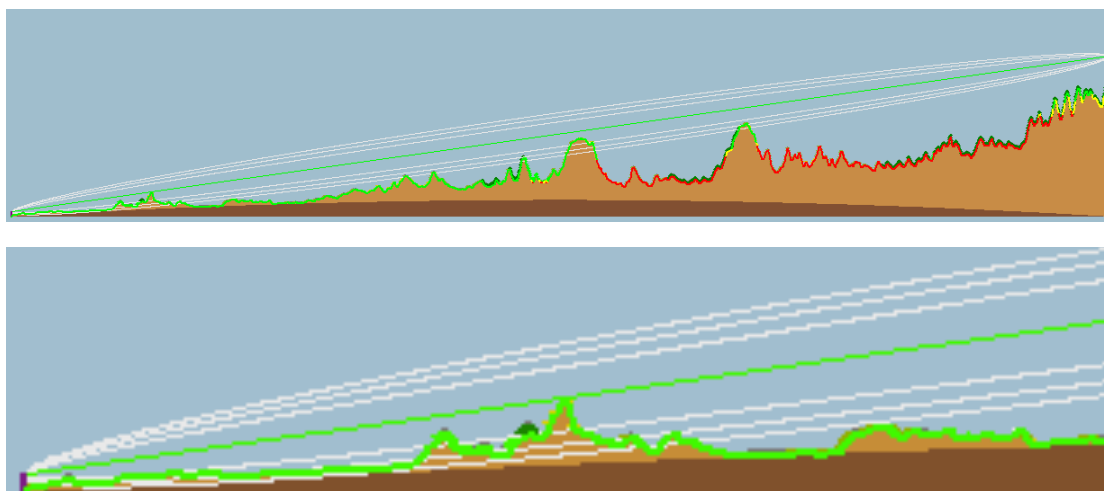
VH-MDX at 3500' AMSL Williamtown TAR

Radar propagation analysis shows that it was possible for Williamstown TAR to interrogate VH-MDX down to 3500' AMSL in this position^[21]. Figure 62 on the next page presents propagation analysis results. This is approximately 500' above terrain level.

Figure 62: Williamtown TAR to ASIB/RCC final radar position prorogation at 3500' AMSL^[27]. The top image zooms in on the most limiting terrain (Image: Radio Mobile Online 2014, analysis Glenn Strkalj 2014).

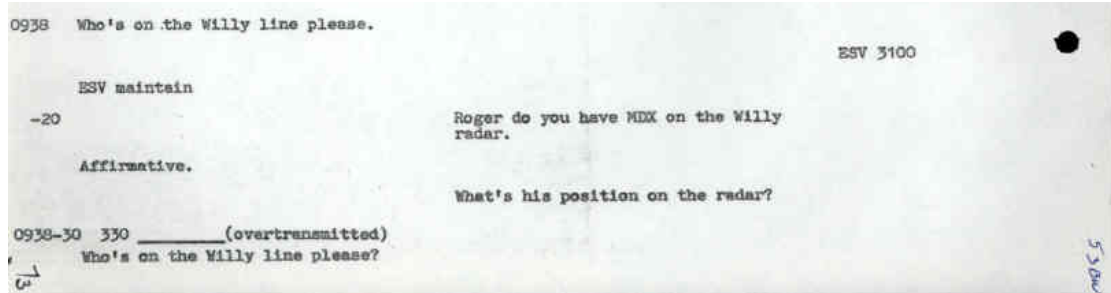
As there is no transcribed distance, of question is how such a distance would have be determined for the map position.

Figure 69: Clipped range at 330°M bearing call. (Image: Australian Government (Air Safety Investigation Branch) 1981).

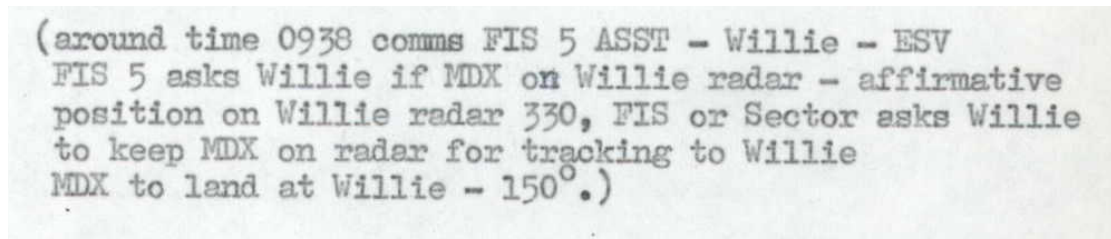
Figure 70: ASIB notes regarding the 330°M call. (Image: Australian Government (Air Safety Investigation Branch) 1981).

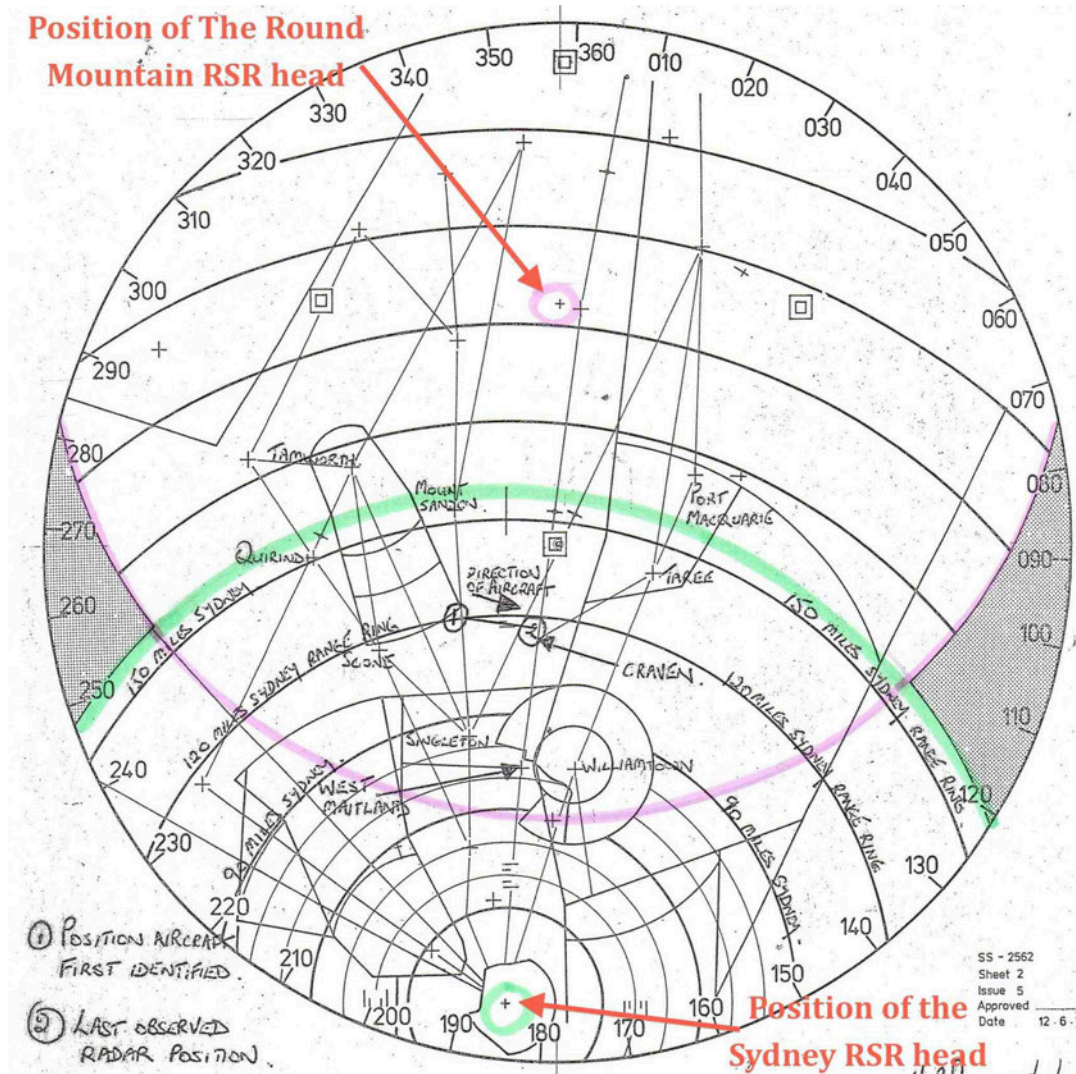
The ATCO's radar plot sheet shows the final radar position of VH-MDX to be approximately 4-5NM north-west of Craven waypoint^[35]. This is indicated as position '2' in figure 71 and 72 on the next page. No time is given for this specific position.

Figure 71: Sydney Northern Mosaic plot sheet. This plot sheet represents what one ATCO observed at the Sector 1 Radar position during the VH-MDX accident. Information from two radars was combined and presented for this *particular* display 'program'. The position of both radar heads is highlighted. The Round Mountain RSR certified radar range is highlighted in pink, Sydney RSR certified range is highlighted in green, both being 160NM. Obviously, terrain masking yields a practical range at lower levels less than nominal (Image: Australian Government (Department of Transport) 1981).
