VH-MDX

Part 1:

An Initial Overview

Version: 2nd Edition (2nd July 2015)

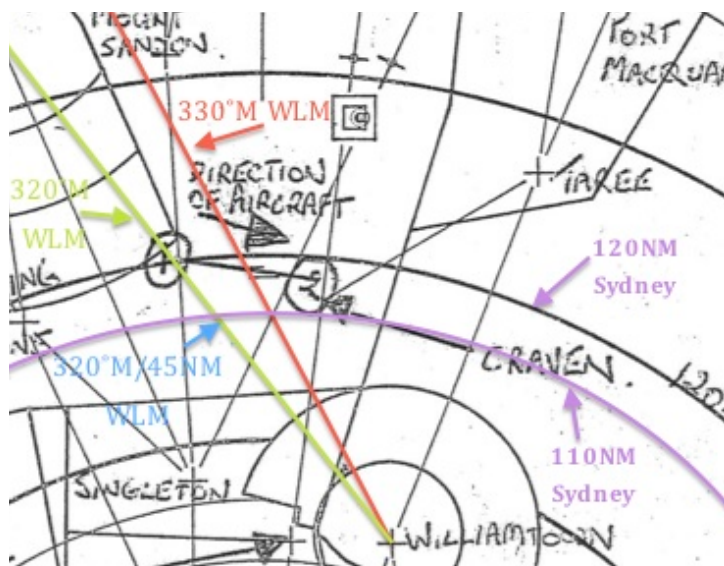
Plotting the Sydney final radar position on Google Earth and adjusting for Williamtown 1981 magnetic variation^[44] gives a bearing from Williamtown of 337°M and range of 42.2NM for '5NM west of Craven' and 340°M/44.9NM for '5NM north-west of Craven'^[20].

Figure 72: Sydney ATC final radar position. Position ‘2’ was reported as the final radar position observed by one Sydney ATCO. It was deposed the position was approximately 5NM west of Craven waypoint/intersection. Of note is that the depicted straight track between both fixes was not possible given VH-MDX’s track south then south-east to the 320°M/45NM fix. The reason for the straight track appears to be because the ATCO only observed the initial few and last few paints as he was assisting the Sector 1 ATCO with other tasks. The following has been approximated by the author: 320°M radial from Williamtown (green), 330°M radial from Williamtown (red), 320°M/45NM position marked at the tip of the blue arrow, 110NM arc from Sydney (purple) (Base image: Australian Government (Department of Transport) 1981, additions: Glenn Strkalj 2014).

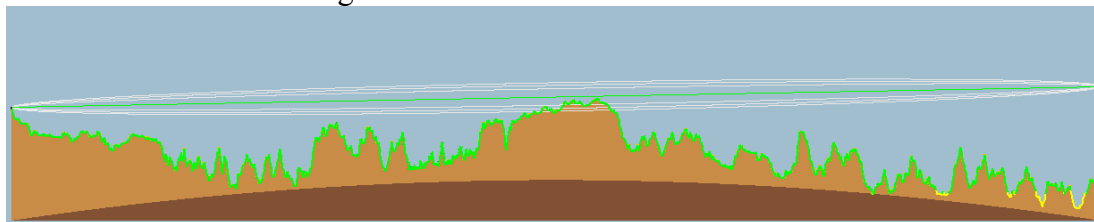
Radar propagation analysis has shown that radar coverage by *The Round Mountain RSR* was likely at this position and indeed generally east of the Gloucester Tops down to at least 6000' AMSL. Figure 73 show this.

Figure 73: Radar propagation from The Round Mountain RSR to VH-MDX at 6000' AMSL located at the final Sydney radar position (centroid of deposited radar plot). Radar coverage was probably possible at altitudes slightly below 6000' AMSL (Image: Radio Mobile Online 2014, analysis Glenn Strkalj 2015).
