## Operation Wittenoom VH-MDX Research

### Introduction

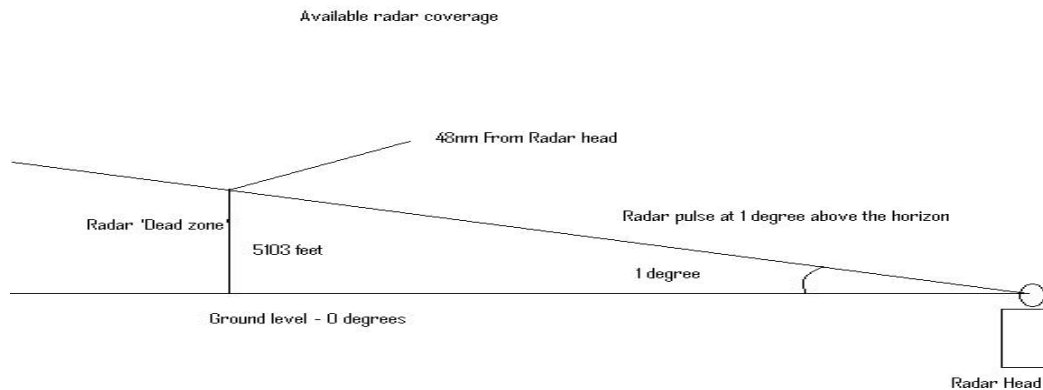
Simplified and exaggerated Radar tilt diagram

Using the simplified (not to scale and exaggerated) radar diagram above you can see that as an angle continues, it subtends to cover a greater distance. Therefore the area not covered by radar below this line gets larger the further from the radar. Interestingly, with the 1 degree tilt found on the radar head at Williamtown in 1981, using simple trigonometry, we find that at a distance of 45nm from Williamtown, the altitude where it a target will do longer be detected is 4800 feet. If you recall, the last reported altitude by MDX was 5000 feet, and the same time it faded from radar and radio contact was lost.

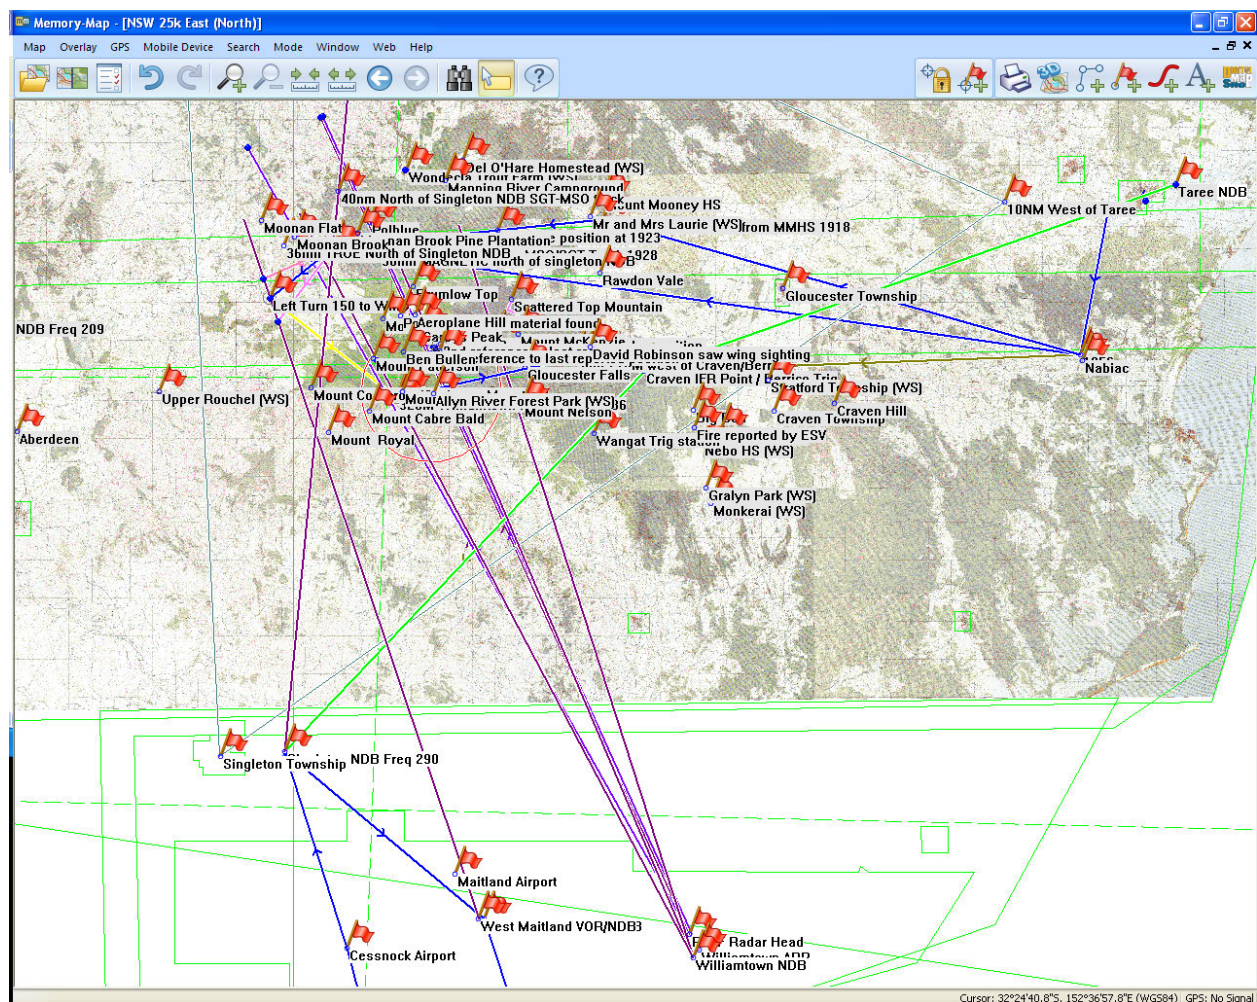
Below is a large scale view of the Barrington tops. It has every geographical piece of information overlaid on it. This includes information contained in "Operation Phoenix" for comparison purposes. Further pictures will be less cluttered, as they will be zoomed into the relative area being discussed at the time.

The purple lines are 'reference lines'. When parts of the transcript say that, for example, he is '36nm north of Singleton on the Mount Sandon / Singleton track' there is a line drawn between the Singleton NDB navigation aid, and the Mount Sandon VOR navigation aid. Then, a point 36nm north of Singleton on that line is marked.

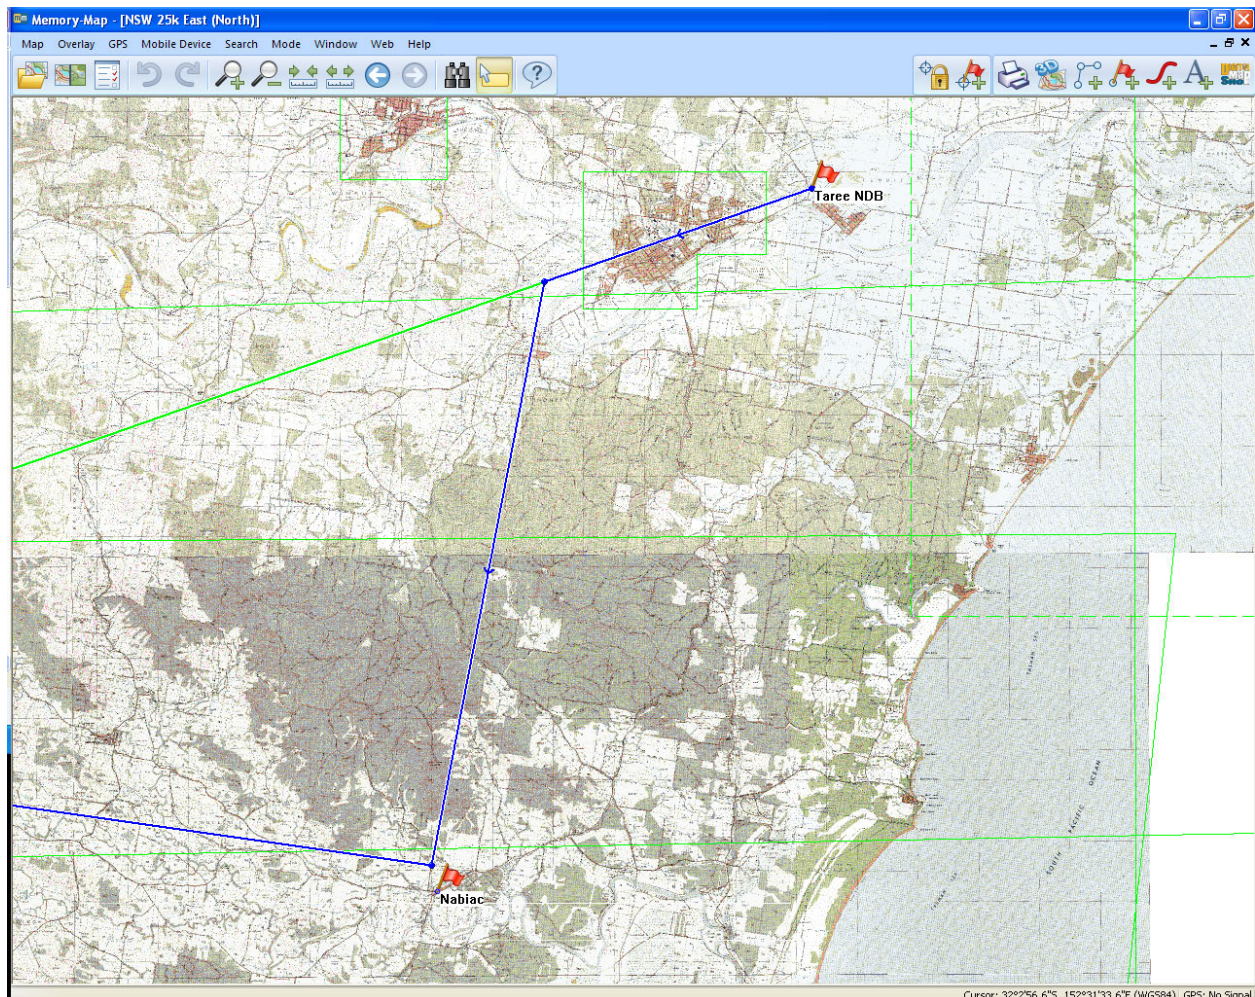
## Taree to Nabitac

For example, he may have immediately turned for Craven over Taree, but then shortly turned again to track to Williamtown, as he was expecting a coastal clearance. When this was not forthcoming, the controller states that he is almost inside controlled airspace. The only way to correspond with the controllers' statement would be that MDX did in fact follow the flight path as mentioned earlier in this paragraph.

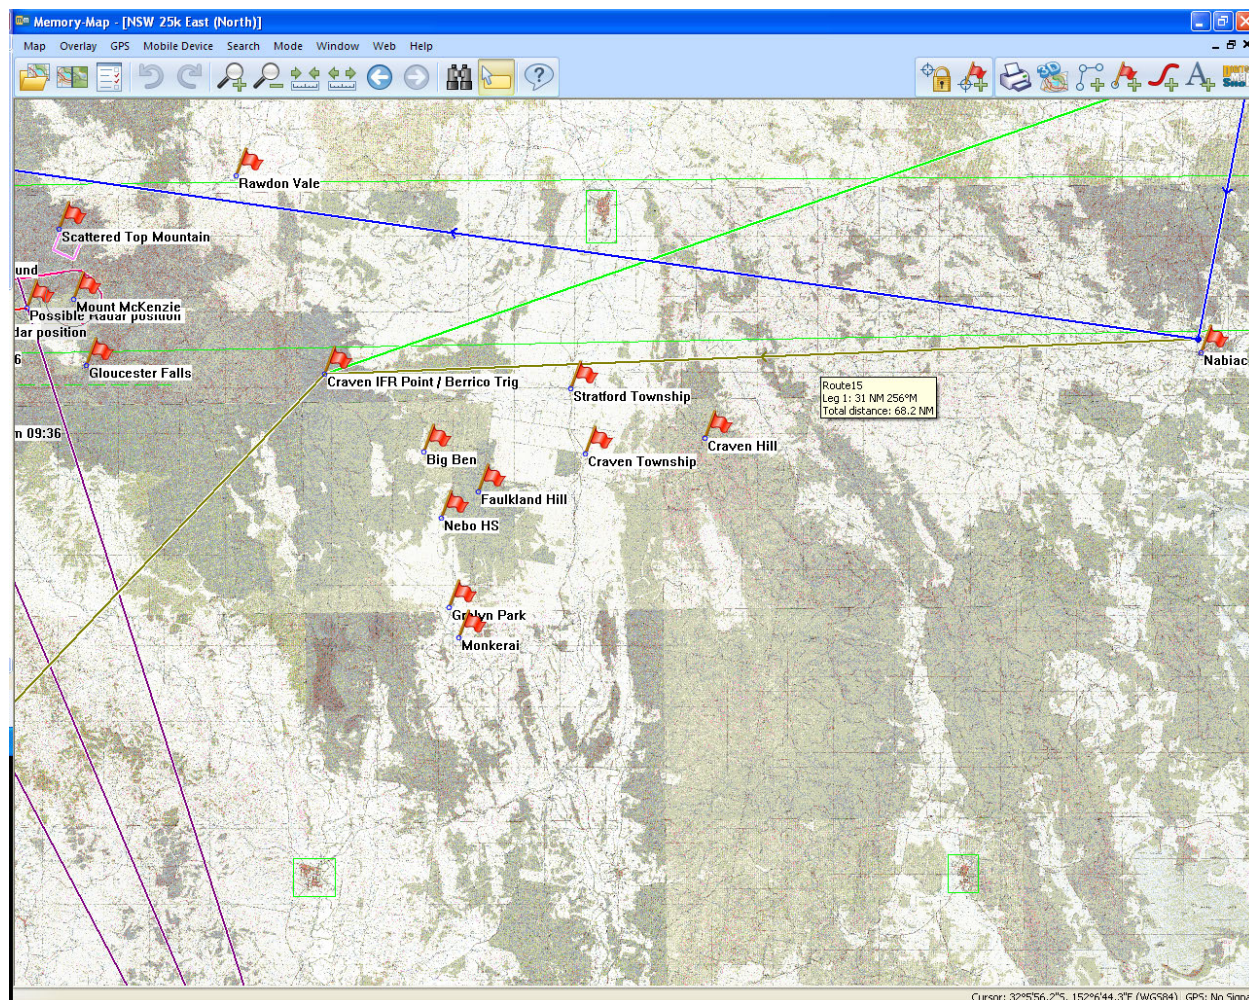
## Nabiac to 1928

From this point, the next position that can be plotted with reasonable certainty is the point 36nm North of Singleton, that will be referred to as 1928 from this point on. From here, the pilot intended to fly to Craven, then Singleton, indicated by the mustard line.

Although MDX did report that he was over Craven at 1918 there is some doubt as to him actually being overhead the reporting point when the report was made. The pilot reported that one of the primary navigation instruments, the ADF, which picks up the radio signal from the Singleton NDB was giving unreliable indications. To use this instrument to deduce his position overhead Craven would have been a relatively straight forward affair for a pilot of his experience.

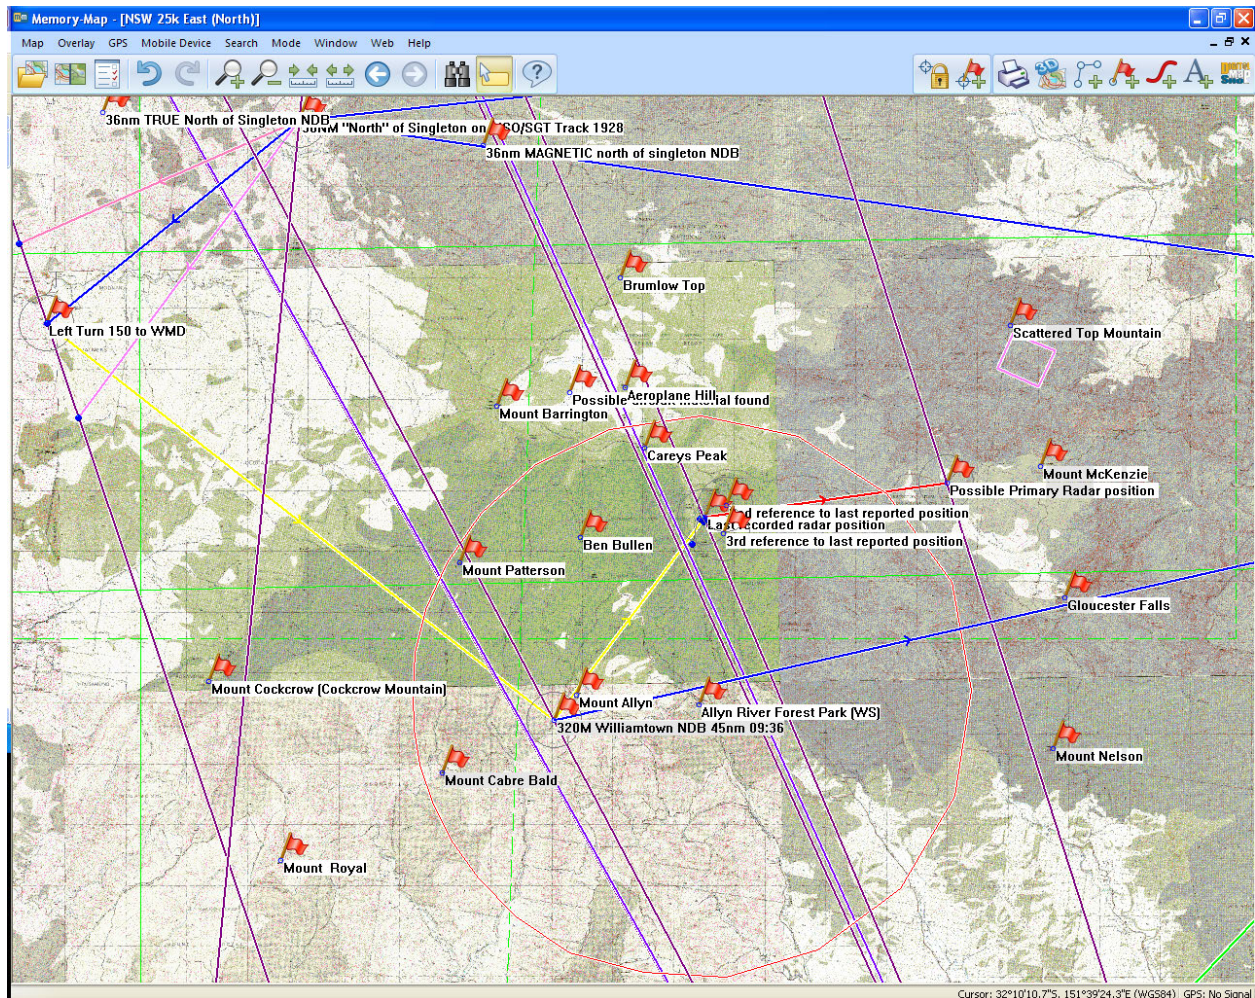
The controllers discuss between themselves the position and the pilot also reports that he is maintaining a magnetic heading somewhere around 220. The blue line from 1928 to 150 WMD is the 220M track, which would only be applicable to still air. The pink splay lines either side are the maximum possible variation given the wind speed and direction. For simplicity sake, I have used the middle point as the start for the next 'leg'. The important point to take from this is that from 1928 to when the controller said that he needs to track 150 to get to West Maitland, he can only be somewhere along that purple line furthest west.

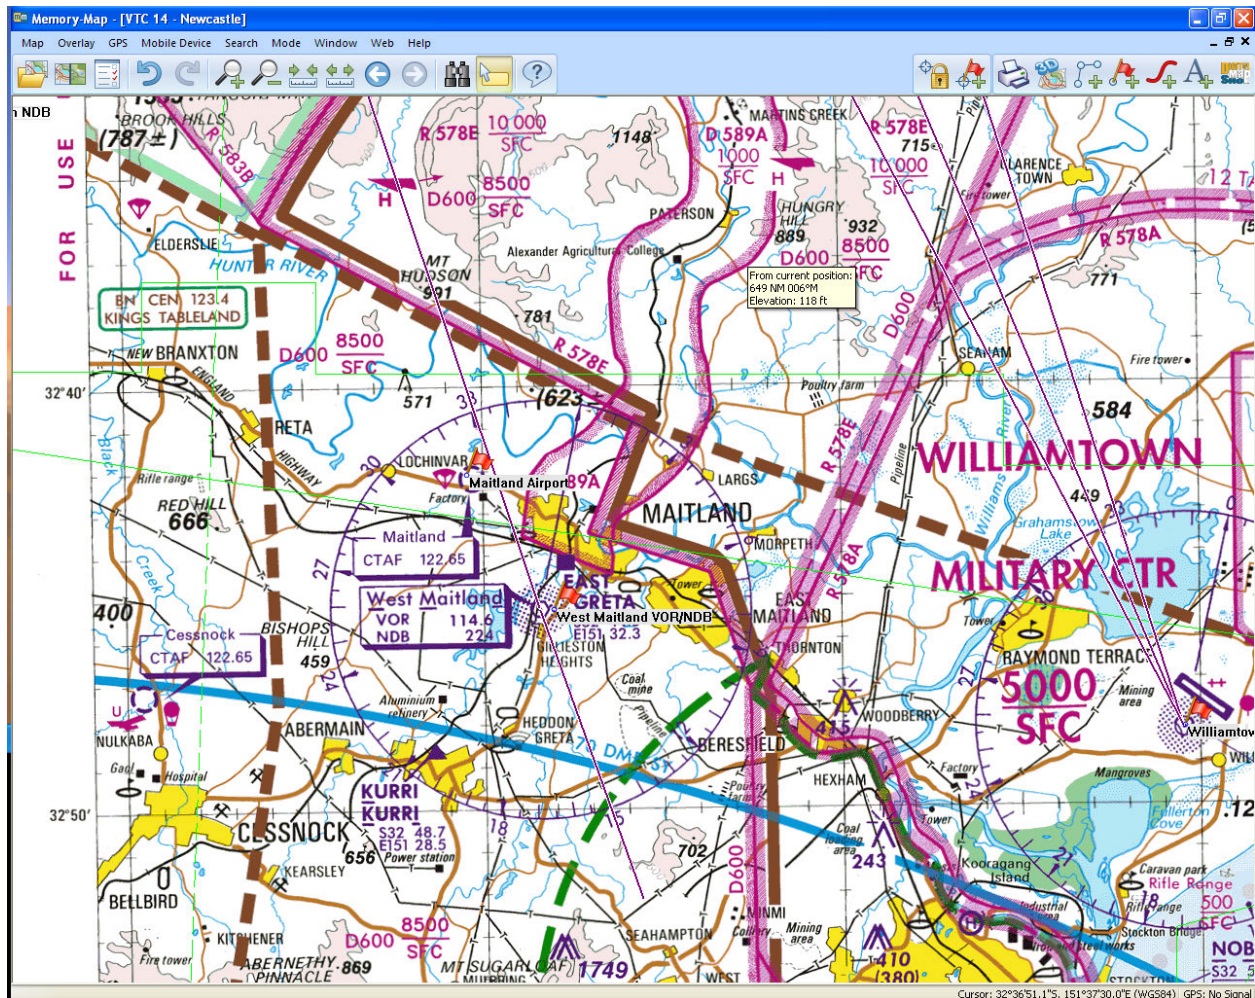
Close up of West Maitland with compass rose and line drawn through 150/330 extending North on the aeronautical map “Newcastle Visual Terminal Chart (VTC)”

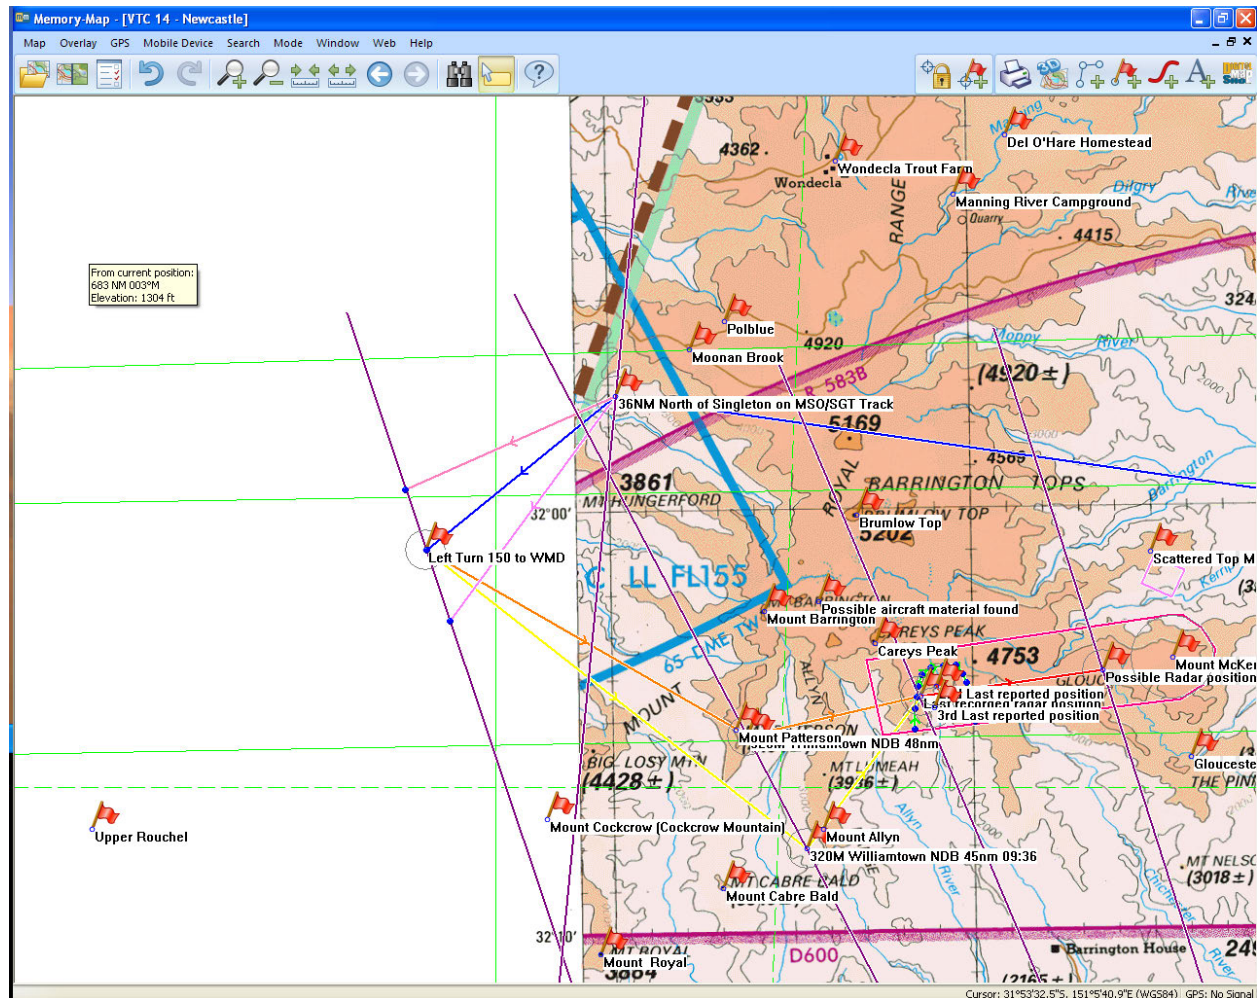
Continuing this line further north to the area in question, using the same map we can see the line extending through the approximate position of MDX.

Although this map coverage ceases just short of the approximate position, it is a scaled and geo-referenced map with the planning lines superimposed, scaled and geo-referenced to match. In summary, if you are anywhere north of the West Maitland VOR radio navigation aid, and need to steer 150 to go to it, you must be somewhere along that line. Conversely, if you are south of the beacon, you must steer 330 to go to it. If you are south of it, steering 150 will take you away from the beacon in a southerly direction. To find out where exactly along that line the aircraft is requires further information, for example, dead reckoning or a position line from another navigation aid, and where those two lines intersect, is where the position may be fixed. The information used to obtain an approximate position of MDX is the start position of 1928, and the pilot reporting his heading as “averaging 220” when queried about it from leaving 1928.

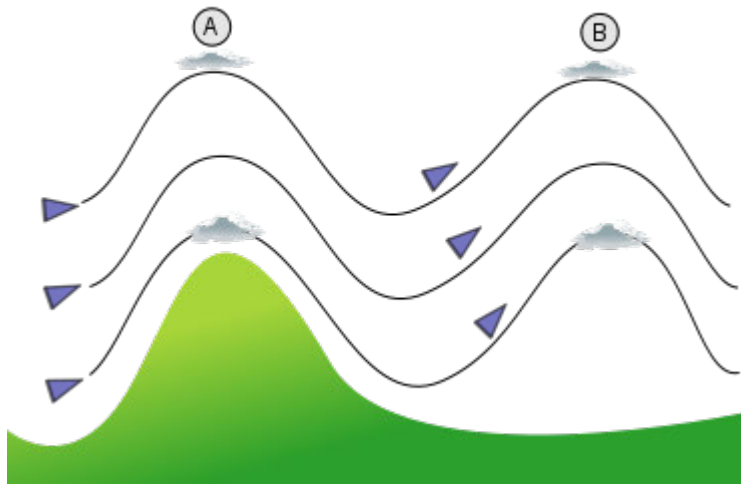
From here MDX was seen to be tracking easterly, and was descending at very high rates of descent. This here is some of the highest ground in the area (for example, Mount Patterson being about 4390 feet AMSL and Careys peak being about 4899 feet AMSL). There are several ridges and valleys parallel to each other that run roughly north/south. The aircraft was heading perpendicular to those and the wind was blowing from the west, also running roughly perpendicular to them. This would have created a phenomenon known as 'lee waves' which are a form of atmospheric standing wave. Below is a simplified diagram of a lee wave.

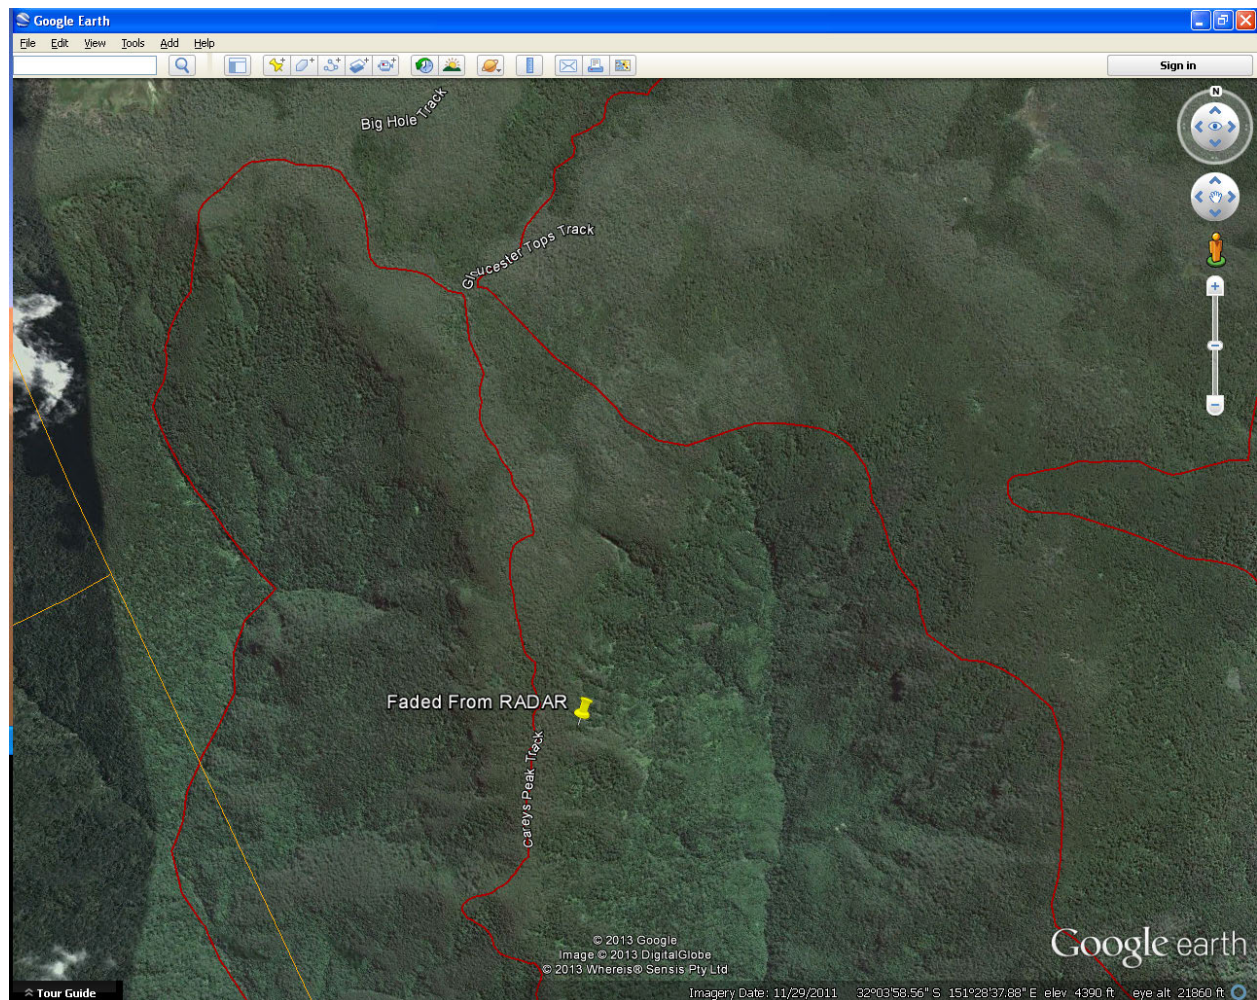
This site, shown above on the map in bright green, has many properties appropriate to the possible crash site of MDX.

- It has high terrain on all sides, just below the last reported height of MDX.
- It would have had very strong lee waves blowing as a tailwind on MDX, pushing it down into the valley.
- It was observed to fade from radar over this point
- This area was never searched in the original foot search for the aircraft. See the GE image below which has the original search areas superimposed on it.
- It is heavily vegetated, with triple canopy forest and very steep terrain.

The lines in red indicate search areas searched in 1981.

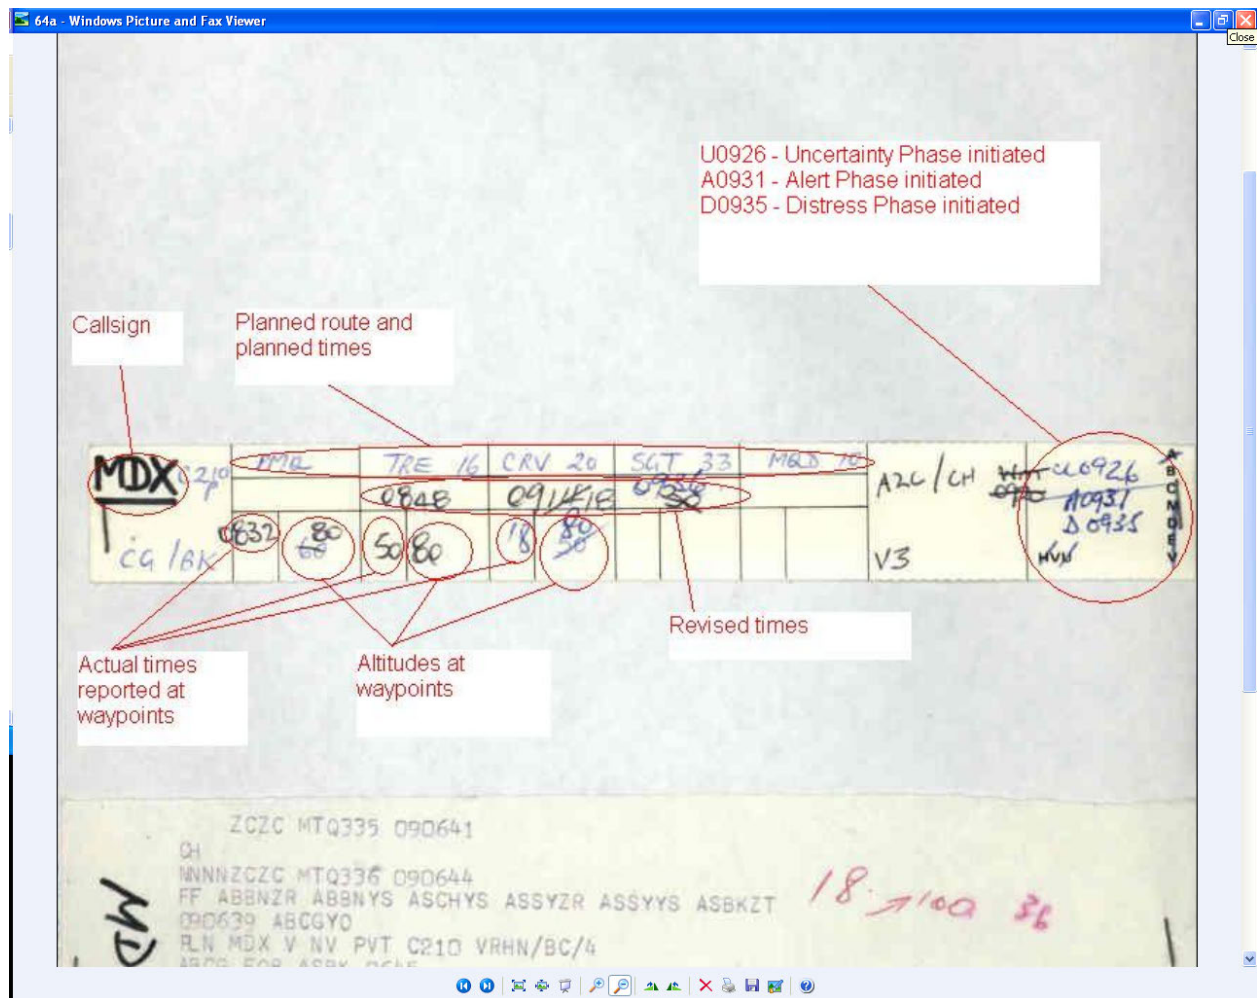
Above is the flight strip written by FIS5. Below is a version with explanations of the writing. Both these files can be found in the dropbox file repository.

As this can be plainly seen, the controller was writing on the flight strips, as the event was unfolding, and would have been looking at the master clock to write the times as events occurred.
